Improve the Quality and Service Life of
Water-based Pavement Marking Paints on
Pavements with High-Iron Aggregates
Final Report

Prepared by Jacobs Engineering Group Inc. for the
New Hampshire Department of Transportation in cooperation with the
U.S. Department of Transportation, Federal Highway Administration

1. Report No. FHWA-NH-RD-15680J	2. Government Accession No.	3. Recipient's Catalog No.	
4. Title and Subtitle Improve the Quality and Service Life of Water-based Pavement Marking Paints on Pavements with High-Iron Aggregates		5. Report Date August 2015

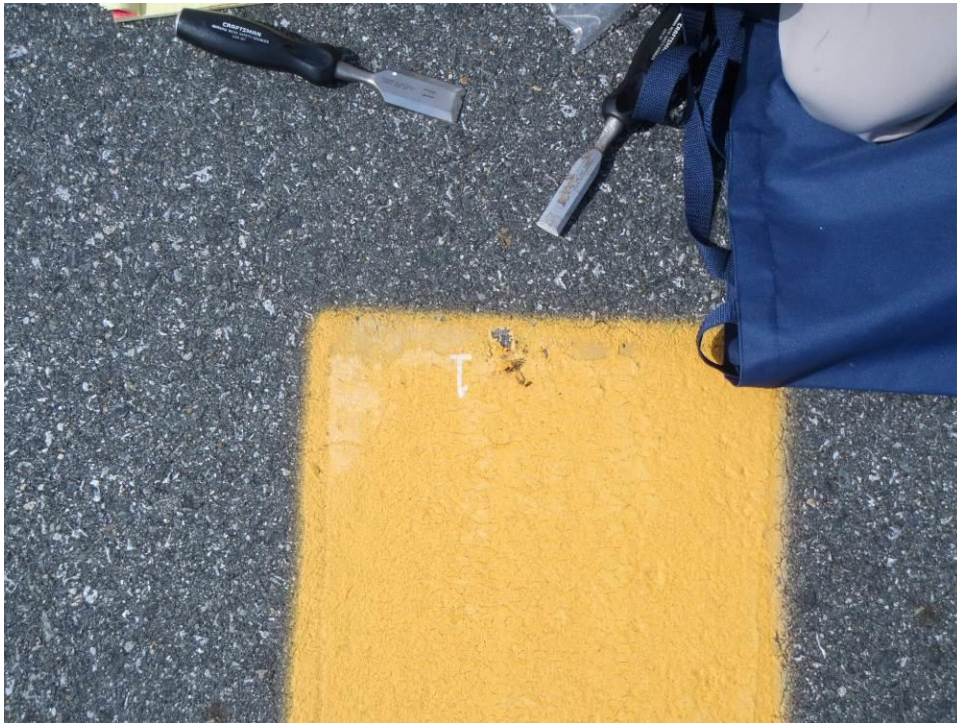
Photo 1 – Close up of paint sample 1. Note only the paint was removed.

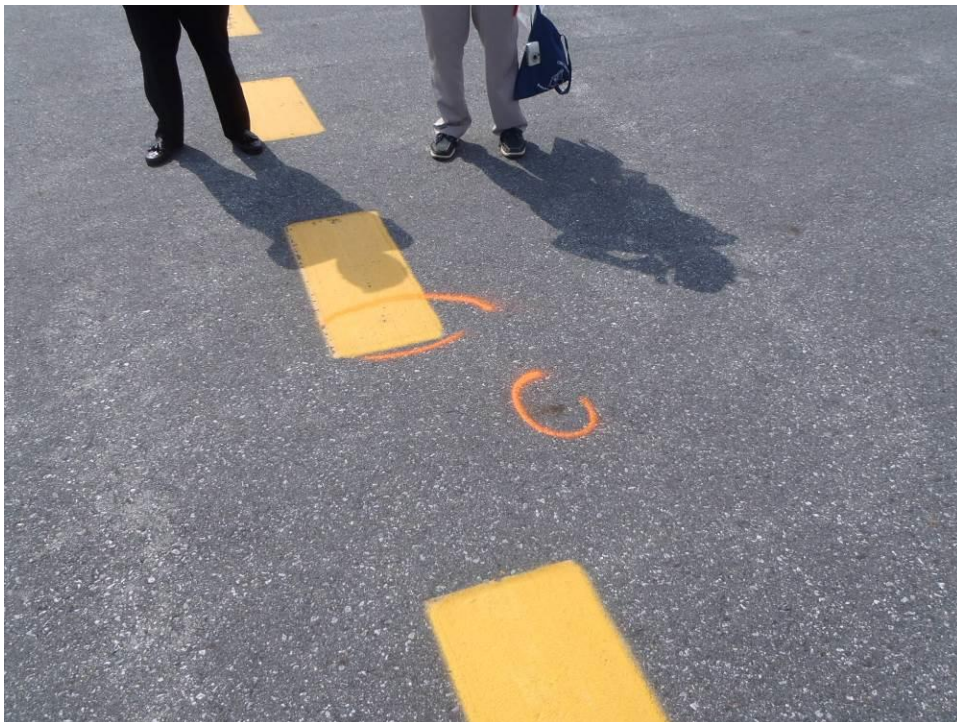
Photo 2 – Proposed core locations 1 and 2. Located on the south central edge of the terminal ramp.

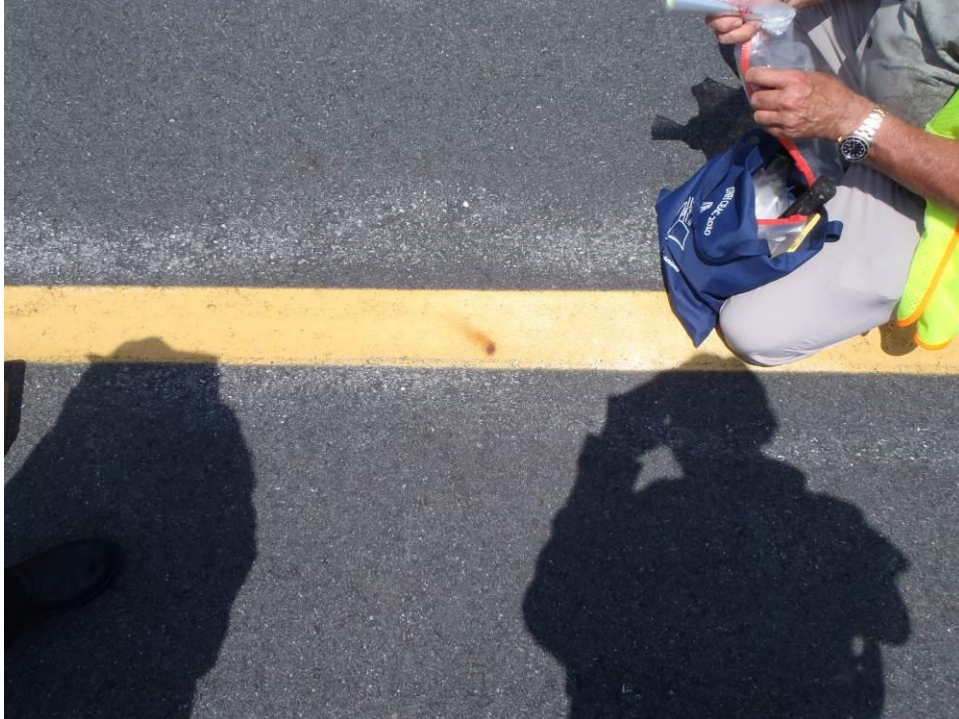
Photo 1 – Paint sample 1 taxiway C west about 200 feet west of taxiway A and C intersection.

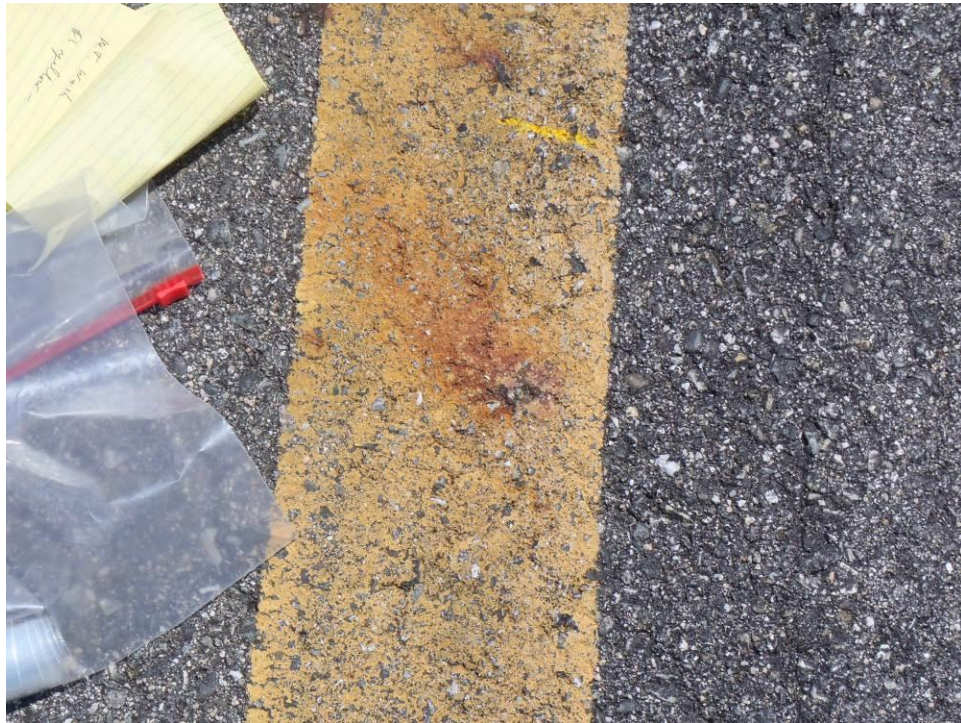
Photo 2 – Close up of paint sample location 1 before sampling.

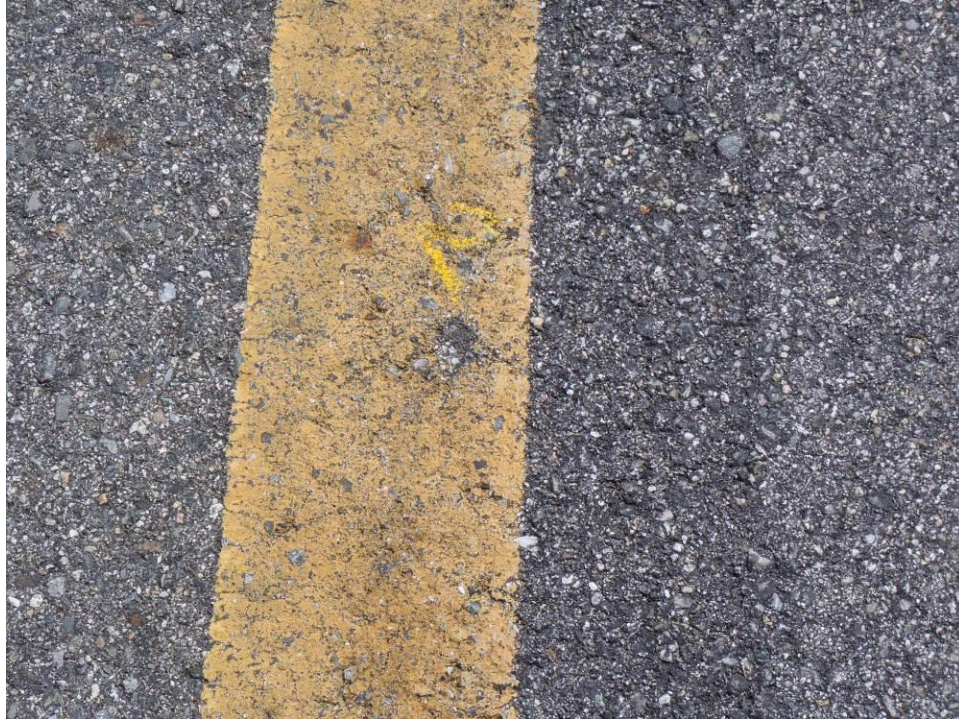
Photo 3 – Close up of paint sample location 2 before sampling.

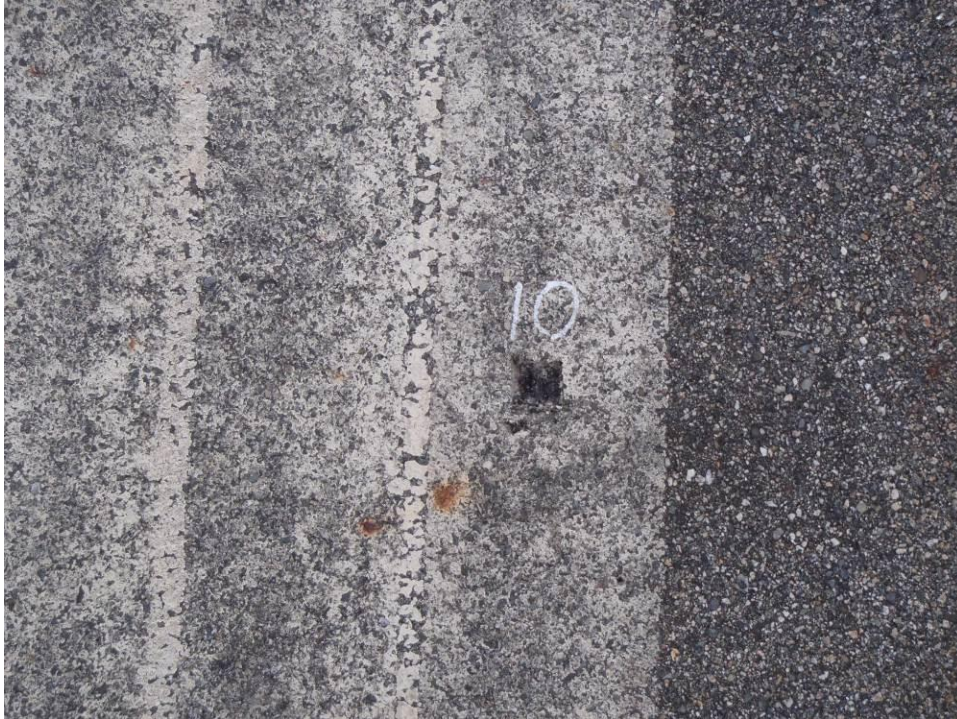
Photo 13 – Close up of paint sample 10 after sample taken.

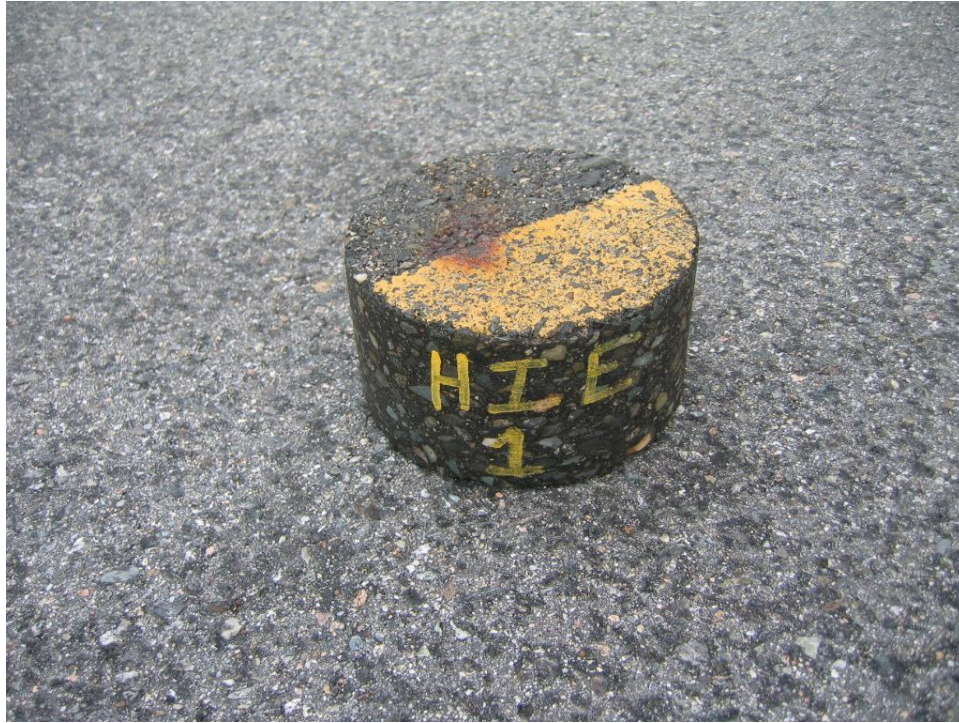
Photo 14 - Mount Washington Regional Airport (HIE) Core 1 from centerline of taxiway A near intersection with taxiway B

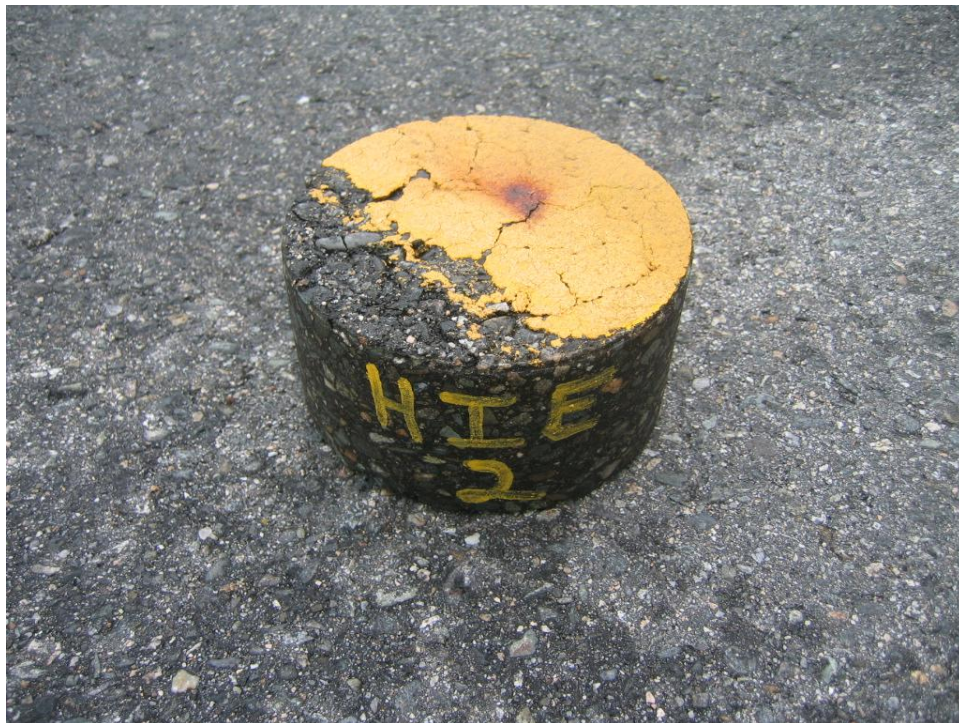
Photo 15 - HIE Core 2 from hold short marking taxiway A at runway 10 right side

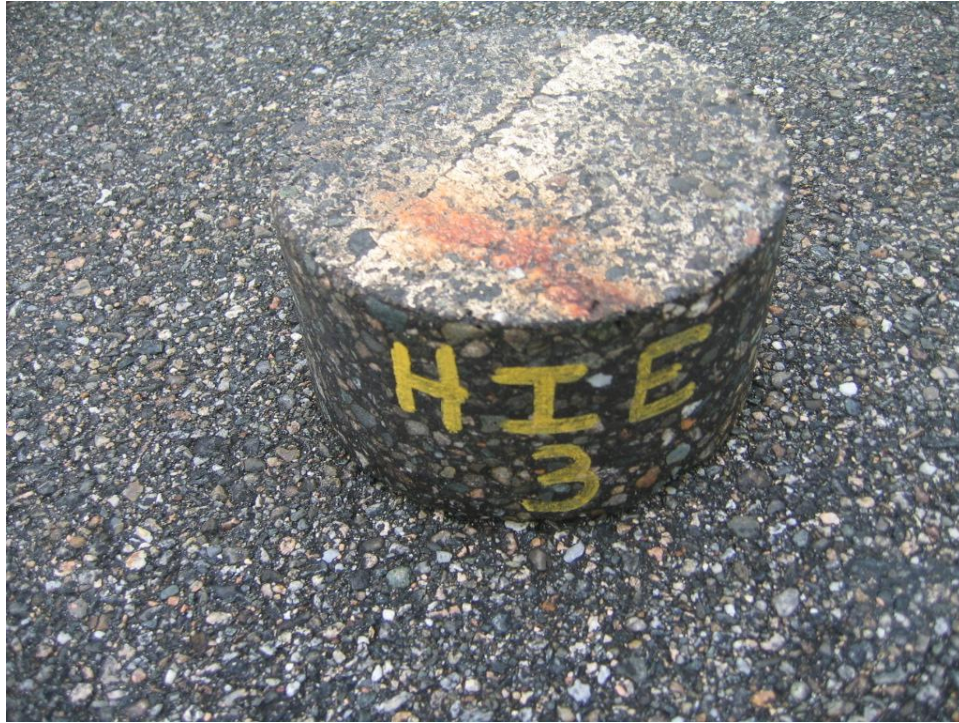
Photo 16 - HIE Core 3 from tough down marking runway 10 end left side.

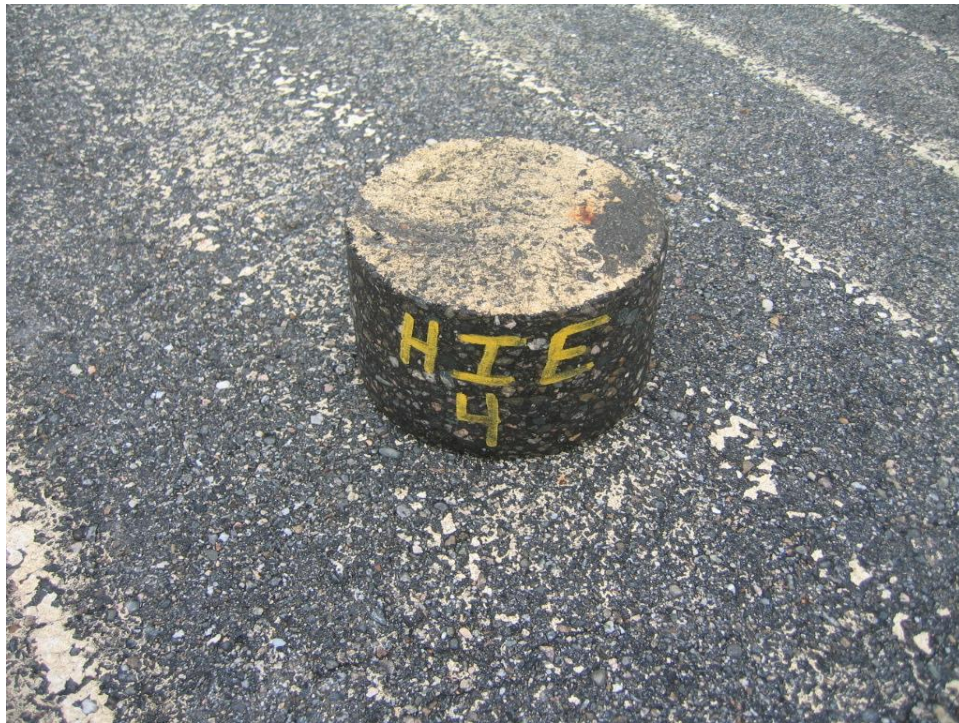
Photo 17 HIE Core 4 from touch down marking runway 10 end right side.

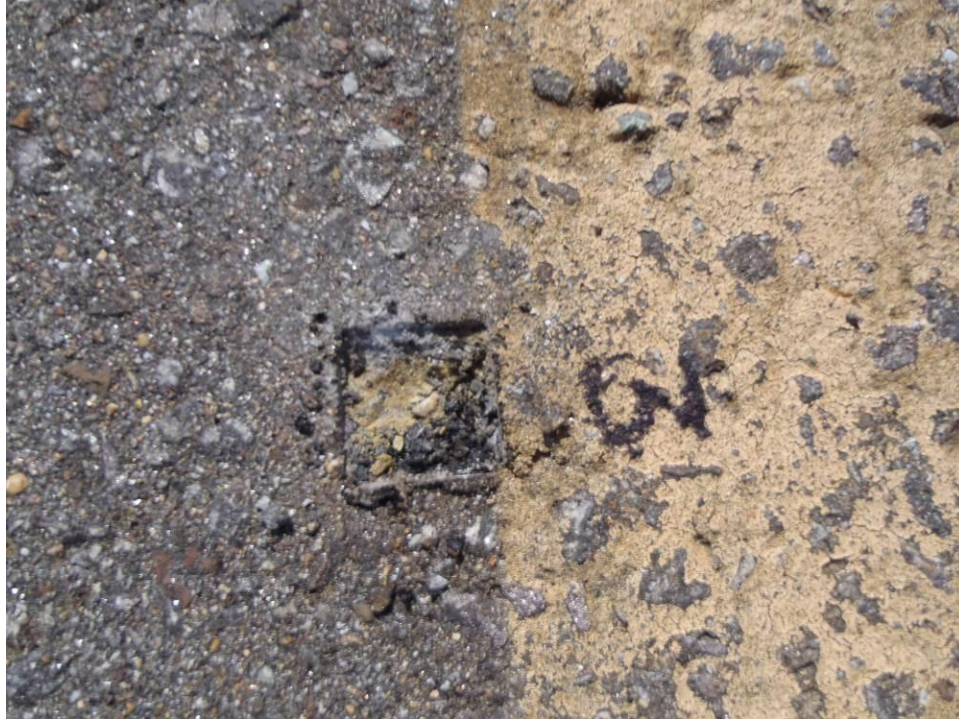
Photo 3 – Close up of sample 3 before removal.

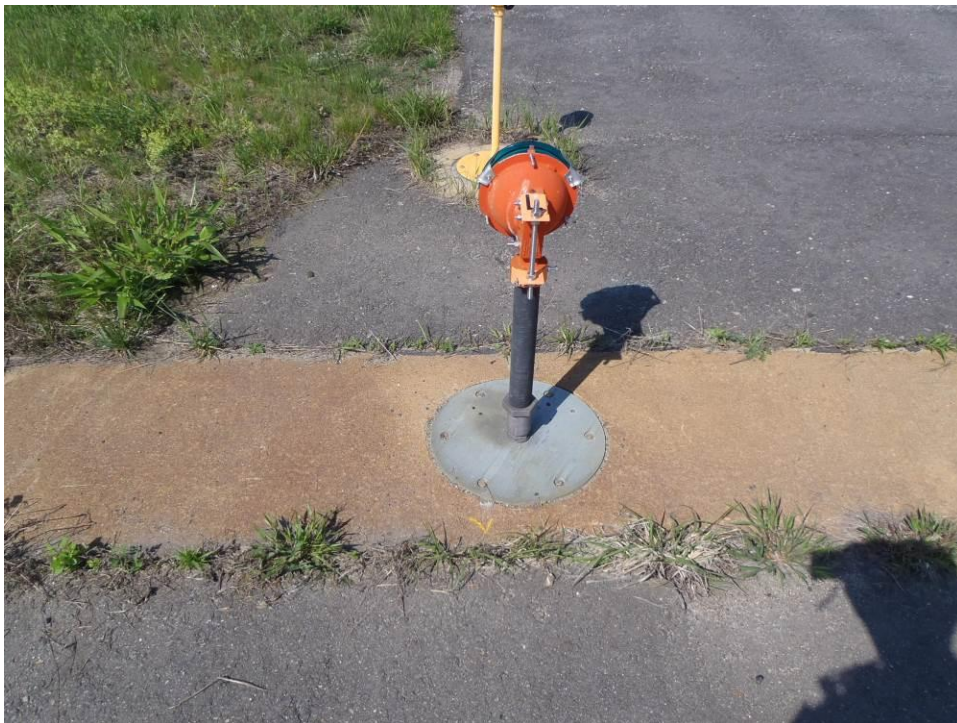
Photo 6 – Southern most runway end light Runway 8. Paint sample 7 taken at base of light.

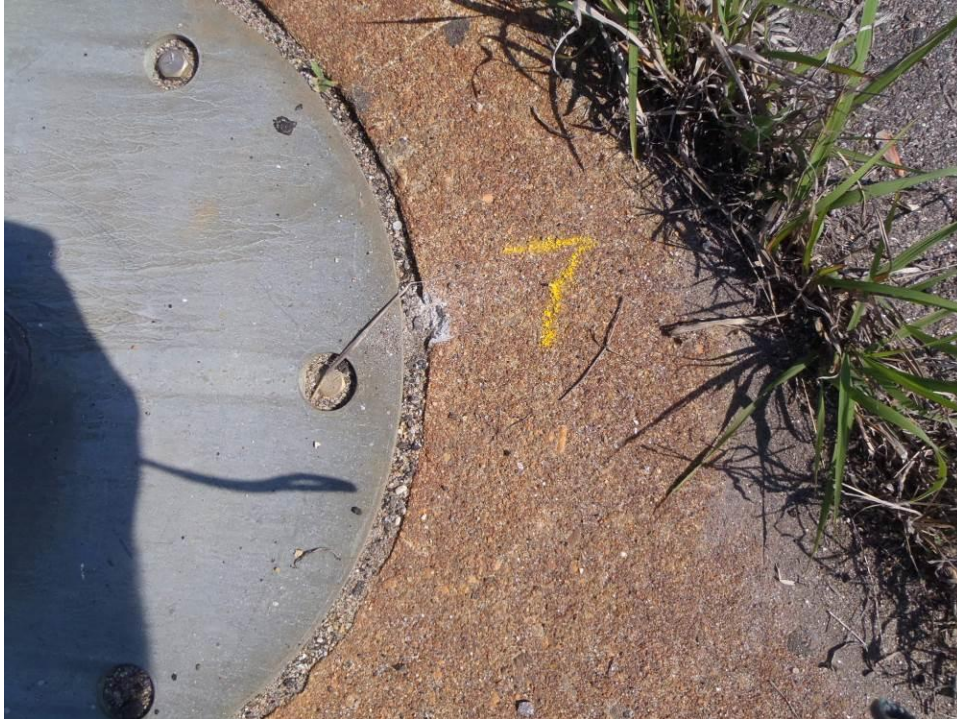
Photo 7 – Close up of paint sample 7 taken on the concrete light bar at the end of Runway 8.

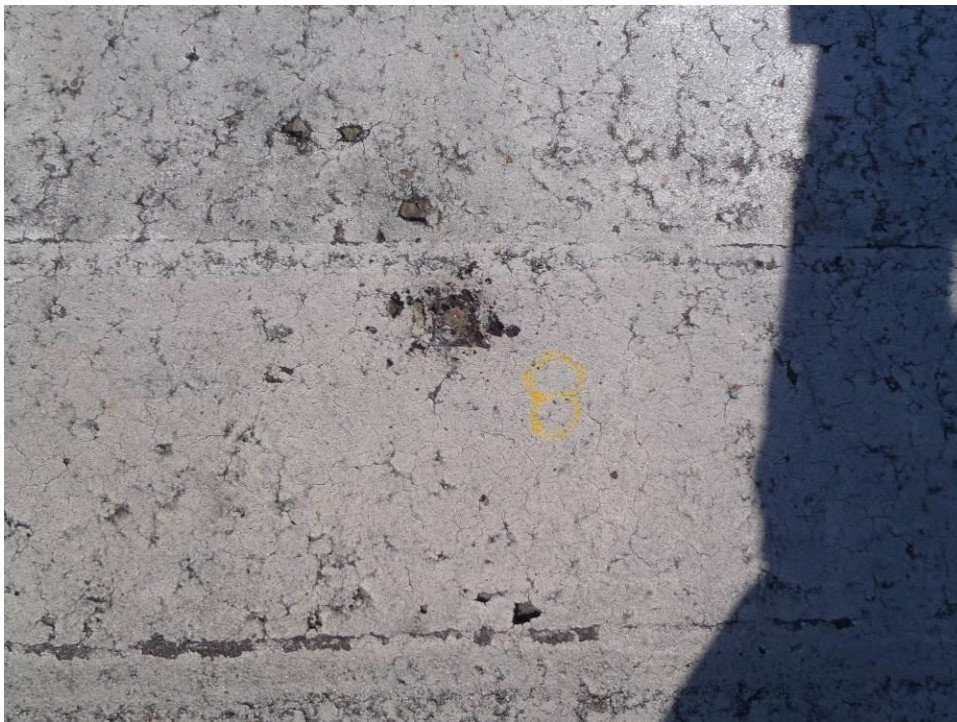
Photo 8 – Close up view of paint sample 8 taken near the centerline of the threshold bar on Runway 8.

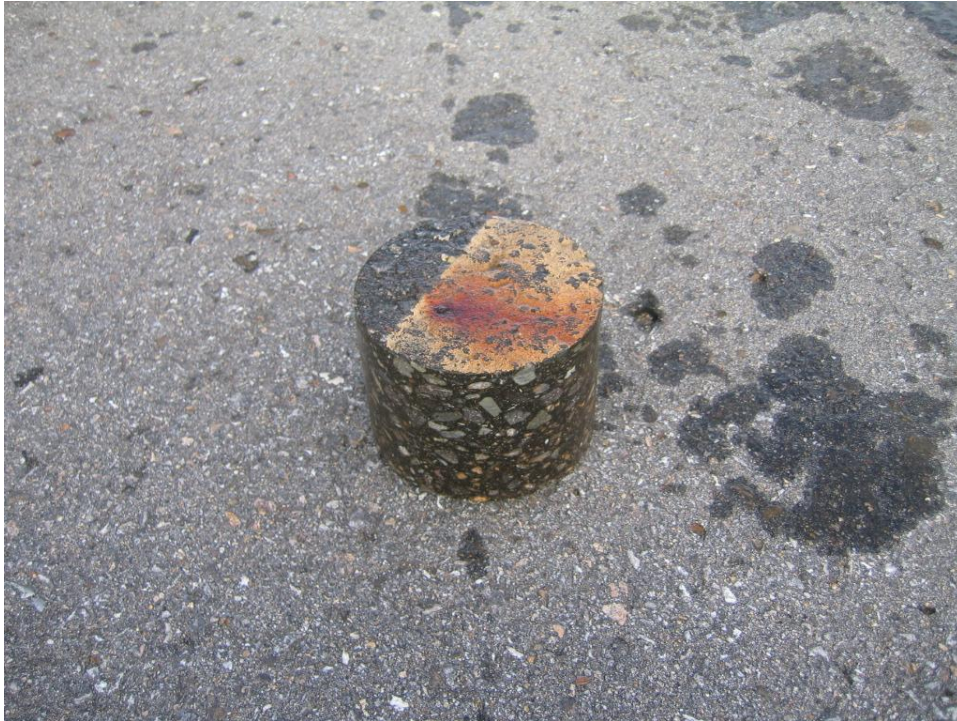
Photo 11 Laconia Airport (LCI) Core 1 - blast pad left side runway 8 end

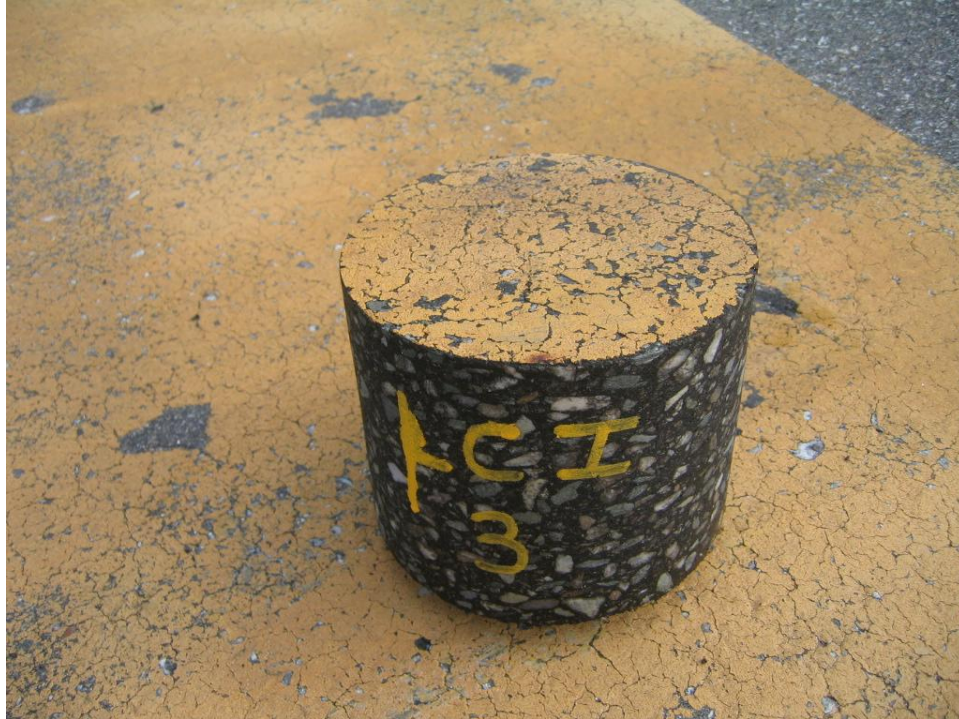
Photo 13 LCI Core 3 - taxiway C western end right side of ILS marking

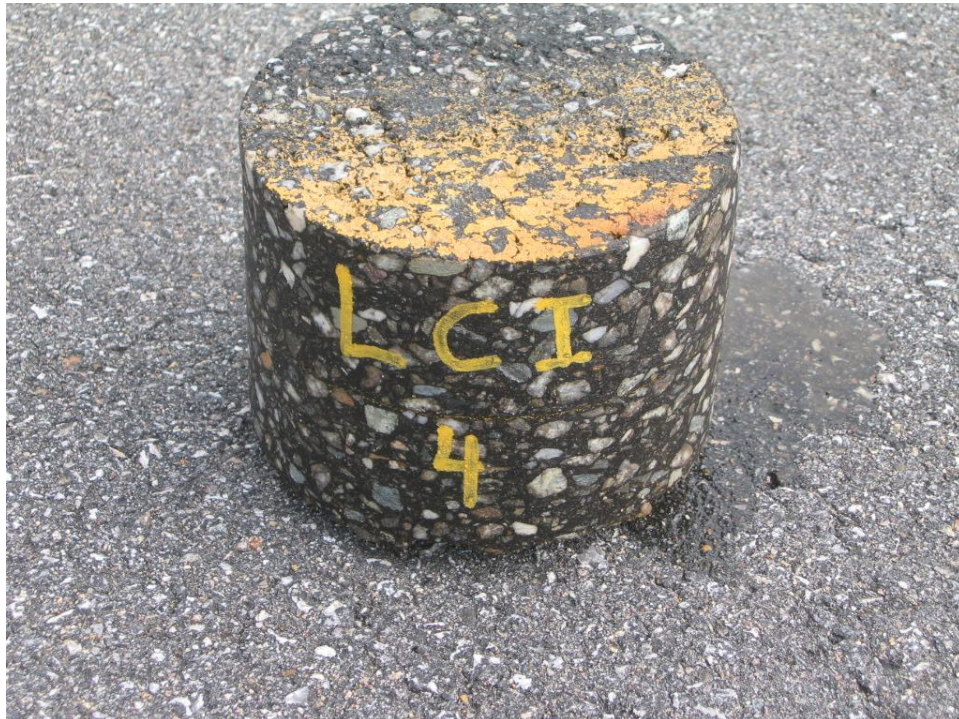
Photo 14 LCI Core 4 - taxiway C centerline across from terminal apron

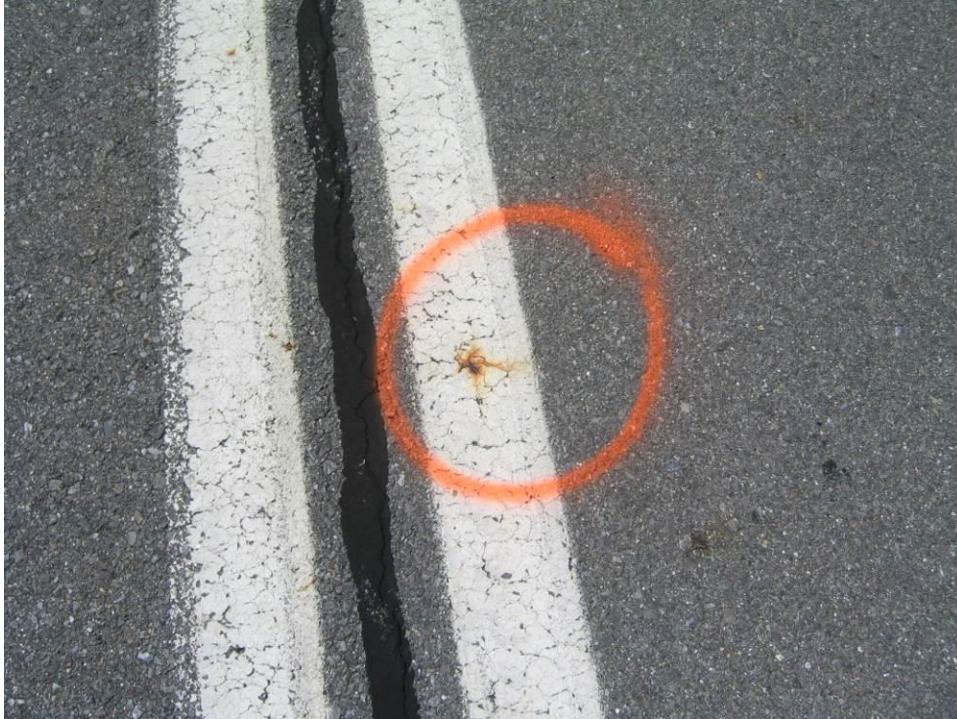
Photo 1 – Close up of paint sample.

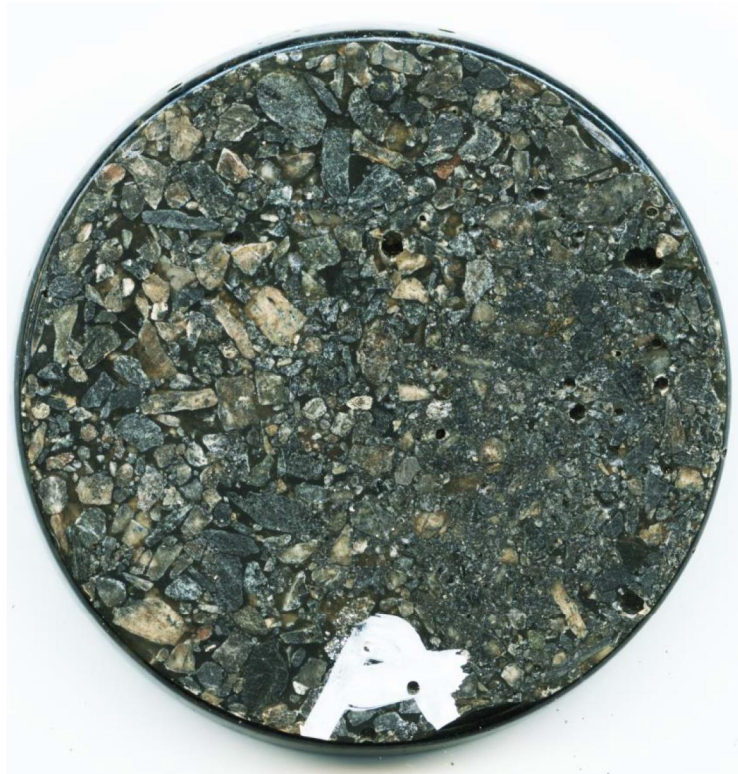
Figure 86 Claremont magnetic aggregate epoxy disk side A after polished in ethanol alcohol

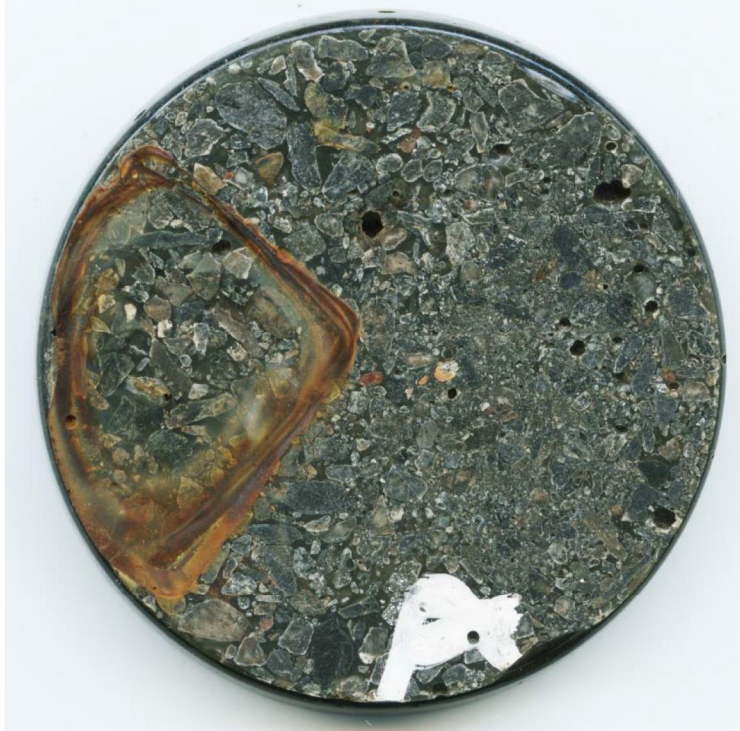
Figure 87 shows Claremont disks sides B and D placed on 1"x1"x1/4" stainless plate such that the disks were above the water line and subject to humidity only. The containers were placed in an oven held at 100 °F for 3 months. Figure 88 shows disk B/A after 3 months of storage over water held at 100 °F. It was noted that rust staining occurred on the plastic container where the stainless steel plate had been. The bottom side of the B face (side A) also showed rust where it had been placed on the stainless steel plate as shown on Figure 89. In all cases the stainless steel showed no signs of rust. The rust originates in the aggregate then becomes mobile and deposits elsewhere similar to what happens in the field on the paint markings and the HMA surface. A close up of the before and after soaked for 3 months is shown on Figure 90.

Figure 89 Claremont magnetic aggregate epoxy disk side A after soaked over water at 100 °F for 3 months
