**EVALUATION OF THE CRASHWORTHINESS OF THIN-WALLED  
ALUMINUM AND STEEL U-CHANNEL SIGN SUPPORTS**

TTI Project No. 405231-1F  
Final Report

June 1995

**Texas Transportation Institute  
Texas A&M University System  
College Station, TX 77843**

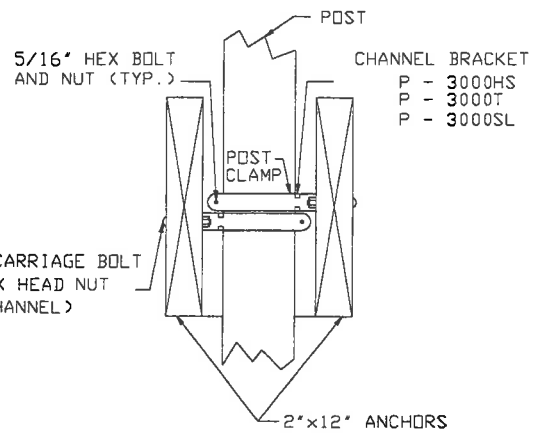
Figure 4. Elevation View of the Modified Dual Thin-Walled Aluminum Sign Support Installation.

During the course of testing, a 102 mm (4.00 in) diameter thin-walled aluminum dual support sign installation failed to comply with the evaluation guidelines presented in NCHRP Report 350. A suitable retrofit was sought for use on installations currently in the field. Two retrofit configurations were considered. The first retrofit, shown in Figure 4, involved modifying the sign supports by drilling two 38 mm (1.5 in) holes in the supports at two different elevations along each support (4 holes total, per support). The holes were drilled at ground level and 457 mm (18.0 in) above ground level. The holes drilled at ground level were oriented 90 degrees to the plane of the sign panel or parallel to the direction of impact. The holes drilled 457 mm (18.0 in) above ground level were oriented parallel to the plane of the sign panel or transverse to the direction of impact. All holes drilled at the same elevation were oriented 180 degrees apart.

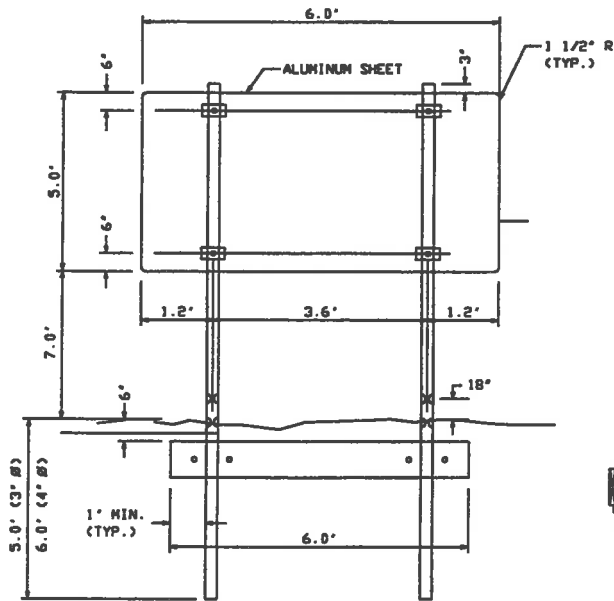
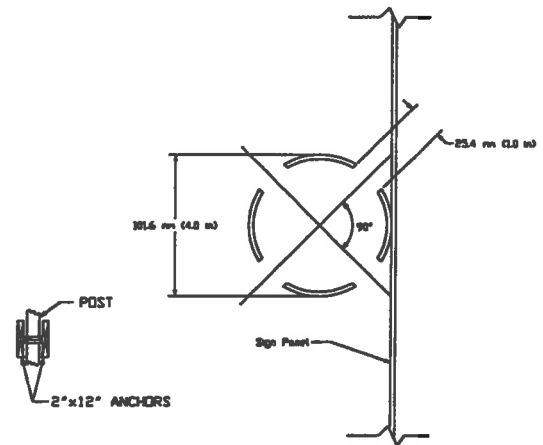
Figure 5. Elevation View of the Vermont Modified Dual Thin-Walled Aluminum Support Sign Installation.

The second retrofit, shown in Figure 5, involved modifying the sign supports by drilling four - 25.4 mm (1.0 in) diameter holes in a cross pattern, 45 degrees relative to the sign panel face. Four holes were drilled at ground level and four additional holes were drilled at 457 mm (18.0 in) above the ground. The cross drilled pattern modification is shown in Figure 5. The holes drilled at the same elevation were oriented 90 degrees apart.

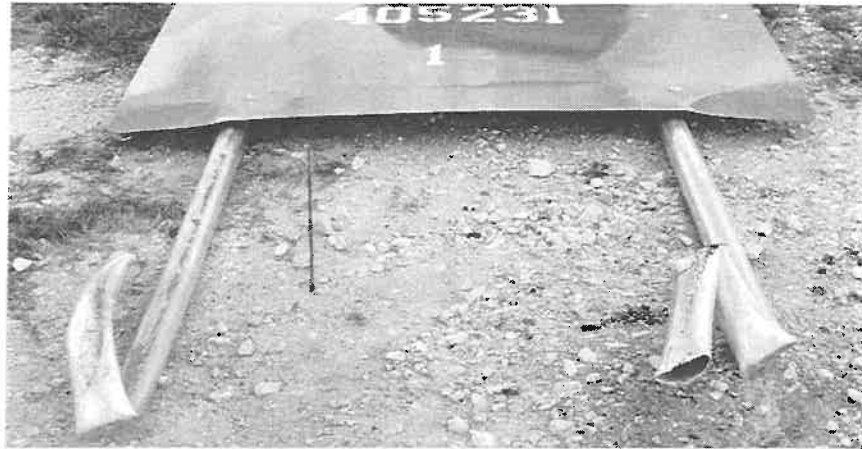
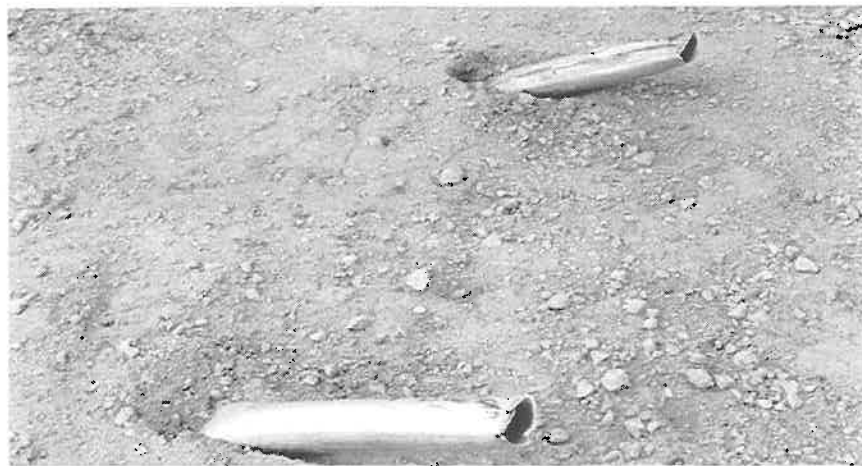
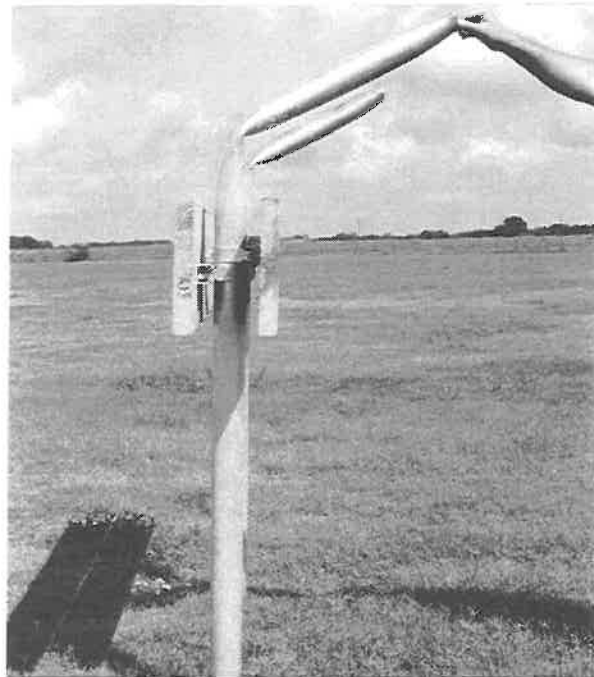
Figure 12 . Dual 3 in. aluminum sign support installation anchored in strong soil after test 405231-1.

As shown in Figure 12, the supports were bent and fractured. The left support failed 381 mm (15.0 in) from ground level and the right support 457 mm (18.0 in) from ground level. The sign panel and all mounting and anchoring hardware received minimal damage and could be

B. The test article should readily activate in a predictable manner by breaking away, fracturing, or yielding.	The sign supports yielded by bending the aluminum tubes at ground level and fracturing in tension near bumper level.	Pass
<u>Occupant Risk</u>

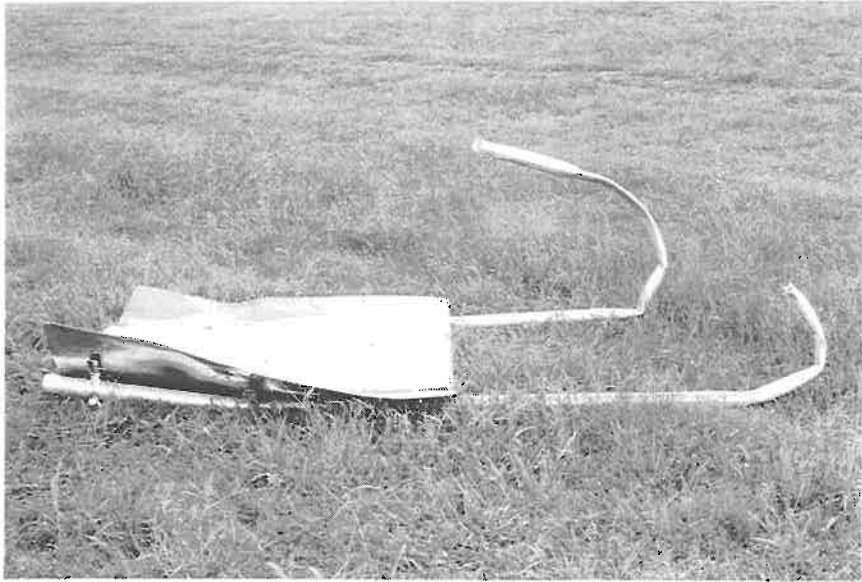
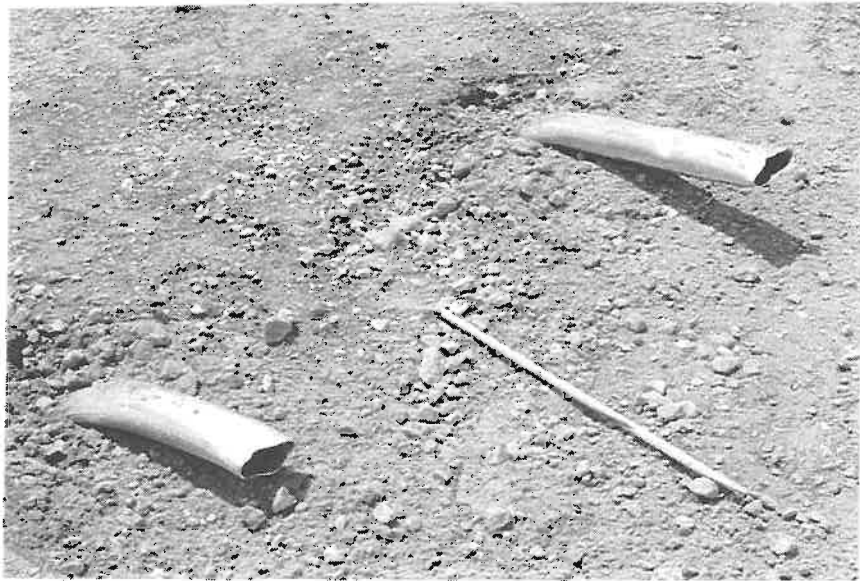
Figure 19 . Dual 3 in. aluminum sign support installation anchored in strong soil after test 405231-2.

As shown in Figure 19, the supports were bent and fractured. The left support failed 572 mm (22.5 in) from ground level and the right support 406 mm (16.0 in) from ground level. The mounting and anchoring hardware received minimal damage and could be reused in field renovation of this installation. However, the sign panel required replacement. Damage sustained by the vehicle during this test is shown in Figure 20. The vehicle sustained moderate roof and hood damage and minor damage to the front bumper, grill and windshield. Maximum vertical crush to the roof was 100 mm (3.9 in). Maximum deformation to the front of the vehicle at the impact points was 10 mm (0.4 in). There was deformation, but no intrusion into the vehicle occupant compartment.

B.	The test article should readily activate in a predictable manner by breaking away, fracturing, or yielding.	The sign supports yielded by bending the aluminum tubes at ground level and fracturing in tension near bumper level.		Pass	
<b>Occupant Risk</b>

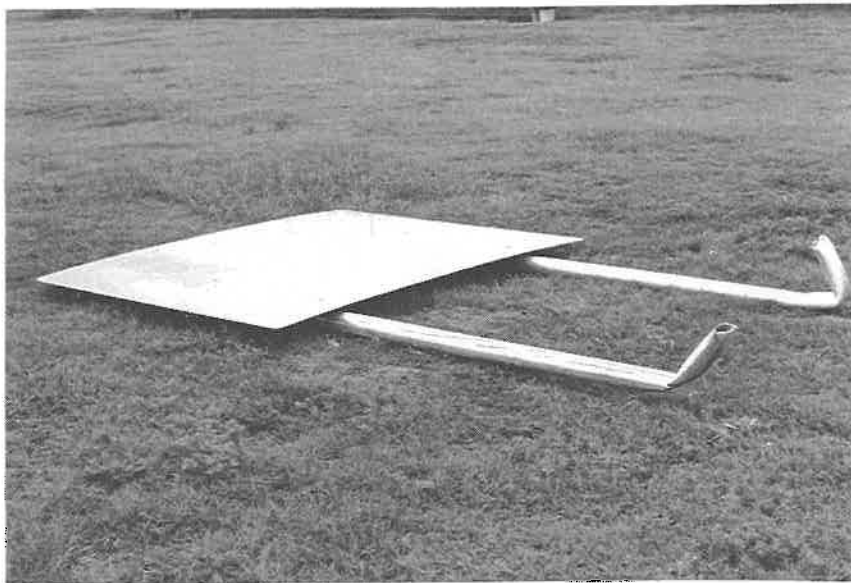
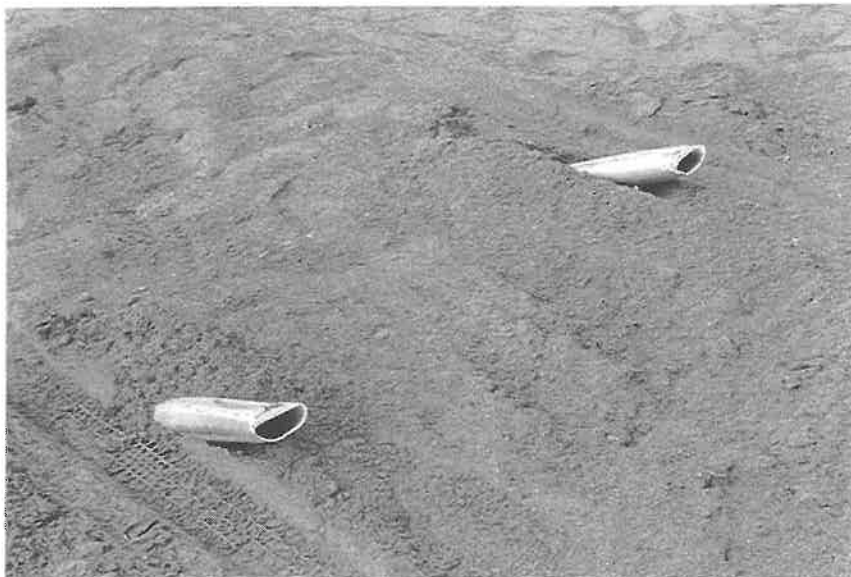
Figure 26 . Dual 3 in. aluminum sign support installation anchored in weak soil after test 405231-3.

As shown in Figure 26, the supports were bent and fractured. The left and right supports failed 406 mm (16.0 in) from ground level. The sign panel and all mounting and anchoring hardware received minimal damage and could be reused in field renovation of this installation. Damage sustained by the vehicle during this test is shown in Figure 27. The vehicle sustained primarily cosmetic damage to the bumper and hood. The left headlight was broken during the test, but the vehicle sustained no permanent deformation to the sheet metal. There was no deformation into the vehicle occupant compartment.

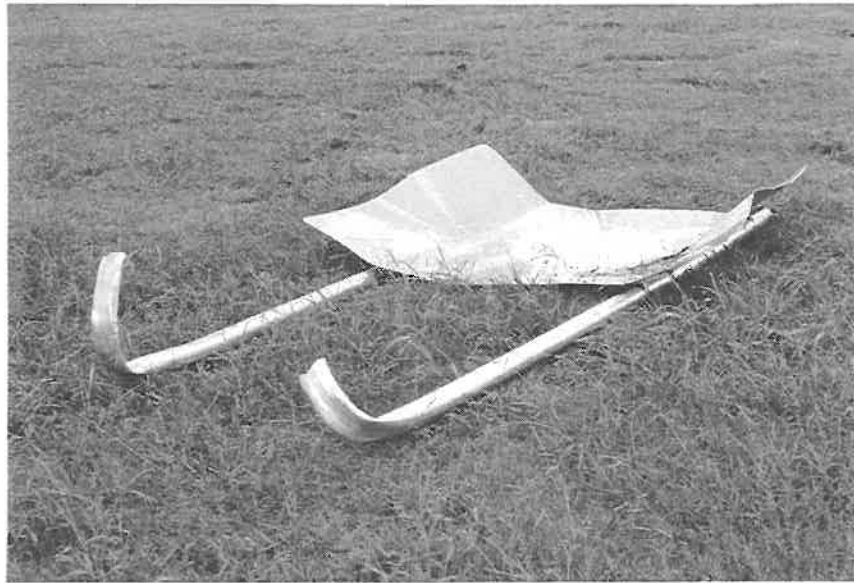
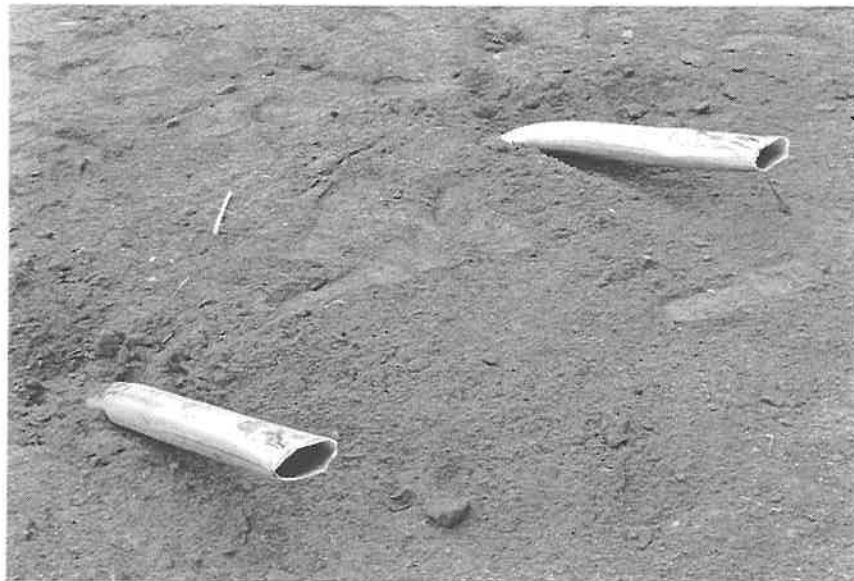
Figure 32 . Dual 3 in. aluminum sign support installation anchored in weak soil after test 405231-4.

As shown in Figure 32, the supports were bent and fractured. The left support failed 610 mm (24.0 in) from ground level and the right support 584 mm (23.0 in) from ground level. The mounting and anchoring hardware received minimal damage and could be reused in field renovation of this installation. However, the sign panel required replacement. Damage sustained by the vehicle during this test is shown in Figure 33. The vehicle sustained moderate roof, hood and top of doors damage. In addition, minor damage to the front bumper, grill, windshield and left front fender were sustained. Maximum vertical crush to the roof was 90 mm (3.5 in).

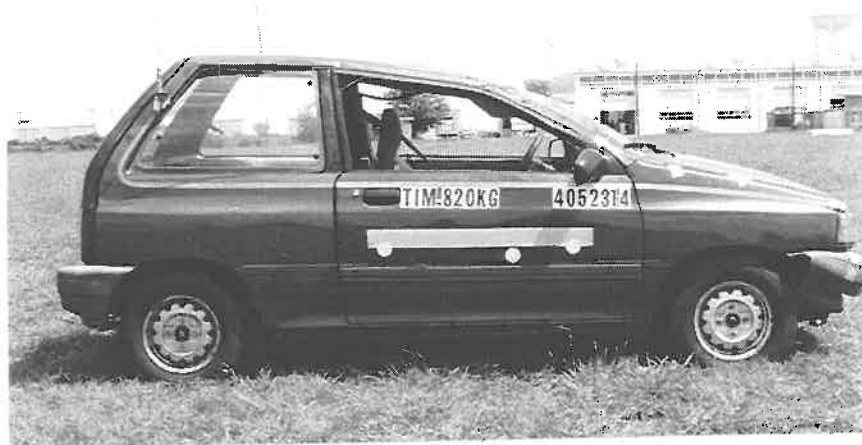
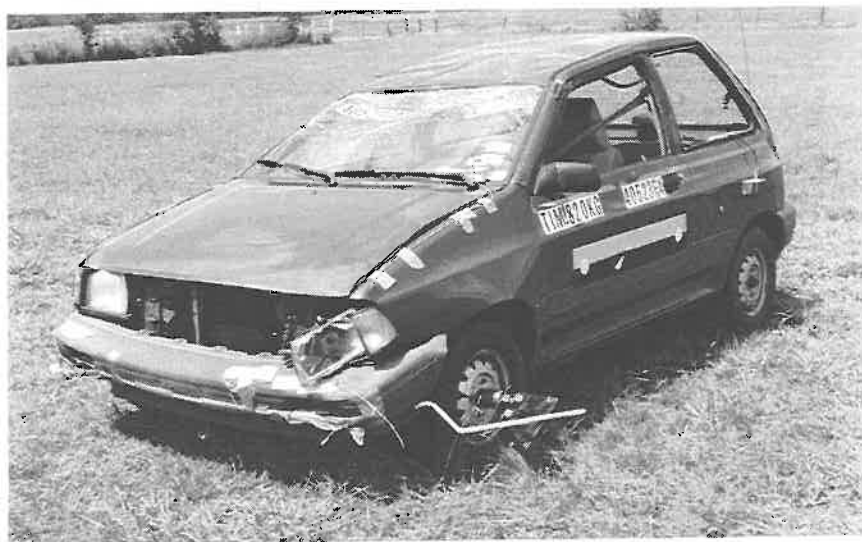
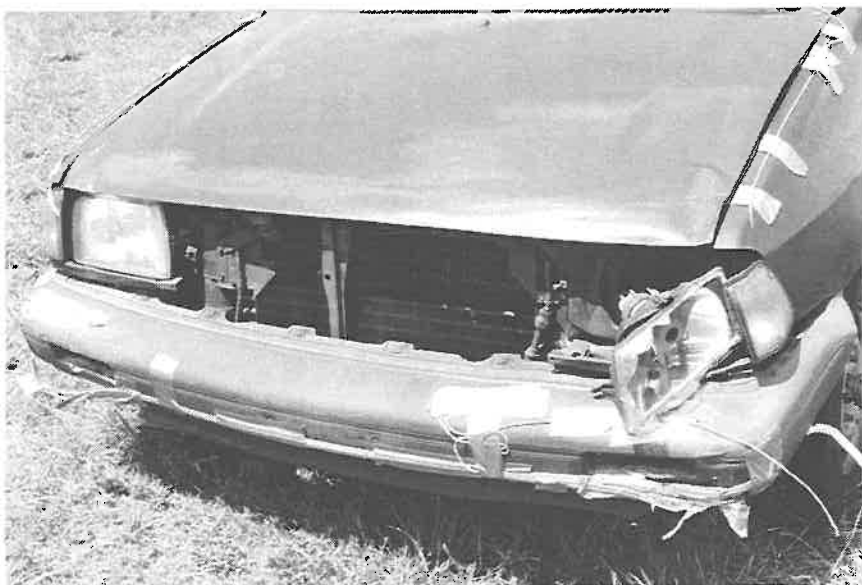
Figure 33 . Vehicle after test 405231-4.

Maximum deformation to the front of the vehicle at the impact point was 30 mm (1.2 in). There was deformation, but no intrusion into the vehicle occupant compartment.

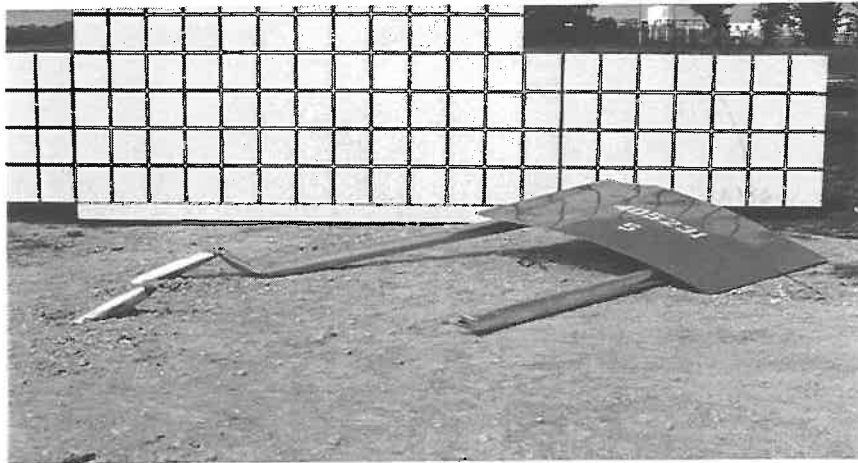
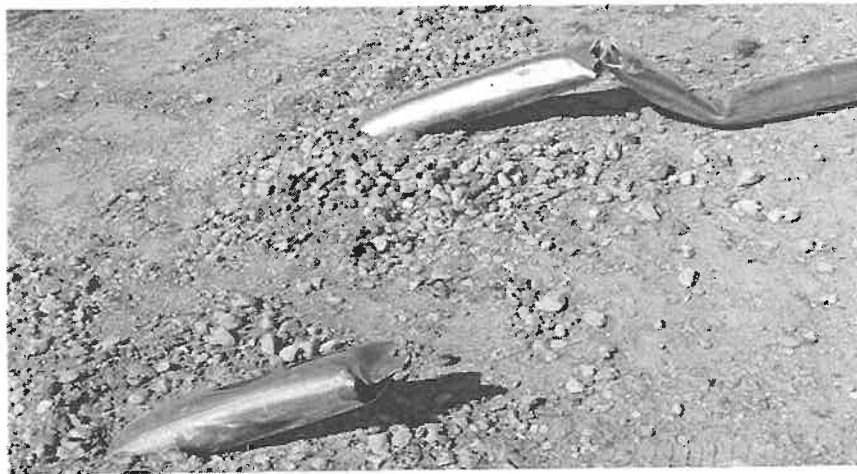
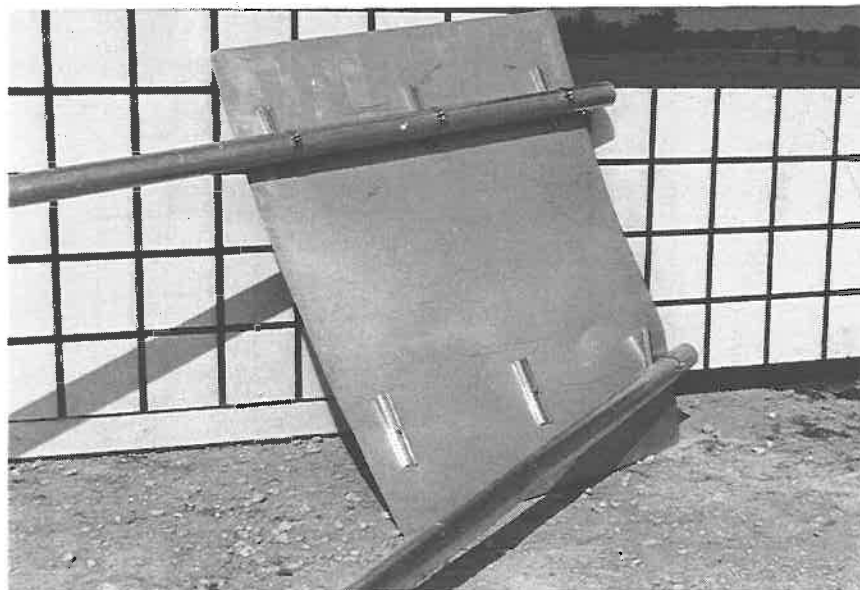
Figure 38 . Dual 4 in. aluminum sign support installation anchored in strong soil after test 405231-5.

As shown in Figure 38, the supports were bent and fractured. The right support failed 432 mm (17.0 in) from ground level and the left support partially fractured 533 mm (21.0 in) from ground level. The sign panel and all mounting and anchoring hardware received minimal damage and could be reused in field renovation of this installation. Damage sustained by the vehicle during this test is shown in Figure 39. The vehicle sustained only minor damage to the bumper. There was no deformation to the vehicle occupant compartment.

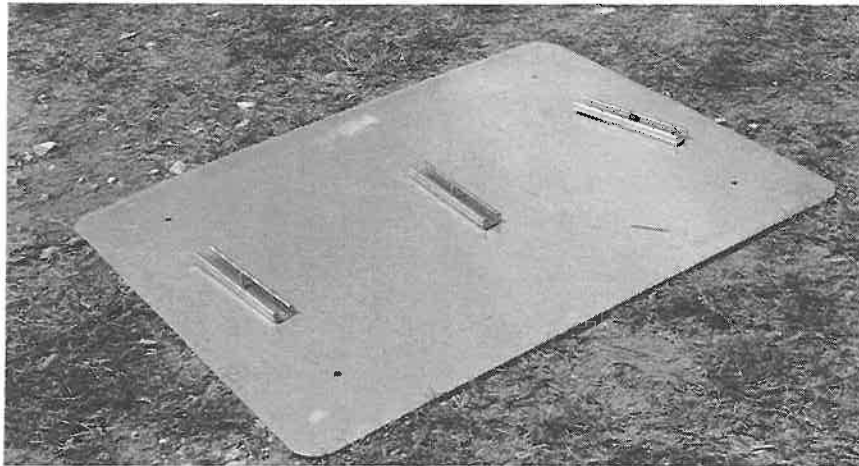
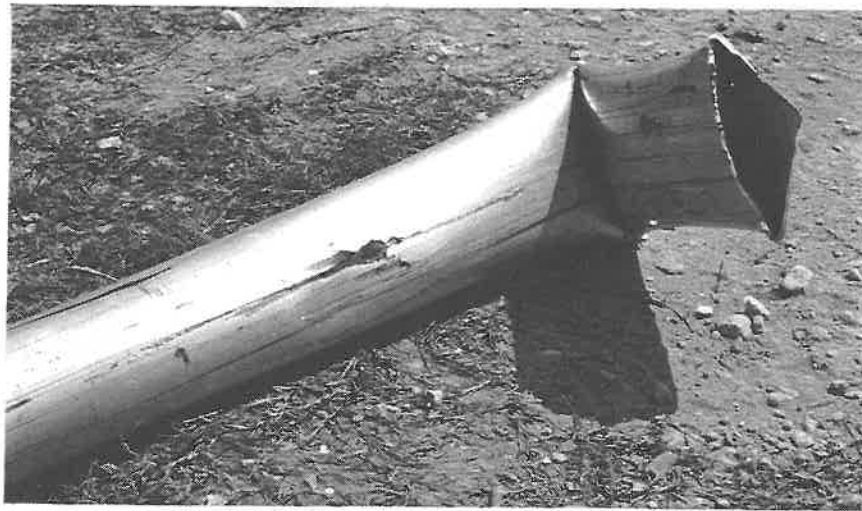
Figure 45 . Single 4 in. aluminum sign support installation anchored in strong soil after test 405231-6.

As shown in Figure 45, the support was bent and fractured. The support failed 521 mm (20.5 in) from ground level. The sign panel and all mounting and anchoring hardware received minimal damage and could be reused in field renovation of this installation. Damage sustained by the vehicle during this test is shown in Figure 46. The vehicle sustained primarily cosmetic damage to the bumper and left front fender. There was no deformation to the vehicle occupant compartment.

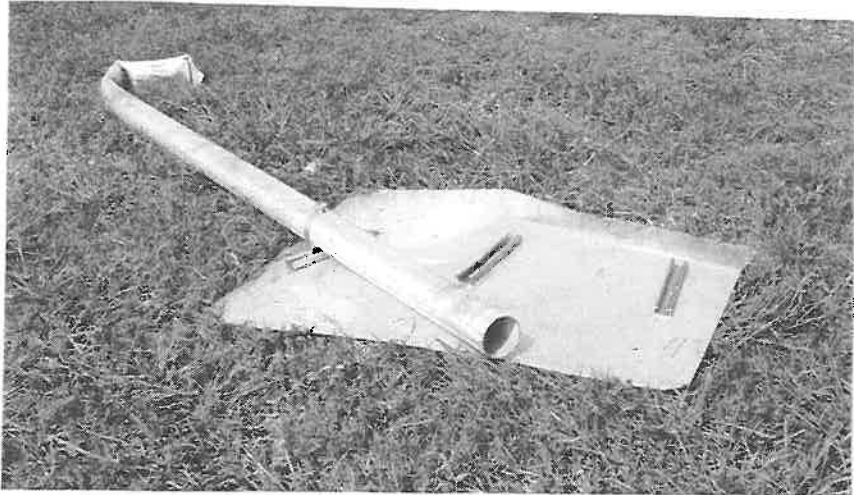
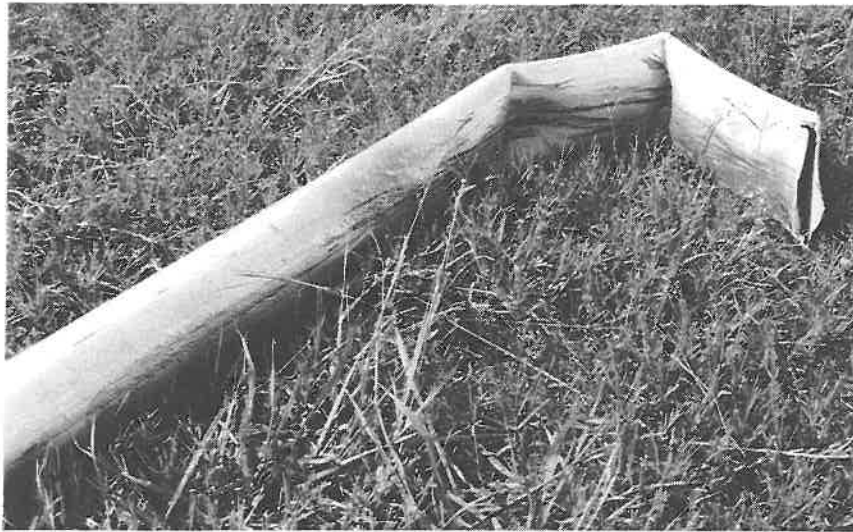
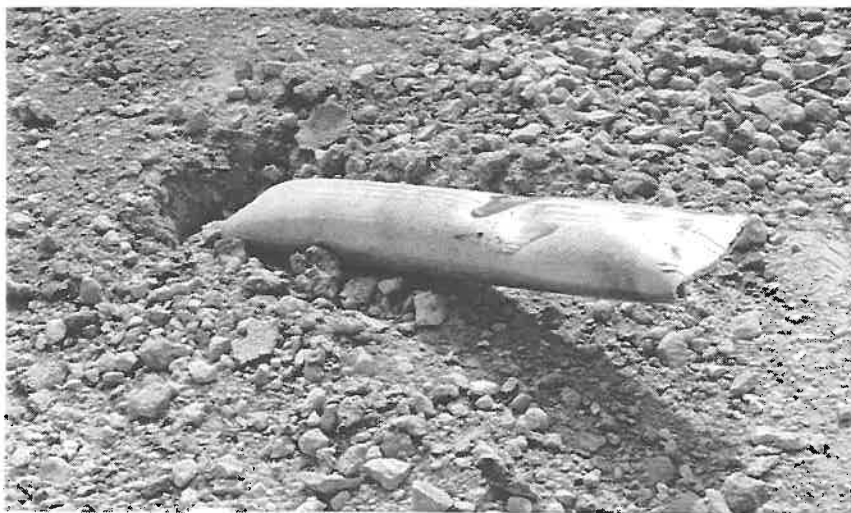
Figure 51 . Single 4 in. aluminum sign support installation anchored in strong soil after test 405231-7.

As shown in Figure 51, the support was bent and fractured. The support failed 699 mm (27.5 in) from ground level. The sign support and sign panel came to rest 63.4 m (208.0 ft) down and 3.0 (10.0 ft) to the right of impact sight. The mounting and anchoring hardware received minimal damage and could be reused in field renovation of this installation. However, the sign panel required replacement. Damage sustained by the vehicle during this test is shown in Figure 52. The vehicle sustained moderate roof, hood, windshield and bumper damage. Maximum vertical crush to the roof was 60 mm (2.4 in). Maximum deformation to the front of the vehicle at the impact point was 65 mm (2.6 in). There were deformation and minor intrusion into the vehicle occupant compartment. The occupant compartment was punctured by two of the bolts anchoring the sign panel to the support.

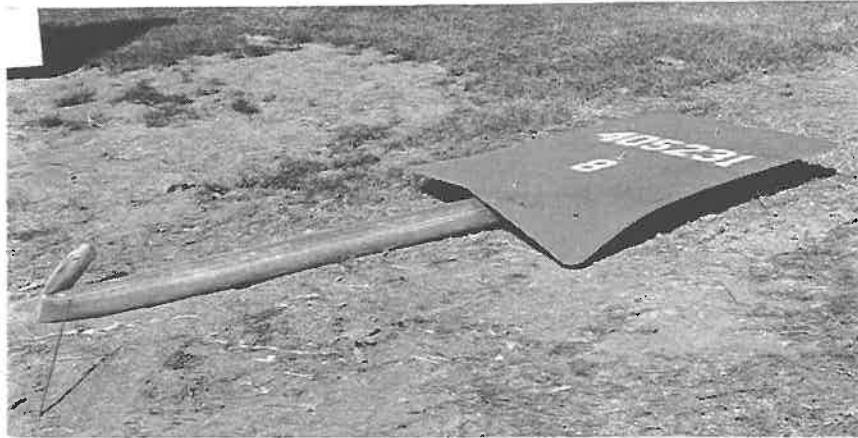
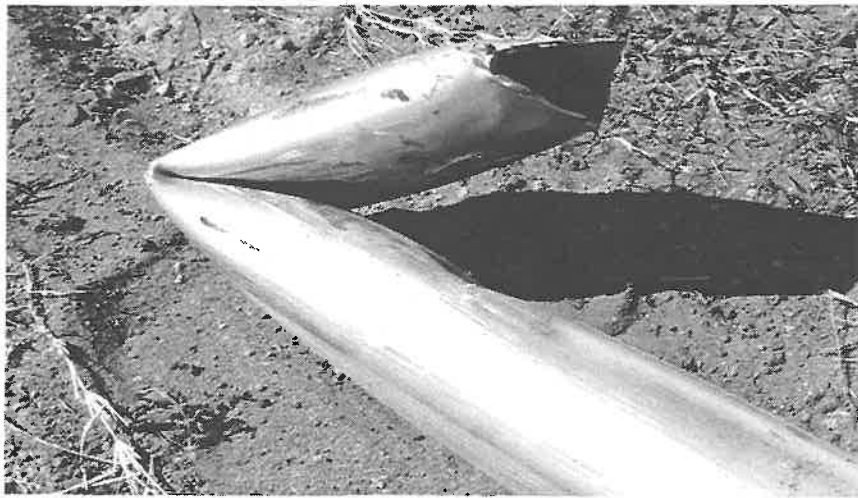
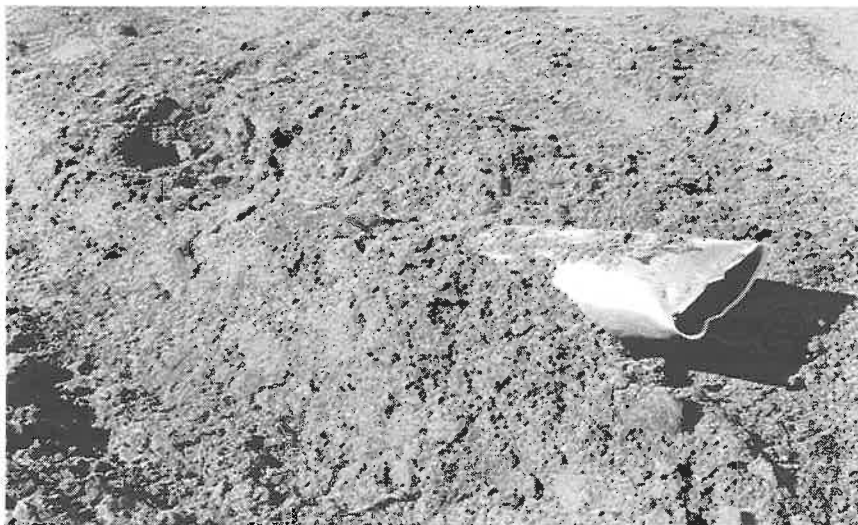
Figure 57 . Single 4 in. aluminum sign support installation anchored in weak soil after test 405231-8.

As shown in Figure 57, the support was bent and fractured. The support failed 457 mm (18.0 in) from ground level. The sign panel and all mounting and anchoring hardware received minimal damage and could be reused in field renovation of this installation. Damage sustained by the vehicle during this test is shown in Figure 58. The vehicle sustained only cosmetic damage to the bumper. The vehicle occupant compartment was not deformed.

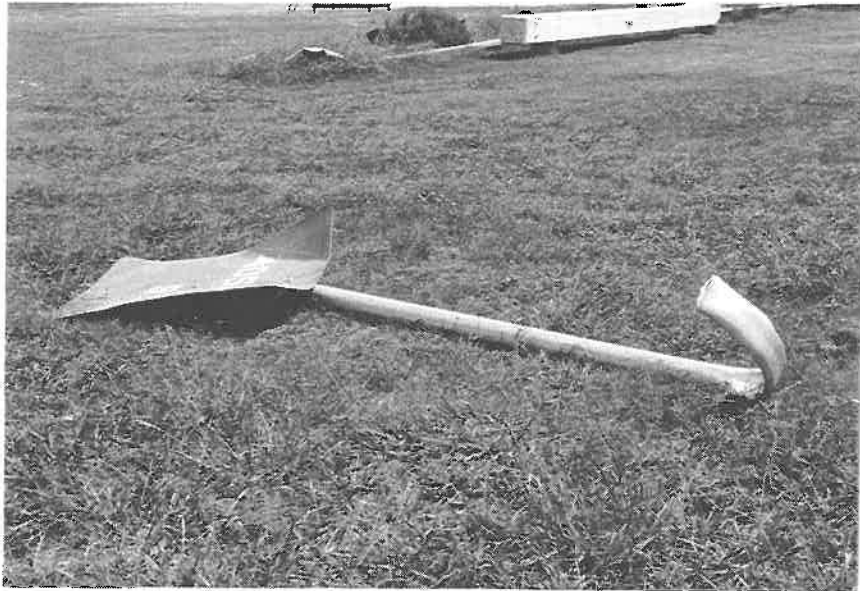
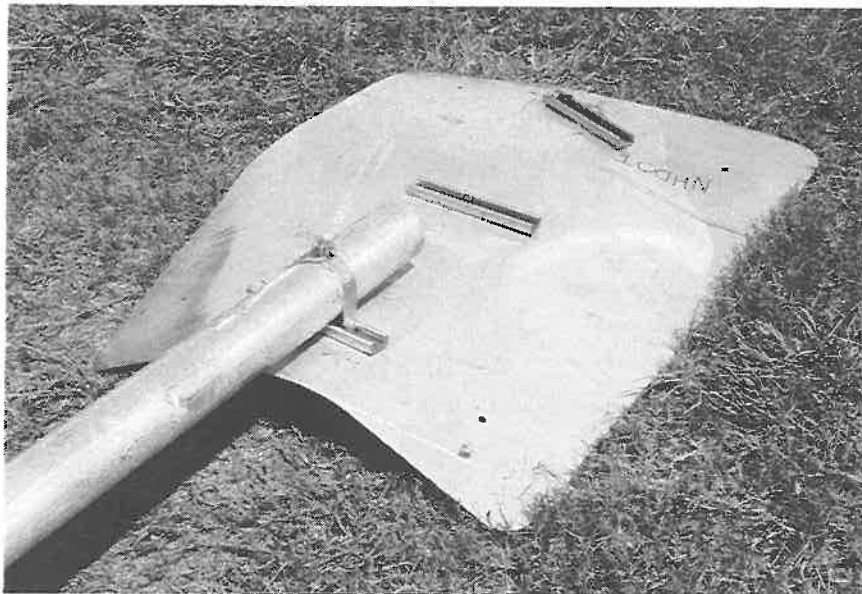
Figure 64 . Single 4 in. aluminum sign support installation anchored in weak soil after test 405231-9.

As shown in Figure 64, the support was bent and fractured. The support failed 609.6 mm (24.0 in) from ground level. The mounting and anchoring hardware received minimal damage and could be reused in field renovation of this installation. However, the sign panel required replacement. Damage sustained by the vehicle during this test is shown in Figure 65. The vehicle sustained moderate roof, hood, windshield, top of right door and bumper damage. Maximum vertical crush to the roof was 110 mm (4.3 in). Maximum deformation to the front of the vehicle at the impact point was 40 mm (1.6 in). There were deformation and minor intrusion into the

B.	The test article should readily activate in a predictable manner by breaking away, fracturing, or yielding.	The sign support yielded by bending the aluminum tube at ground level and fracturing in tension near bumper level.		Pass	
<b>Occupant Risk</b>

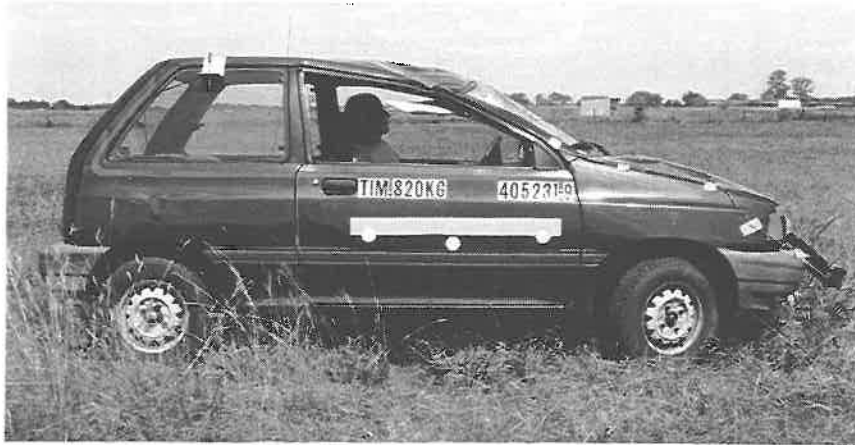
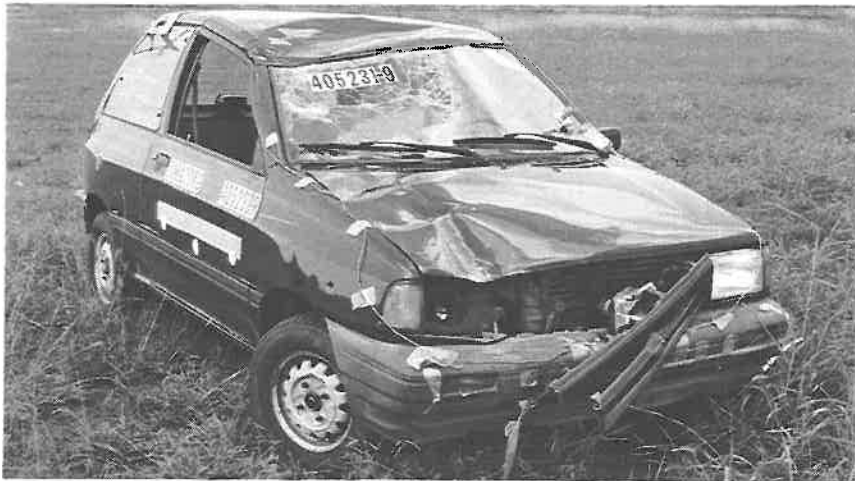
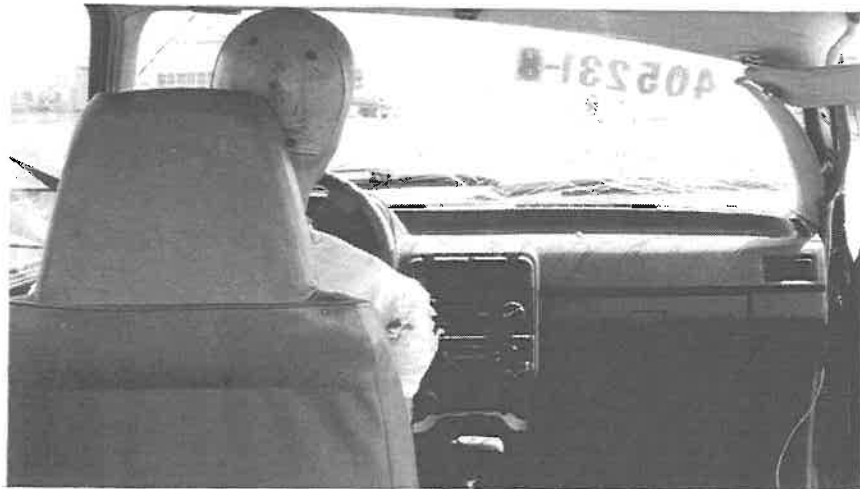
Figure 65 . Vehicle after test 405231-9.  
100

vehicle occupant compartment. The occupant compartment was punctured by one of the bolts anchoring the sign panel to the support.

D.	Detached elements should not penetrate the occupant compartment, or present an undue hazard to other traffic, pedestrians, or personnel in a work zone. Deformations of the occupant compartment that could cause serious injuries should not be permitted.	The sign support fractured but did not present a hazard to other travel lanes. There was deformation of the front portion of the occupant compartment, but no actual intrusion into the compartment.		Pass

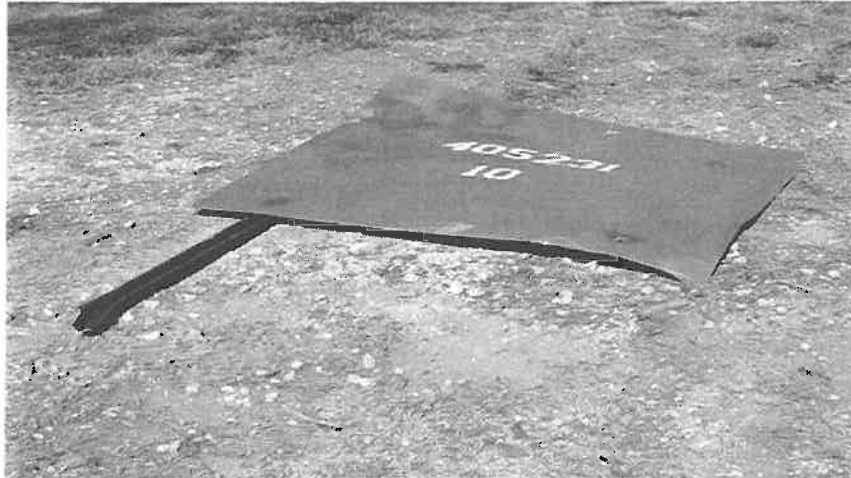
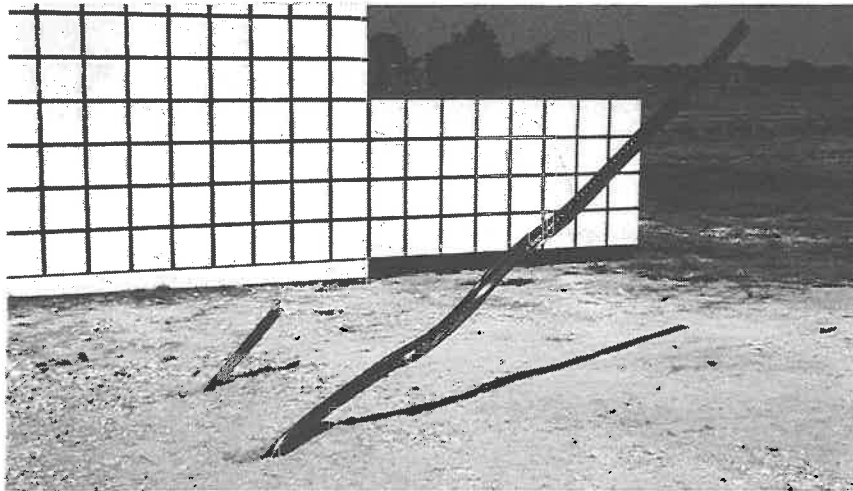
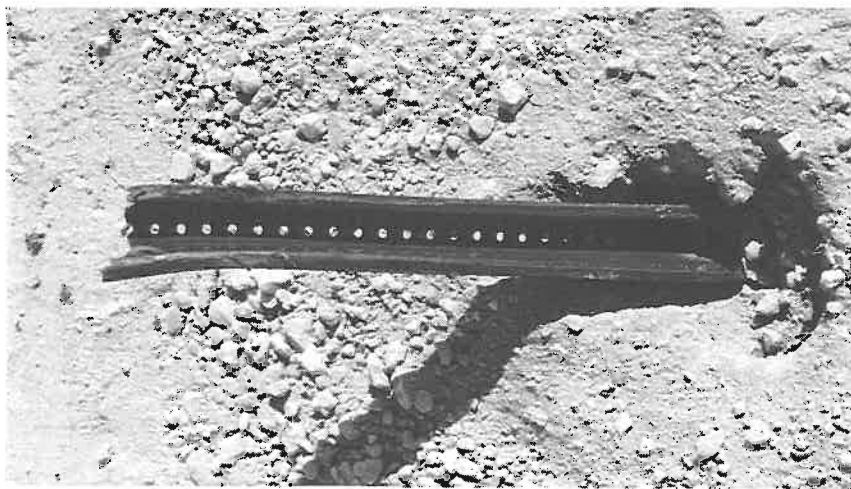
Figure 71. dual 2-1/2 lb steel U-channel support installation anchored in strong soil after test 405231-10.

As shown in Figure 71, the supports were bent and fractured. The left support failed 533 mm (21.0 in) from ground level and the right support remained intact. Damage sustained by the vehicle during this test is shown in Figure 72. The vehicle sustained only cosmetic damage to the bumper. The vehicle occupant compartment was not deformed.

B. The test article should readily activate in a predictable manner by breaking away, fracturing, or yielding.		The left sign support yielded by bending the steel U-channel at ground level and fracturing near bumper level. The right support was bent at ground level, but did not fracture.		Pass	
<u>Occupant Risk</u>

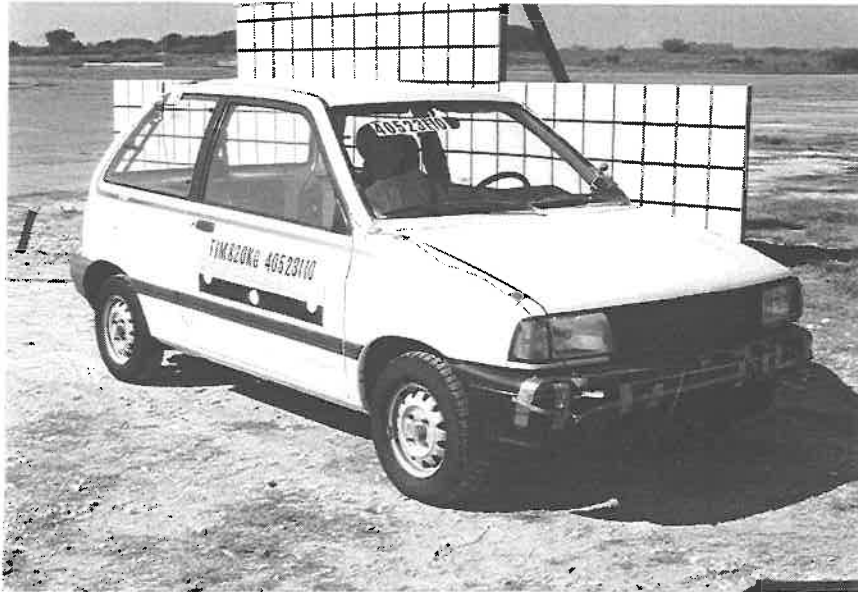
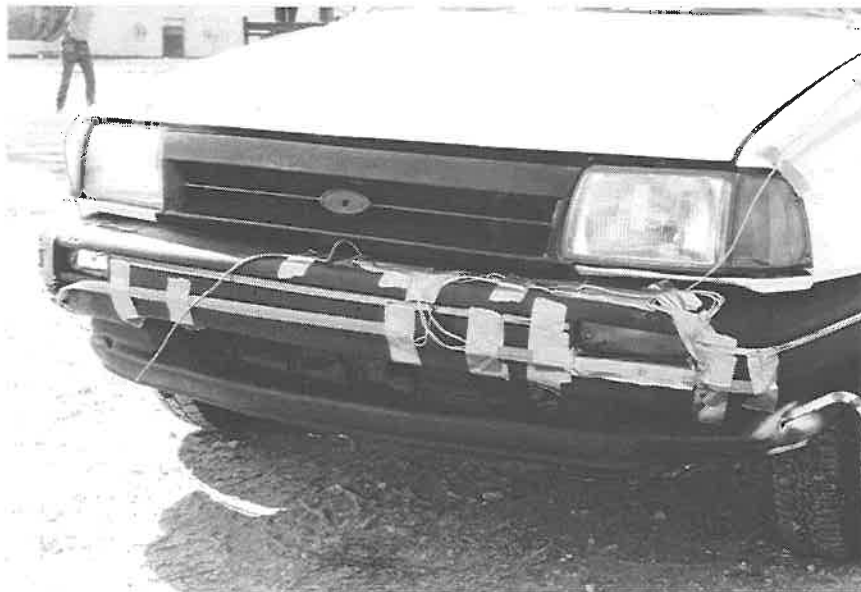
Figure 72 . Vehicle after test 405231-10.

D. Detached elements should not penetrate the occupant compartment, or present an undue hazard to other traffic, pedestrians, or personnel in a work zone. Deformations of the occupant compartment that could cause serious injuries should not be permitted.		The sign supports yielded and <b>did not</b> present a hazard to other travel lanes. There was <b>no</b> deformation of or intrusion into the occupant compartment.		Pass

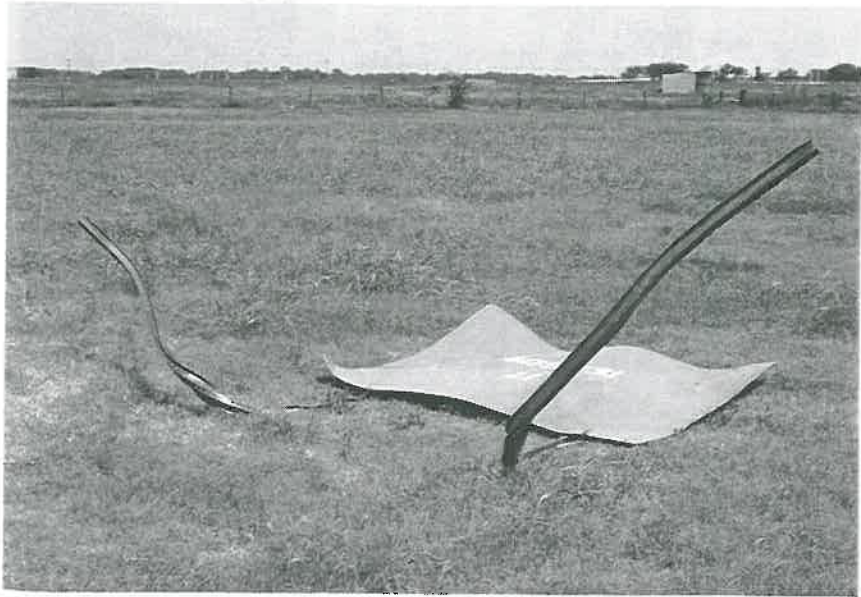
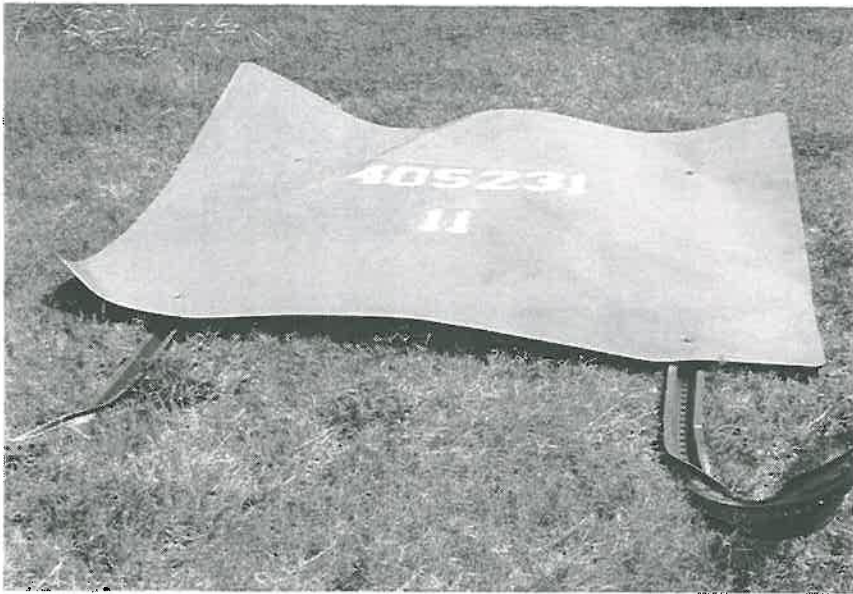
Figure 78. Dual 2-1/2 lb steel U-channel support installation anchored in strong soil after test 405231-11.

As shown in Figure 78, the supports were bent and twisted. The supports pulled completely from the ground without fracturing. The sign support and sign panel came to rest just ahead of the vehicle. Damage sustained by the vehicle during this test is shown in Figure 79. The vehicle sustained moderate roof, hood, windshield and bumper damage. Maximum vertical crush to the roof was 180 mm (7.1 in). Maximum deformation to the front of the vehicle at the impact point was 105 mm (4.1 in). There was deformation, but no intrusion into the vehicle occupant compartment.

B.	The test article should readily activate in a predictable manner by breaking away, fracturing, or yielding.	The sign supports yielded by bending the steel U-channel at ground level and fracturing near the bumper level.		Pass	
<u>Occupant Risk</u>

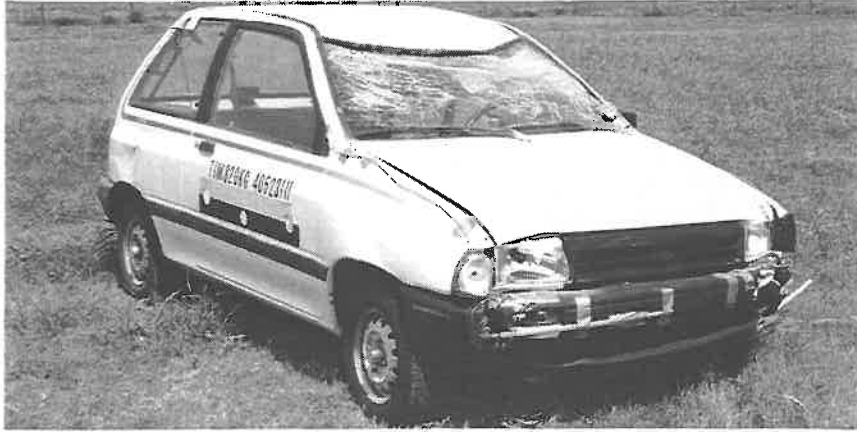
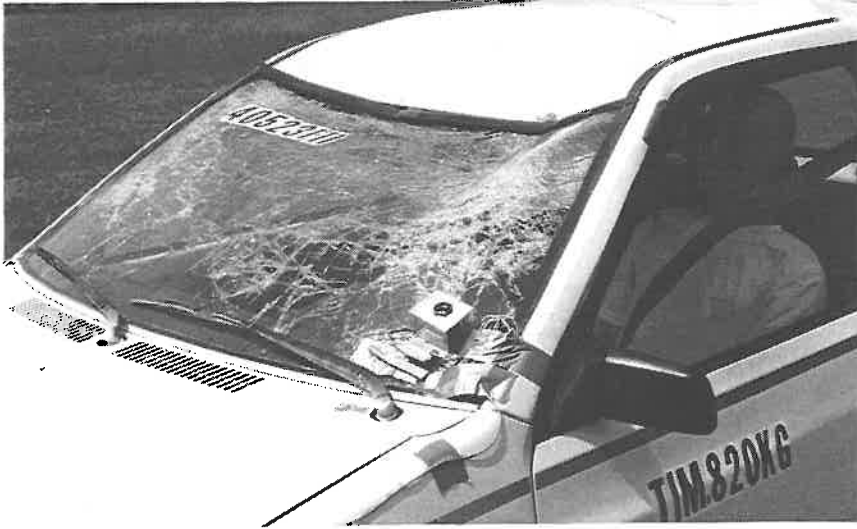
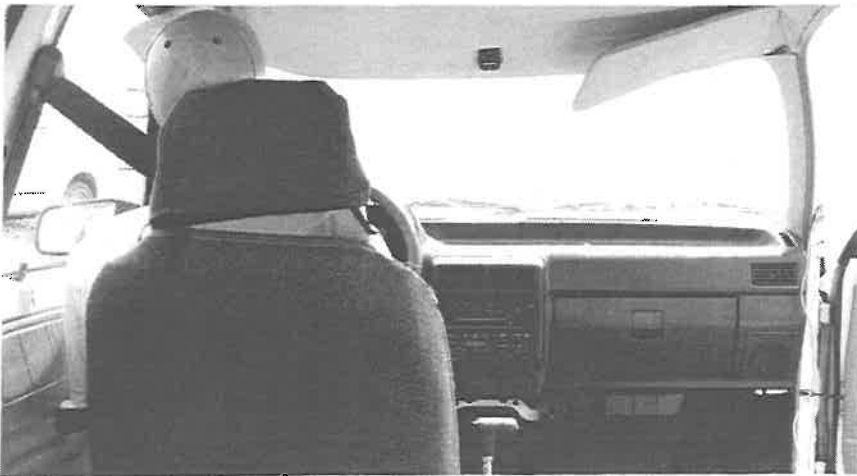
Figure 79 . Vehicle after test 405231-11.

As the vehicle impacted the sign installation, the supports began to bend at ground level and pocket around the front of the vehicle. The sign panel struck the roof of the vehicle at 0.072 seconds. The sign panel struck the roof with a force sufficient to deform the roof and A-pillars and break the windshield. At some indeterminable time, the supports were completely pulled from the ground. The sign installation remained wrapped around the front of the vehicle as it exited. The brakes were applied and the vehicle came to rest out of view of the high-speed camera. The vehicle came to final rest upright 61.3 m (201.0 ft) downstream and 16.6 m (54.5 ft) right of the point of impact. Final rest positions of the vehicle and sign installation are shown in Figure 77. Sequential photographs of the crash test are shown in Appendix B.

D.	Detached elements should not penetrate the occupant compartment, or present an undue hazard to other traffic, pedestrians, or personnel in a work zone. Deformations of the occupant compartment that could cause serious injuries should not be permitted.	The sign supports fractured but <b>did not</b> present a hazard to other travel lanes. There was deformation of the front portion of the occupant compartment, but no actual intrusion into the compartment		Pass

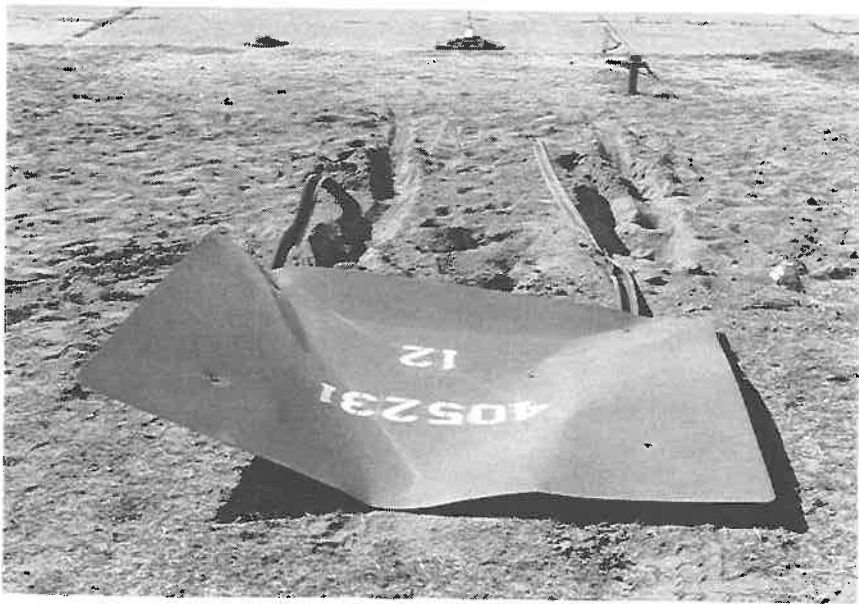
Figure 85. Dual 2-1/2 lb steel U-channel support installation anchored in weak soil after test 405231-12.

As shown in Figure 85, the supports were bent and pulled up from the ground. The left support was completely pulled from the ground while 18 mm (0.7 in) of the right support remained in the ground. Damage sustained by the vehicle during this test is shown in Figure 86. The vehicle sustained 100.0 mm (3.9 in) of crush to the bumper. In addition, the right front fender and hood were dented and scraped. There was no deformation to the vehicle occupant compartment.
