**EVALUATION OF THE CRASHWORTHINESS OF THIN-WALLED  
ALUMINUM AND STEEL U-CHANNEL SIGN SUPPORTS**

TTI Project No. 405231-1F  
Final Report

June 1995

**Texas Transportation Institute  
Texas A&M University System  
College Station, TX 77843**

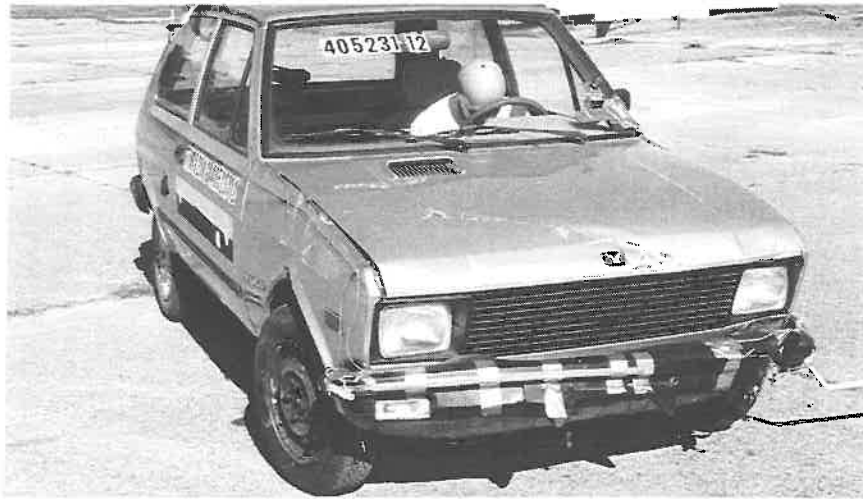
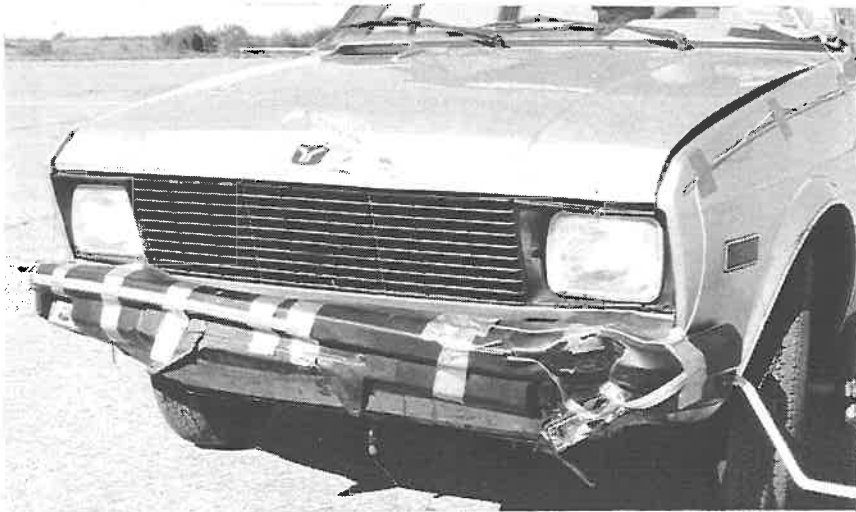
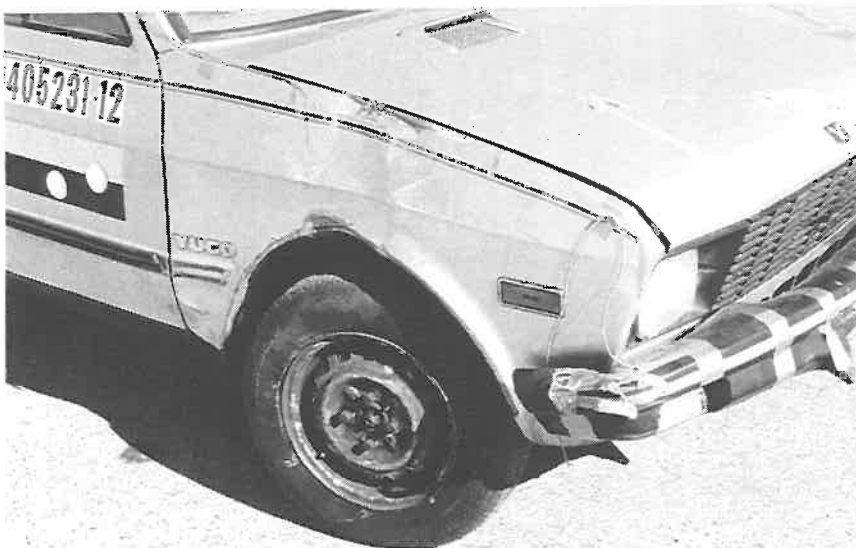
Figure 86 . Vehicle after test 405231-12.

As shown in Figure 85, the supports were bent and pulled up from the ground. The left support was completely pulled from the ground while 18 mm (0.7 in) of the right support remained in the ground. Damage sustained by the vehicle during this test is shown in Figure 86. The vehicle sustained 100.0 mm (3.9 in) of crush to the bumper. In addition, the right front fender and hood were dented and scraped. There was no deformation to the vehicle occupant compartment.

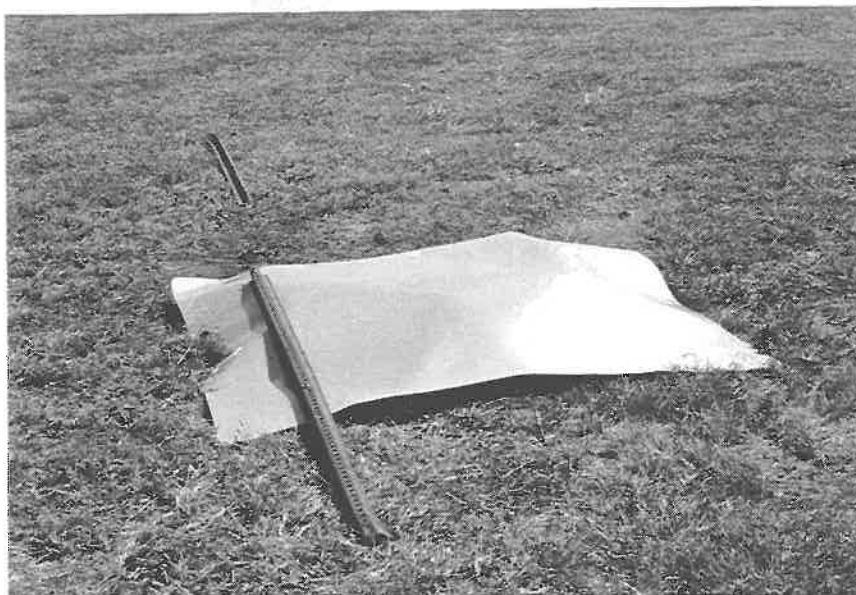
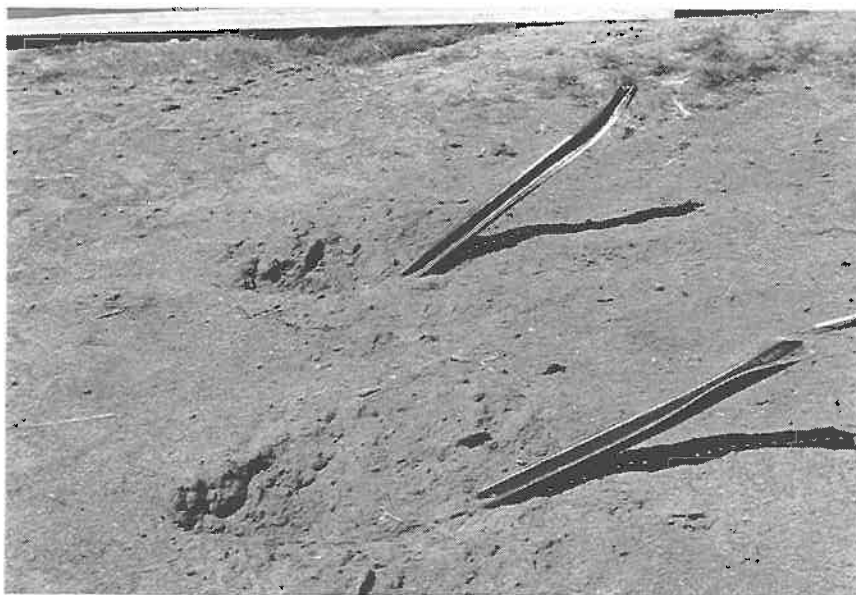
Figure 92. Dual 2-1/2 lb steel U-channel support installation anchored in weak soil after test 405231-13.

As shown in Figure 92, the supports were fractured and bent. The right support fractured 977 mm (38.5 in) from ground level and the left support 840 mm (33.1 in) from ground level. The right sign support and the sign panel came to rest 75.6 m (248.0 ft) down and 2.7 m (9.0 ft) to the right of the point of impact. The upper portion of the left support, detached from the sign panel, came to rest 72.6 m (238.0 ft) from the point of impact and inline with the sign panel. Damage sustained by the vehicle during this test is shown in Figure 93. The vehicle sustained minor damage to the roof and hood. The windshield was broken and the bumper required replacement. Maximum vertical crush to the roof was 20 mm (0.8 in). Maximum deformation to the front of the vehicle at the impact point was 90 mm (3.5 in). There was deformation, but no intrusion into the vehicle occupant compartment.

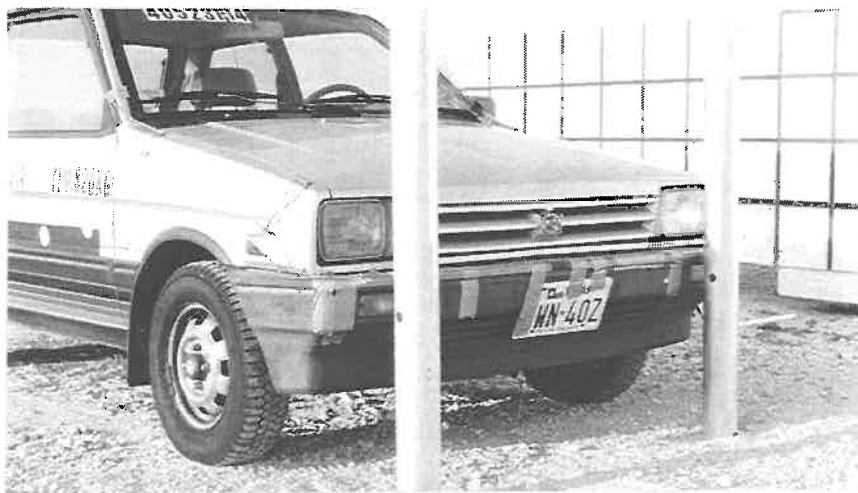
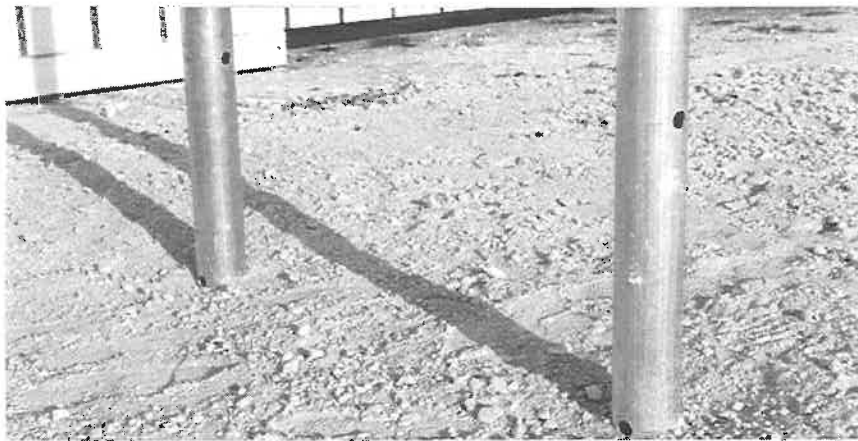
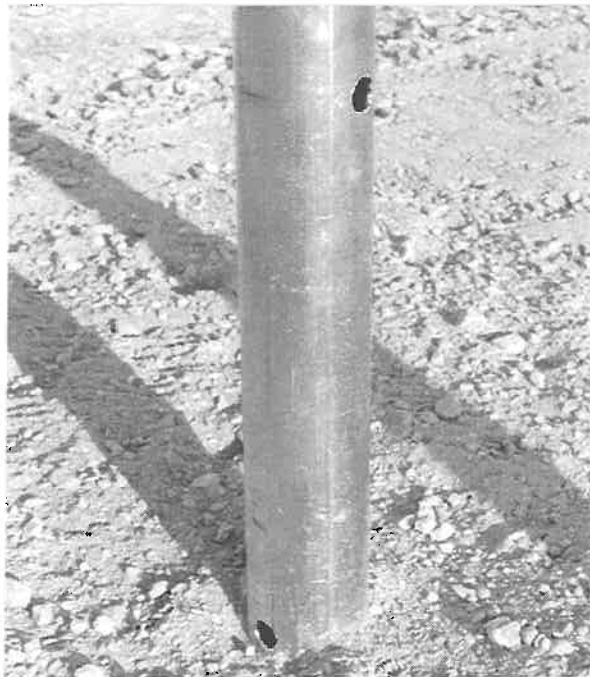
Figure 95 . Dual 4 in. aluminum sign support installation modified with four - 1.0 in. holes and anchored in strong soil (test 405231-14).

Both the 25 mm (1.0 in) and 32 mm (1.25 in) diameter holes, test 405231-14 and 15 respectively, proved unsuccessful in full-scale crash testing. The results of these two tests are given in Table 26 and warrant no further discussion. However, a successful retrofit was found utilizing a 38 mm (1.5 in) diameter hole. This test is discussed in the section that follows.

Following the failure of the 35 km/h (21.8 mi/h) test involving the dual 102 mm (4.0 in) diameter dual aluminum sign support installation anchored in strong soil (test no. 405231-5), the Department acknowledged the need for a suitable retrofit for supports of this type already installed in the field. Two developmental tests (405231-14 & 15) were performed to evaluate the impact performance of the 102 mm (4.0 in) diameter supports when modified by reducing the cross-sectional area by placing four (4) holes through the supports. These modifications are illustrated in Figures 95 and 96.

The dual 102 mm (4.0 in) diameter aluminum supports with 3.2 mm (0.125 in) wall thicknesses were modified as shown in Figure 95. The sign supports were modified by drilling two 38 mm (1.5 in) holes in the support cross-section at two different elevations along each support (4 holes total). The two elevations of four holes each were drilled at ground level and 457 mm (18.0 in) up from ground level. The holes drilled at ground level were oriented 90 degrees to the plane of the sign panel or parallel to the direction of impact. The holes drilled 457 mm (18.0 in) above ground level were oriented parallel to the plane of the sign panel or transverse to the direction of impact. The 102 mm (4.0 in) diameter aluminum support sign installation, when modified as described above, performed satisfactorily in both the low-speed and high-speed crash tests (16 and 17) conducted in strong soil. A low-speed test (22) performed in weak soil produced unsatisfactory results.

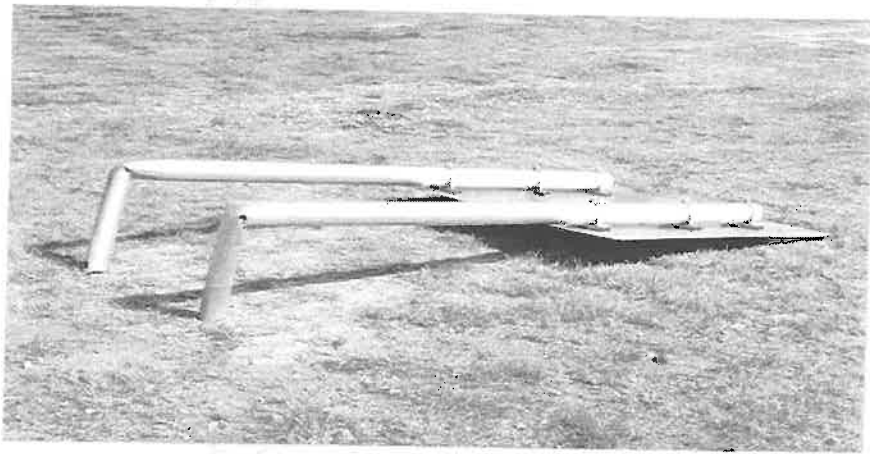
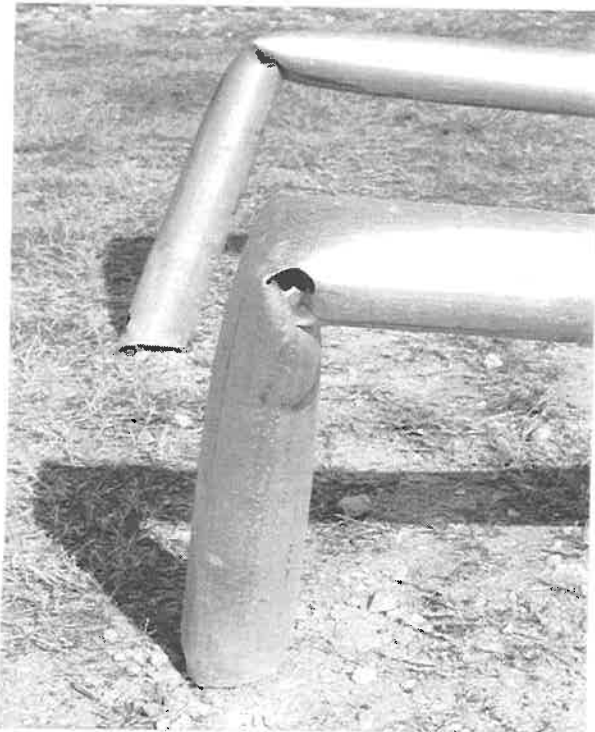
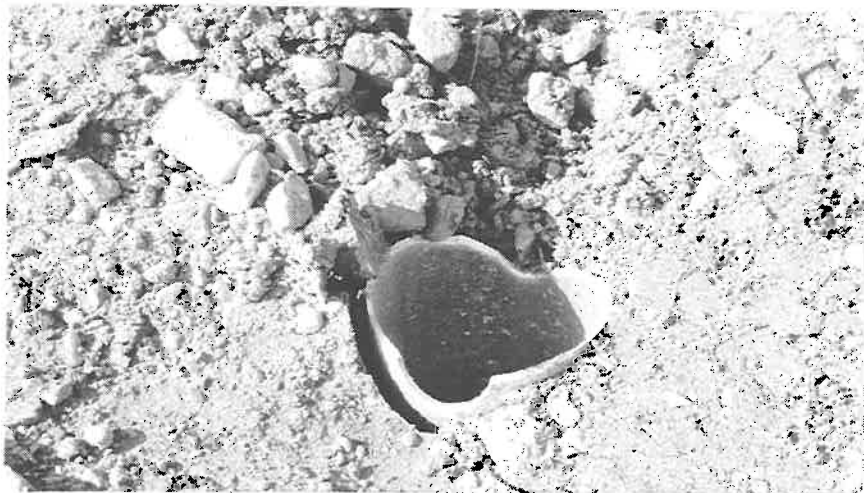
Figure 101. Dual 4 in. aluminum sign support installation modified with four - 1.5 in. holes and anchored in strong soil after test 405231-16.

As shown in Figure 101, the supports were bent and fractured. The left and right supports failed their entire cross-sections at the holes located at ground level. In addition, both supports were collapsed at the holes located near bumper height. The sign panel and all mounting and anchoring hardware received minimal damage and could be reused in field renovation of this installation. Damage sustained by the vehicle during this test is shown in Figure 102. The vehicle sustained minor damage to the bumper, hood and windshield. Maximum deformation to the vehicle was 60 mm (2.4 in), located at the leading edge of the hood directly above the headlights. There was no deformation to the vehicle occupant compartment.

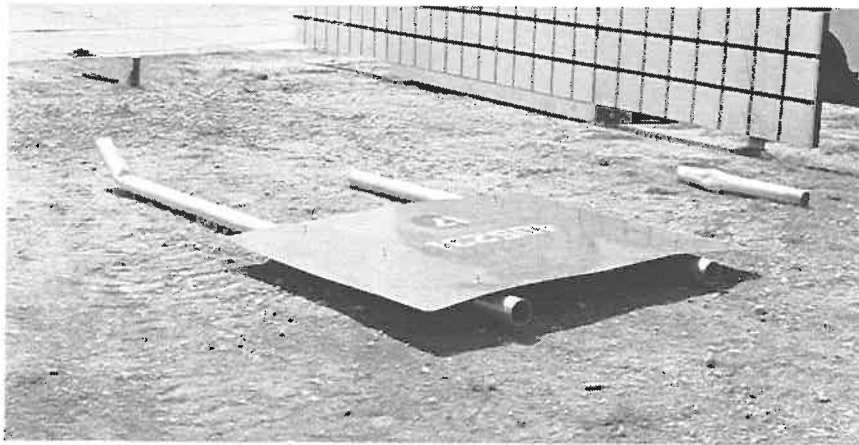
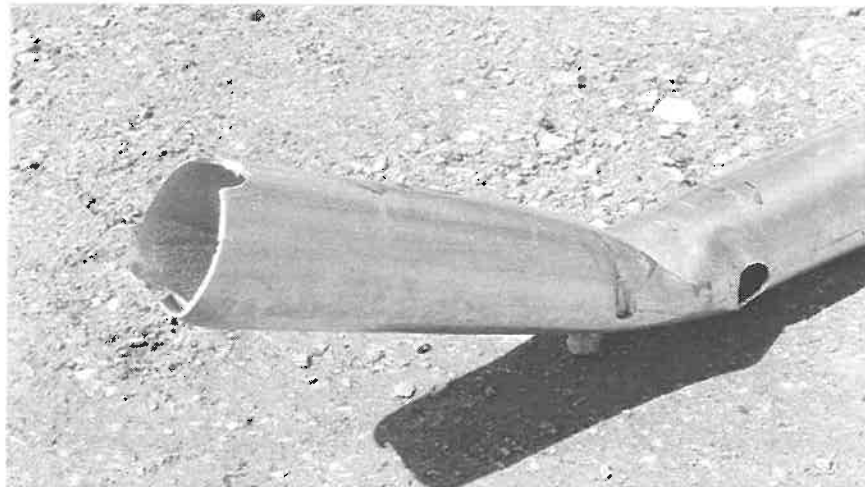
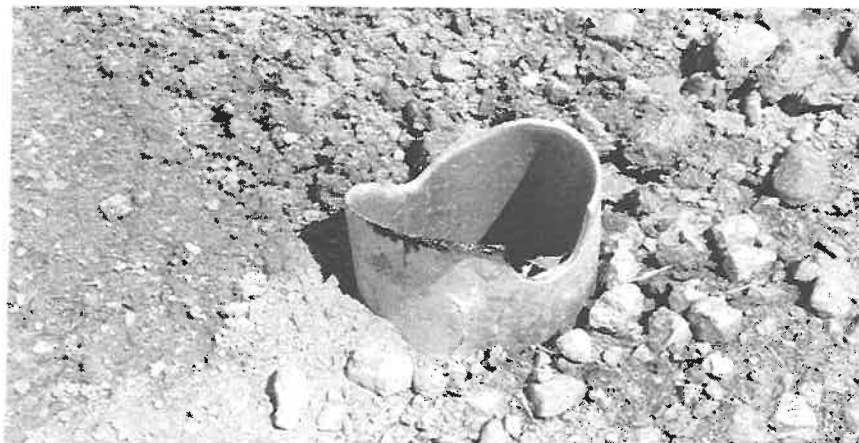
Figure 108. Dual 4 in. aluminum sign support installation modified with four - 1.5 in. holes and anchored in strong soil after test 405231-17.

As shown in Figure 108, the supports were bent and fractured. Both supports failed at the holes located at ground level. The supports however bent 88.9 mm (3.5 in) below the upper holes. The sign panel and mounting and anchoring hardware received minimal damage and could be reused in field renovation of this installation. It should be noted, the left support was fabricated from two pieces of tubing by welding the sections together. In addition, the fabricated support failed at the weld when the support impacted the ground after the test and not due to the initial vehicle impact. The sign installation came to rest 7.6 m (25.0 ft) from the point of impact. Damage sustained by the vehicle during this test is shown in Figure 109. The vehicle sustained

B.	The test article should readily activate in a predictable manner by breaking away, fracturing, or yielding.	Both the right and left sign supports yielded by fracturing the aluminum tubes at the front of the holes located at ground level.		Pass	
<u>Occupant Risk</u>

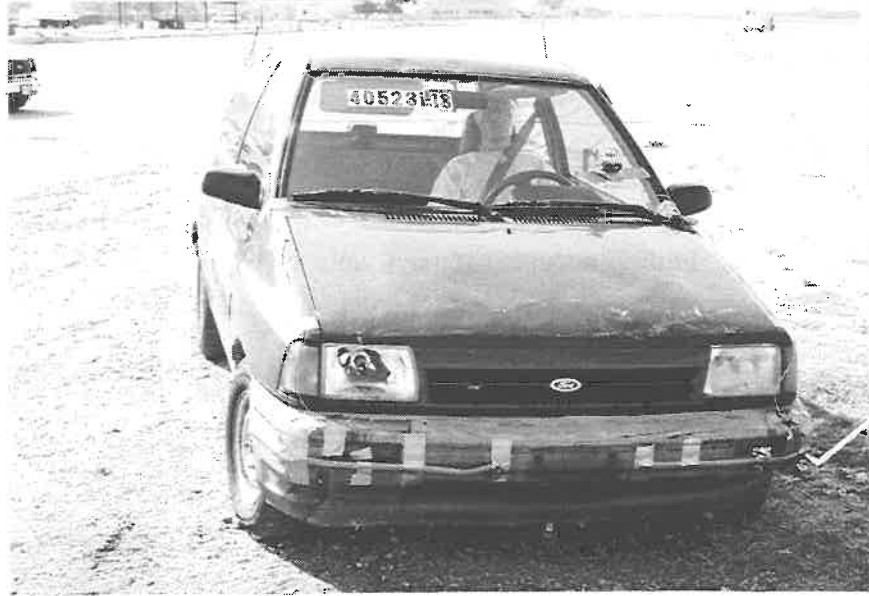
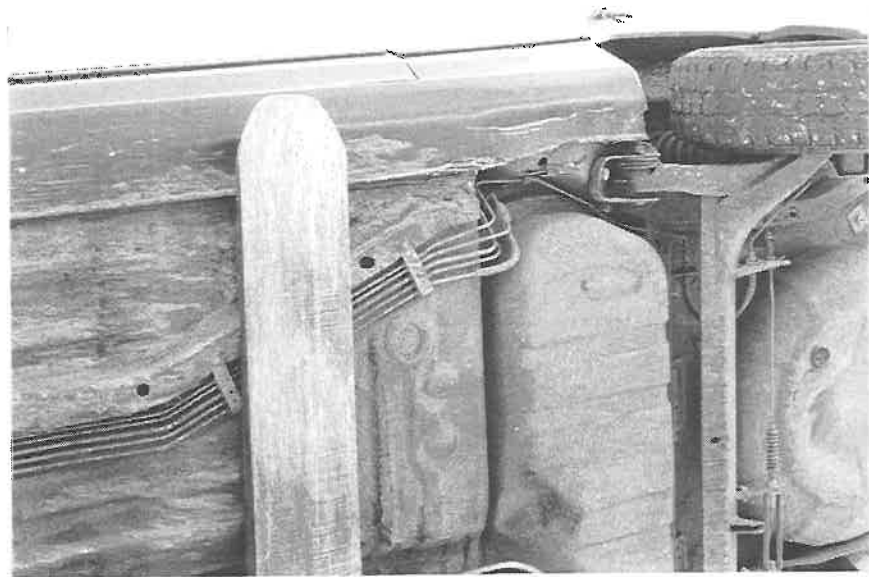
Figure 116. Vehicle after test 405231-18.  
174

by the vehicle during this test is shown in Figure 116. The vehicle sustained only cosmetic damage to the bumper, hood, roof and undercarriage. There was no deformation to the vehicle occupant compartment.

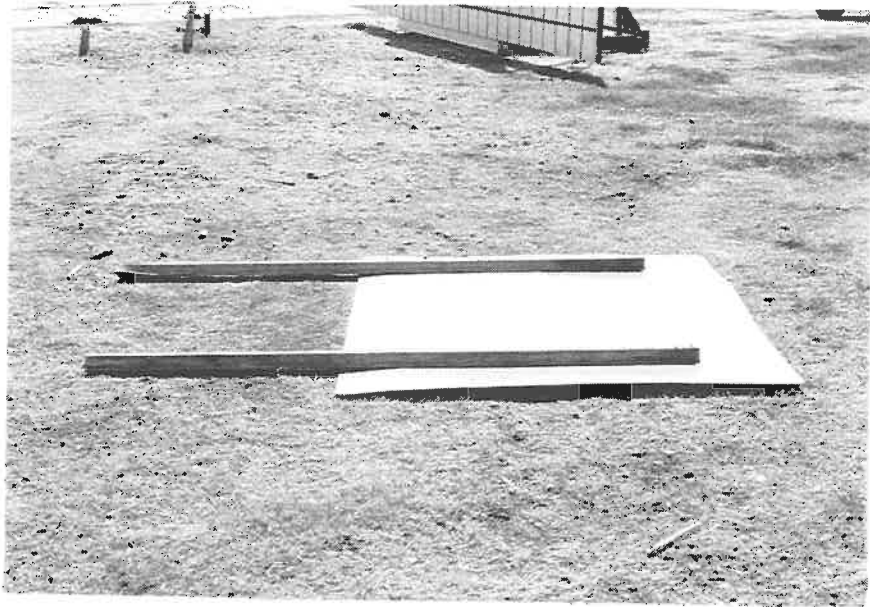
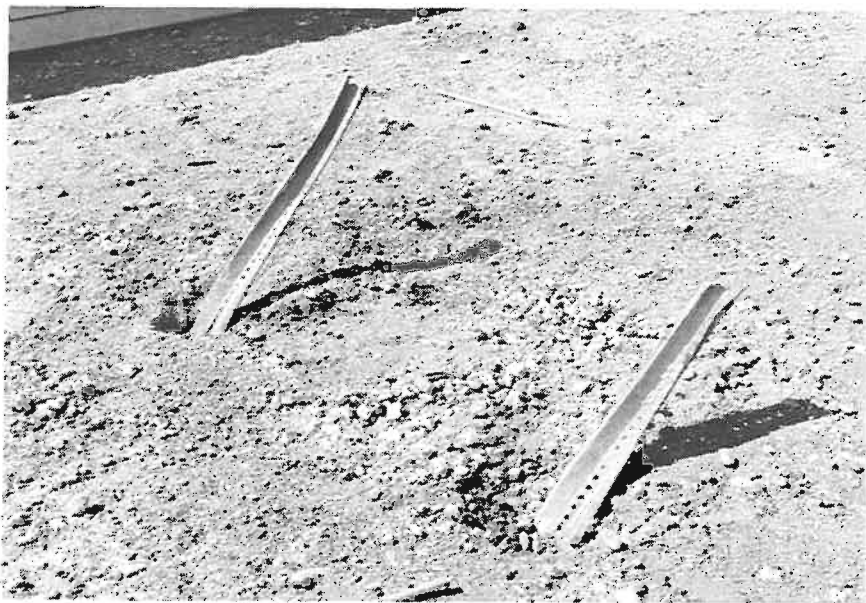
Figure 122. Dual 3-lb sign support installation anchored in strong soil after test 405231-19.

As shown in Figure 122, the supports were bent and fractured. The right support failed 584 mm (23.0 in) from ground level and the left support 737 mm (29.0 in). Damage to the vehicle during this test is shown in Figure 123. The vehicle sustained minor damage to the bumper, hood, roof and left front fender. Maximum crush to the bumper was 100 mm (3.9 in). There was no deformation to the vehicle occupant compartment.

B.	The test article should readily activate in a predictable manner by breaking away, fracturing, or yielding.	The sign supports fractured 584 mm (23 in) and 737 mm (29 in) from ground level (right and left support, respectively).		Pass	
<u>Occupant Risk</u>

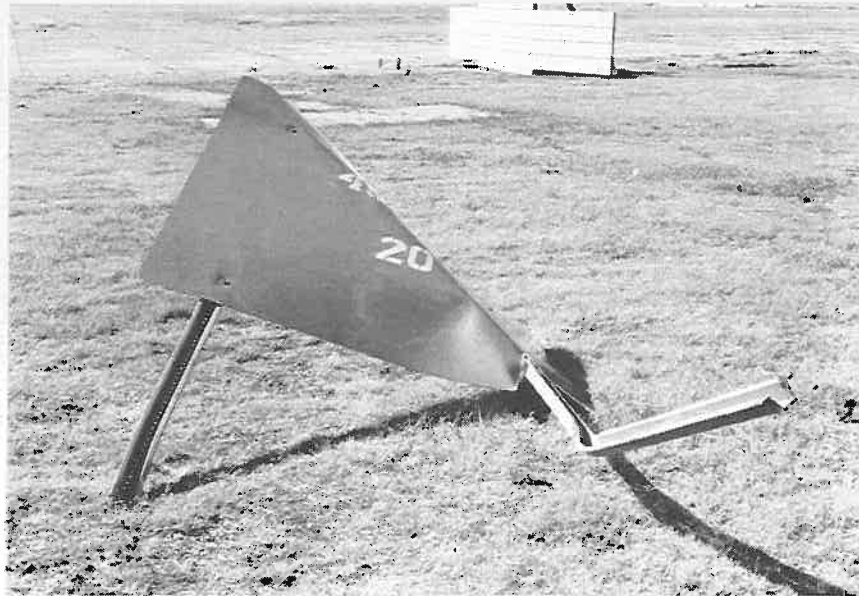
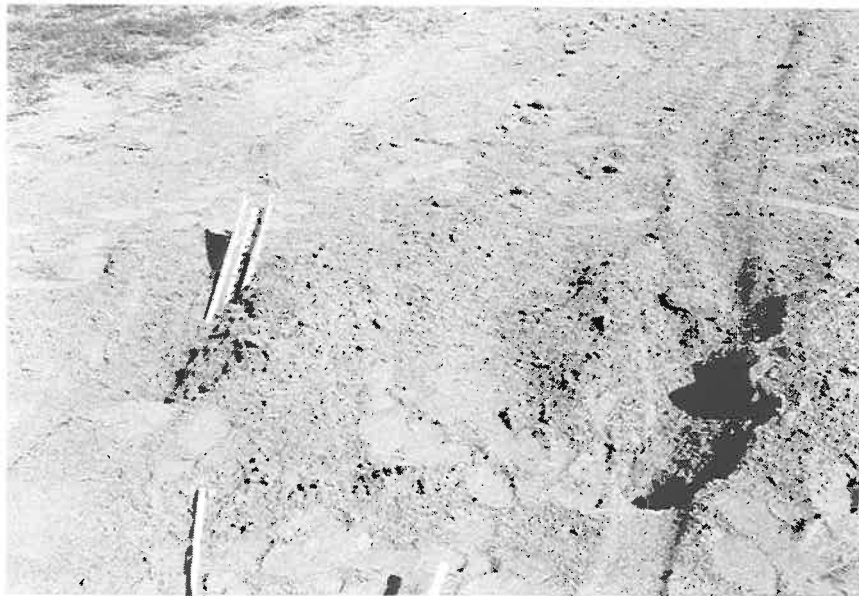
Figure 129. Dual 3-lb sign support installation anchored in weak soil after test 405231-20.

As shown in Figure 129, the left support fractured and the right support was pulled up from the ground. The left support was pushed rearward 648 mm (25.5 in) and fractured 406 mm (16.0 in) from ground level. The sign installation stayed on the front of the vehicle during the crash. Damage sustained by the vehicle during this test is shown in Figure 130. The vehicle sustained a 100 mm (3.9 in) cut in the right front fender. Damage sustained by the vehicle was primarily cosmetic, with the notable exception of a dent in the right A-pillar. There was no deformation to the vehicle occupant compartment.

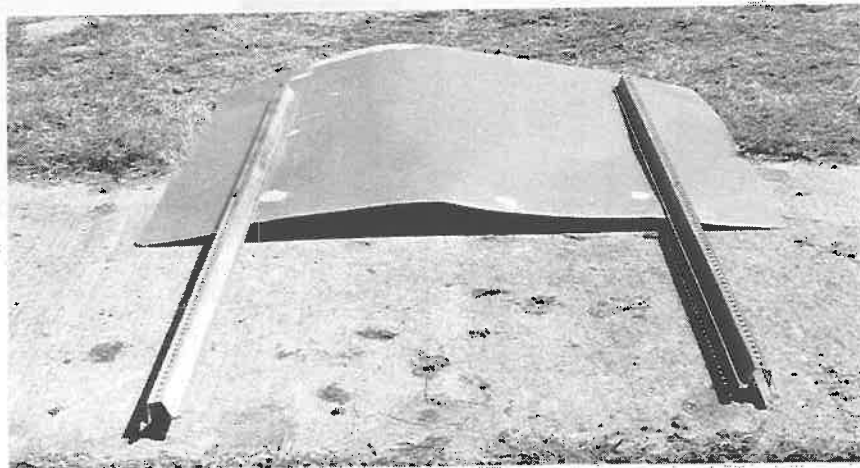
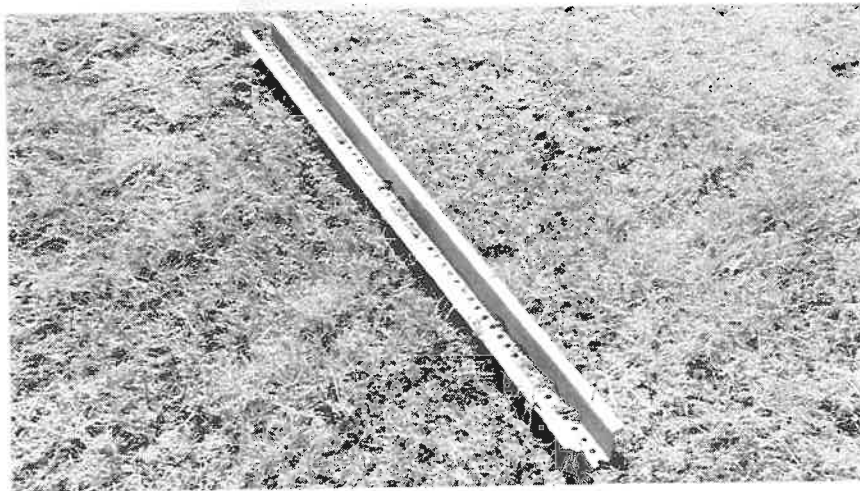
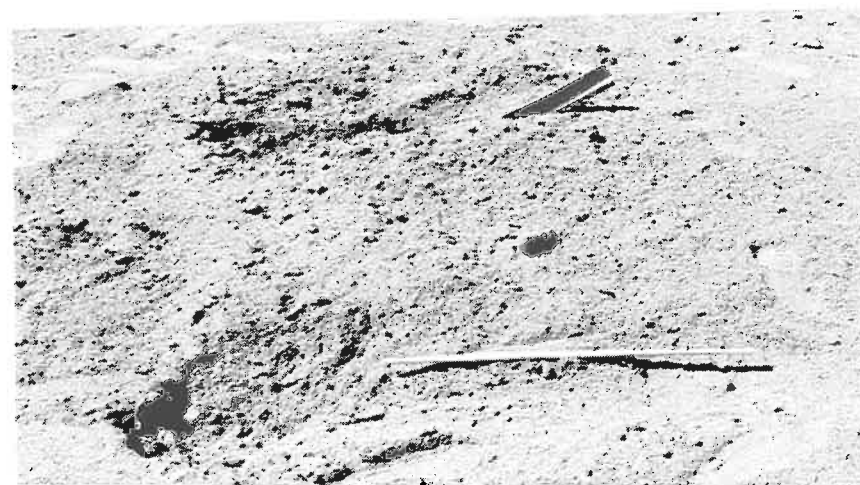
Figure 136. Dual 3-lb sign support installation anchored in weak soil after test 405231-21.

As shown in Figure 136, the right support fractured 533 mm (21.0 in) from ground level and the left support 483 mm (19.0 in) from ground level. The right support not only fractured, but was pulled from the ground as well. The left ground stub was displaced 660 mm (26.0 in) rearward. The upper portions of the right and left sign supports and sign panel came to rest 8.4 m (27.5 ft) down and 4.6 m (15.0 ft) to the right of the point of impact. The lower portion of the right support, came to rest 15.9 m (52.0 ft) from the point of impact and in line with the left ground stub. Damage sustained by the vehicle during this test is shown in Figure 137. The vehicle sustained minor damage to the roof and bumper. Maximum deformation to the front of the vehicle at the impact point was 72 mm (2.8 in). There was deformation, but no intrusion into the vehicle occupant compartment.

B.	The test article should readily activate in a predictable manner by breaking away, fracturing, or yielding.	The sign supports fractured 483 mm (19 in) and 533 mm (21 in) from ground level (right and left support, respectively).		Pass	
<b>Occupant Risk</b>

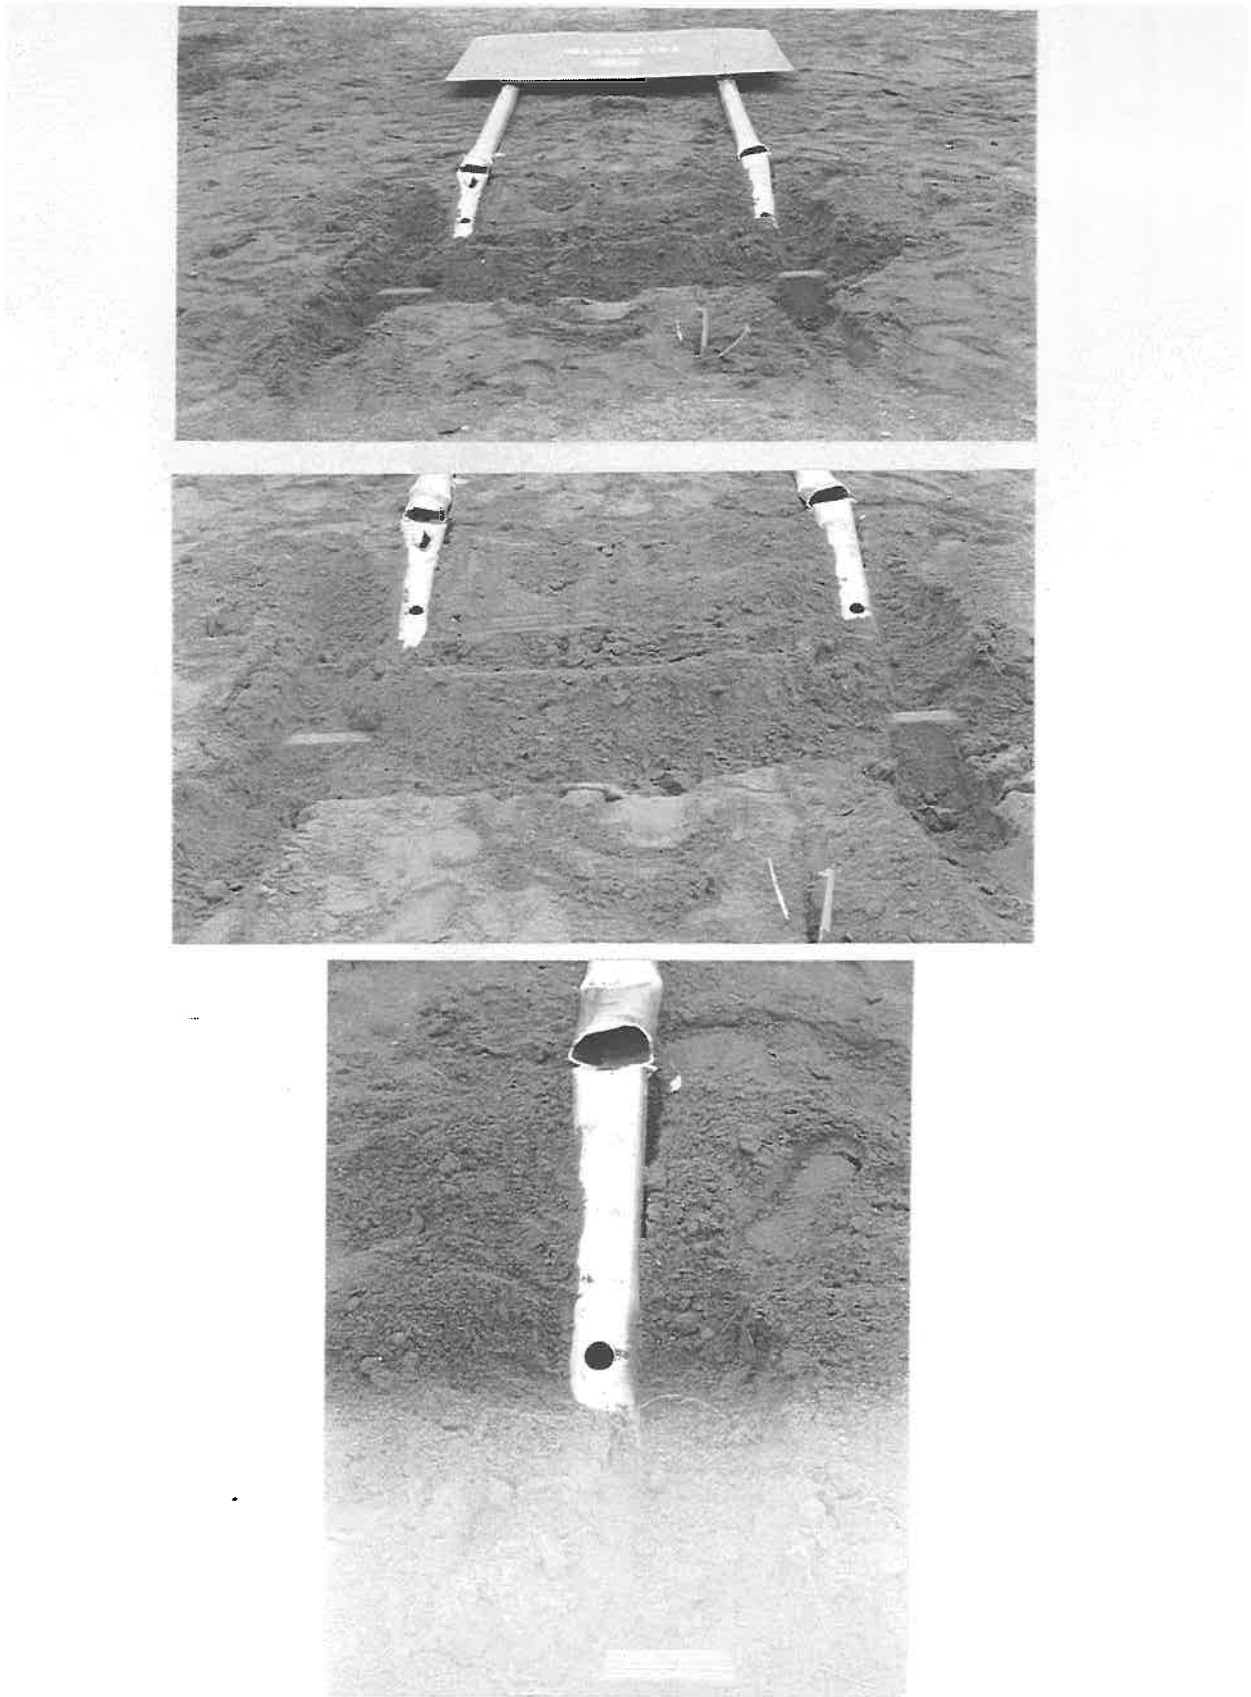
Figure 143 . Dual 4-in with 1-1/2 in holes aluminum sign support installation anchored in weak soil after test 405231-22.

As shown in Figure 143, the supports were bent and fractured. The left and right supports failed at the holes located at bumper level. All, but a 64 mm (2.5 in) wide strip across the rearward cross-section of each support, failed in tension. In addition, the soil plates were pulled upward and displaced rearward approximately 38 mm (1.5 in). The sign panel and all mounting and anchoring hardware received minimal damage and could be reused in field renovation of this installation. Damage sustained by the vehicle during this test is shown in Figure 144. The vehicle sustained minor damage to the bumper only. No measurable deformation to the vehicle was recorded. There was no deformation or intrusion into the vehicle occupant compartment.

B.	The test article should readily activate in a predictable manner by breaking away, fracturing, or yielding.	The sign supports partially fractured at the holes located near bumper level.		Fail	
<u>Occupant Risk</u>

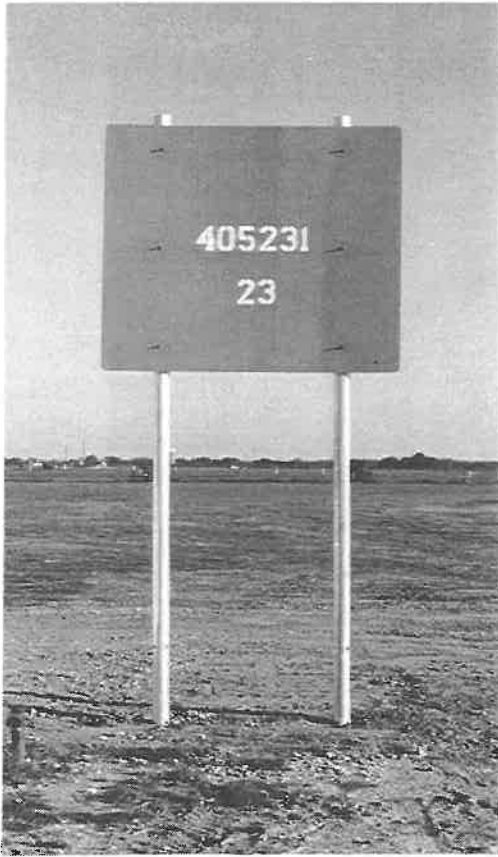
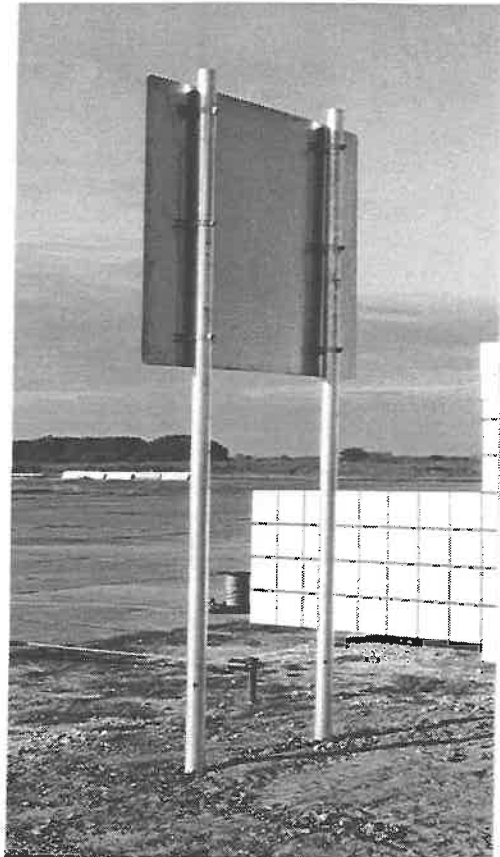
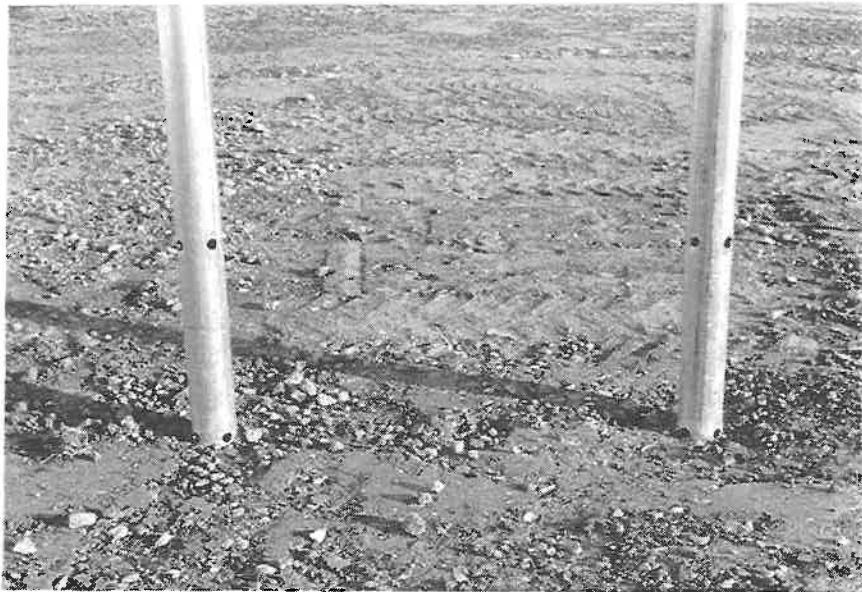
Figure 148 . Dual 4-in with 1-in holes aluminum sign support installation anchored in strong soil before test 405231-23.

The dual 102 mm (4.0 in) diameter aluminum supports with a 3.2 mm (0.125 in) wall thicknesses were modified as shown in Figure 148. The sign supports were modified by drilling four 25 mm (1.0 in) holes in the support cross-section at two different elevations along each support (8 holes total). The two elevations of four holes each were drilled at ground level and 457 mm (18.0 in) above ground level. The holes were oriented 90 degrees with respect to each other and 45 degrees with respect to the plane of the sign panel. The 102 mm (4.0 in) diameter aluminum support sign installations, when modified as described above, performed satisfactorily in the crash tests conducted in both weak and strong soil.

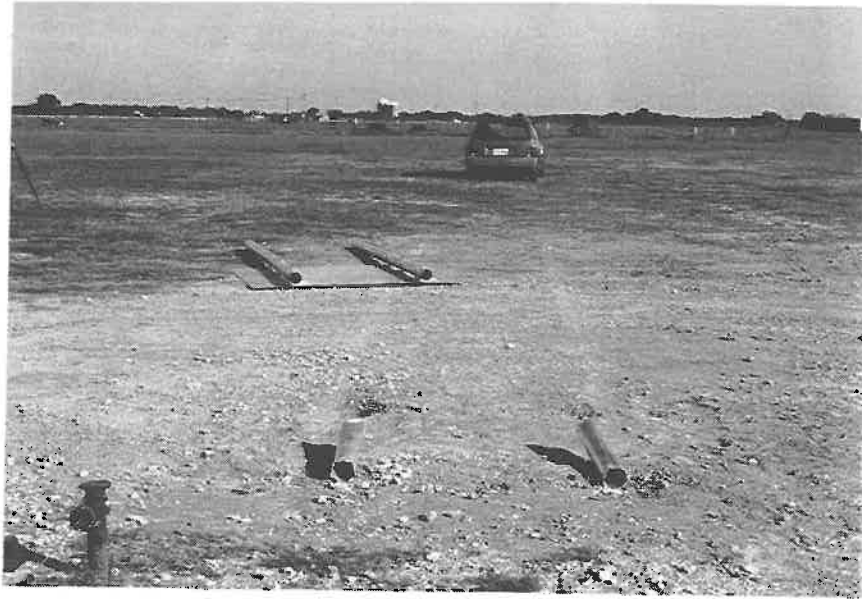
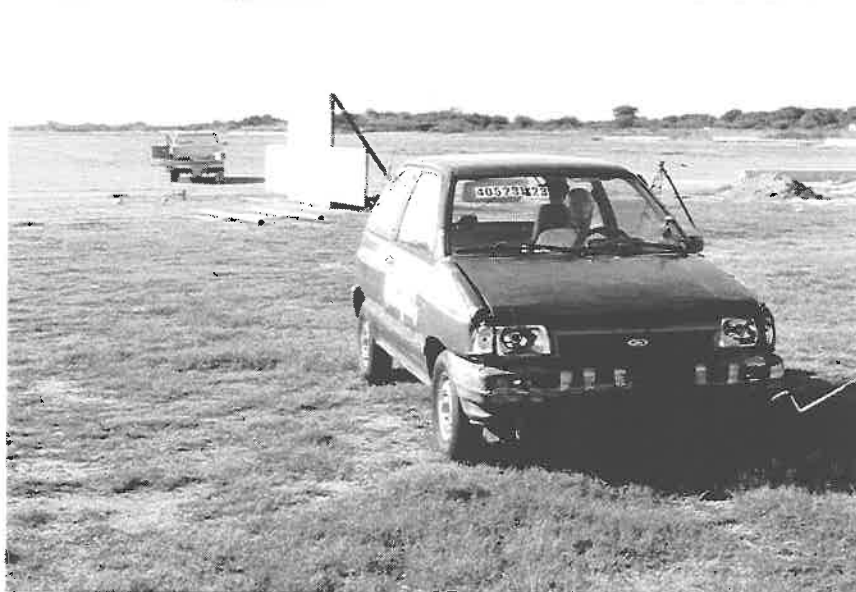
Figure149. Final rest position of the sign installation and vehicle (test 405231-23).

Upon the vehicle impacting the sign installation, the supports began to deflect at bumper height. As the vehicle continued traveling forward, the supports began to fracture at 0.017 seconds and subsequently fail across their entire cross-section at bumper height. At 0.022 seconds, the supports began to partially fracture at ground level. As the vehicle traveled over the stubs, the supports and attached sign panel slid downward, contacting the ground and rotating over and toward the vehicle. The vehicle pushed the supports and attached sign panel upward and over the hood of the vehicle. The vehicle lost contact with the supports at 0.167 seconds. As the vehicle passed under the installation, the sign panel struck the roof at 0.352 seconds. Thereafter, the sign panel lost contact with the roof of the vehicle at 0.906 seconds. The vehicle came to rest upright 25.6 m (84.0 ft) downstream from the point of impact and the sign installation came to rest 8.2 m (27.0 ft) down and 0.9 m (3.0 ft) over from the point of impact. Final rest positions of the vehicle and sign installation are shown in Figure 149. Sequential photographs of the crash test are shown in Appendix B.

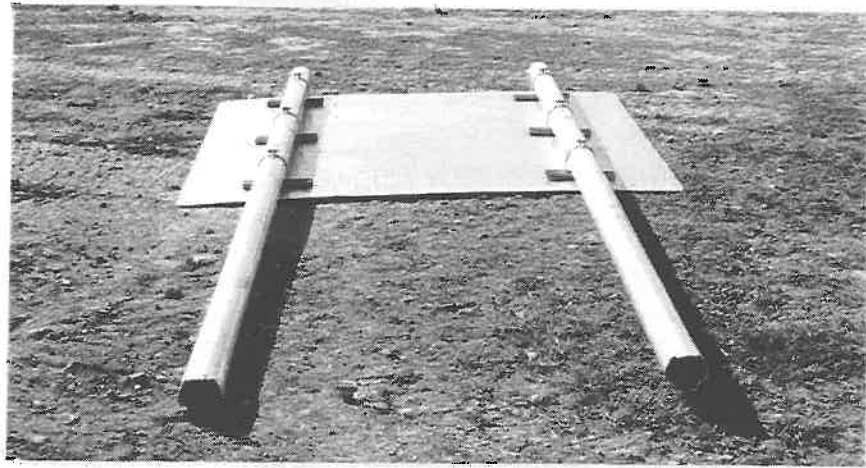
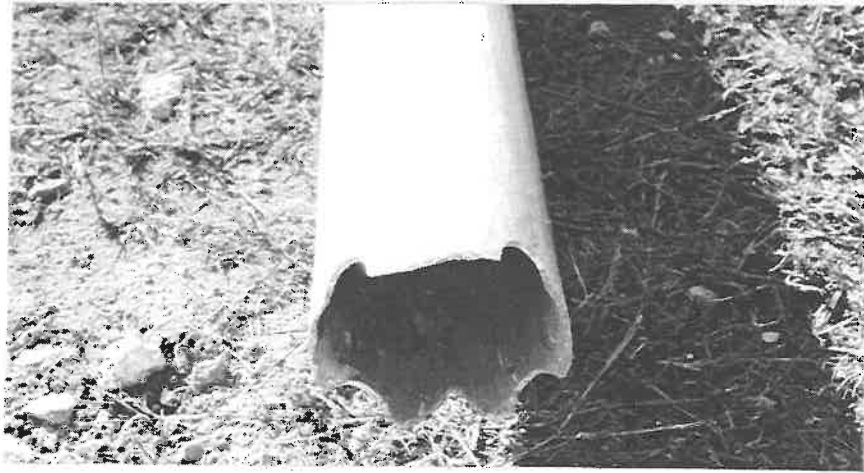
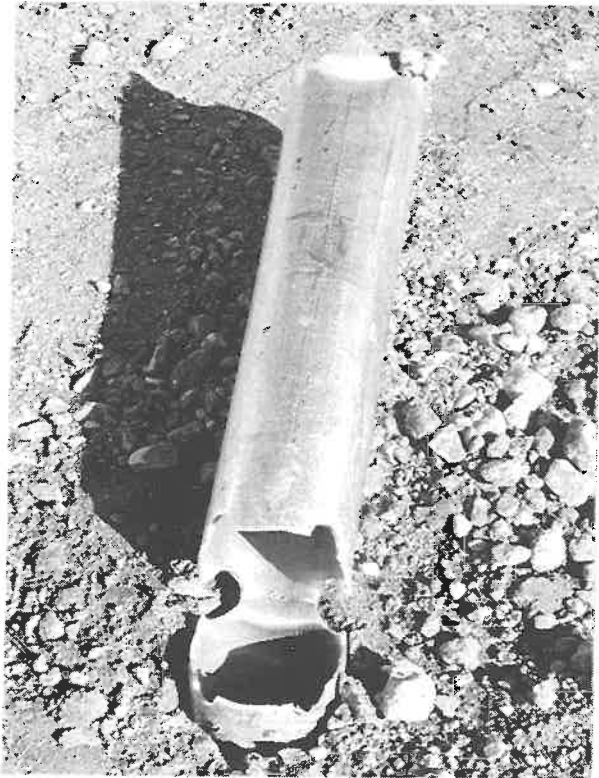
Figure 150 . Dual 4-in with 1-in holes aluminum sign support installation anchored in strong soil after test 405231-23.

As shown in Figure 150, the supports were bent and fractured. The left and right supports failed in tension across their entire cross-section at the holes located near bumper height. In addition, both supports failed in tension across all but the most rearward part of their cross\sections at the holes located at ground level. The sign panel and all mounting and anchoring

B.	The test article should readily activate in a predictable manner by breaking away, fracturing, or yielding.	The sign supports yielded by fracturing the aluminum tubes at bumper level and partially fracturing and bending at ground level.		Pass	
<u>Occupant Risk</u>

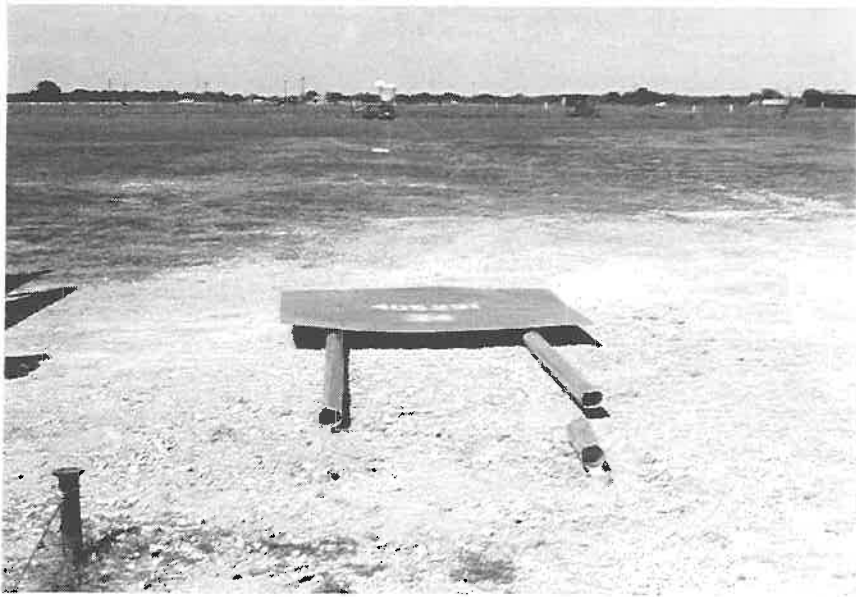
Figure 156. Final rest position of the sign installation and vehicle (test 405231-24).

Upon impact the support began to deflect toward the ground. As the vehicle continued traveling forward, the right support began to fracture at bumper height at 0.005 seconds. Subsequently, the left support fractured at bumper height at 0.007 seconds. As the vehicle traveled over the stubs, the vehicle pushed the supports and attached sign panel up and over the hood and roof of the vehicle. The vehicle lost contact with the supports at 0.040 seconds. The sign installation rotated 270 degrees over the vehicle and came to rest 3.0 m (10.0 ft) from the point of impact. The vehicle lost contact with the installation traveling 94.7 km/h (58.9 mi/h), the brakes were applied, and the vehicle came to rest upright 109.5 m (359.0 ft) downstream and 4.6 m (15.0 ft) from the point of impact. Final rest positions of the vehicle and sign installation are shown in Figure 156. Sequential photographs of the crash test are shown in Appendix B.

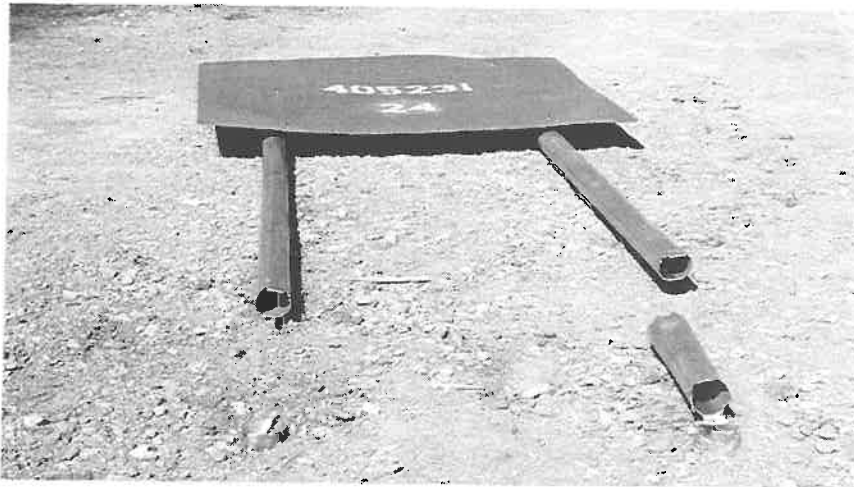
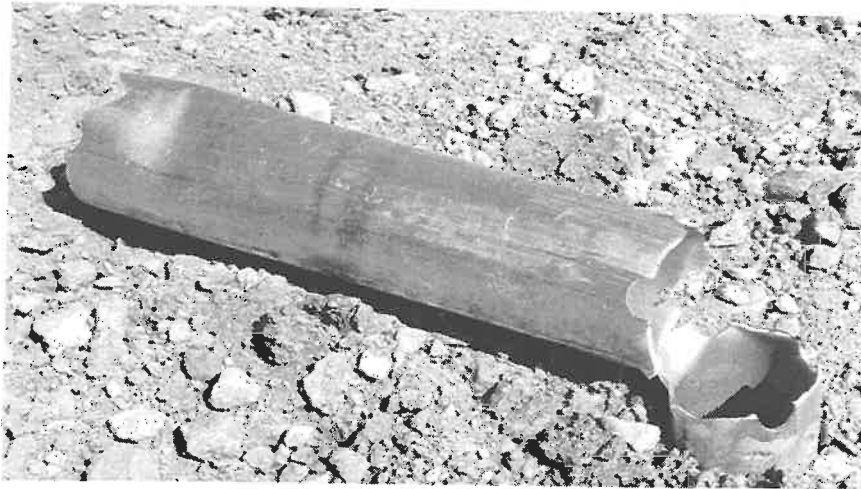
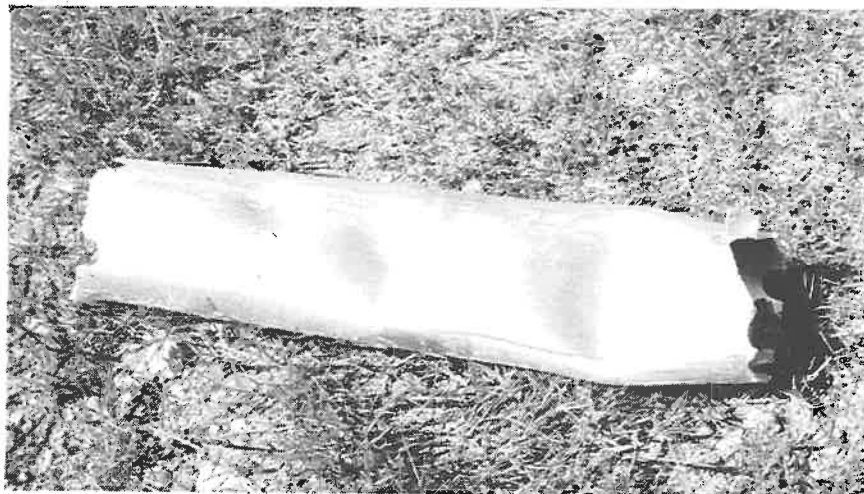
Figure 157. Dual 4-in with 1-in holes aluminum sign support installation anchored in strong soil after test 405231-24.

As shown in Figure 157, the supports were bent and fractured. The left and right supports failed in tension across their entire cross-sections at the holes located near bumper height. In addition, the right support failed in tension across all but the most rearward part of its cross-section at the holes located at ground level. The left support failed the entire cross-section at the holes located at ground level. The sign panel and all mounting and anchoring hardware received minimal damage and could be reused in field renovation of this installation. Damage sustained to the vehicle during this test is shown in Figure 158. The vehicle sustained minor damage to the

B.	The test article should readily activate in a predictable manner by breaking away, fracturing, or yielding.	The sign supports yielded by fracturing the aluminum tubes at bumper level. The left support was fractured and the right support only partially fractured at ground level.		Pass	
<u>Occupant Risk</u>
