**EVALUATION OF THE CRASHWORTHINESS OF THIN-WALLED  
ALUMINUM AND STEEL U-CHANNEL SIGN SUPPORTS**

TTI Project No. 405231-1F  
Final Report

June 1995

**Texas Transportation Institute  
Texas A&M University System  
College Station, TX 77843**

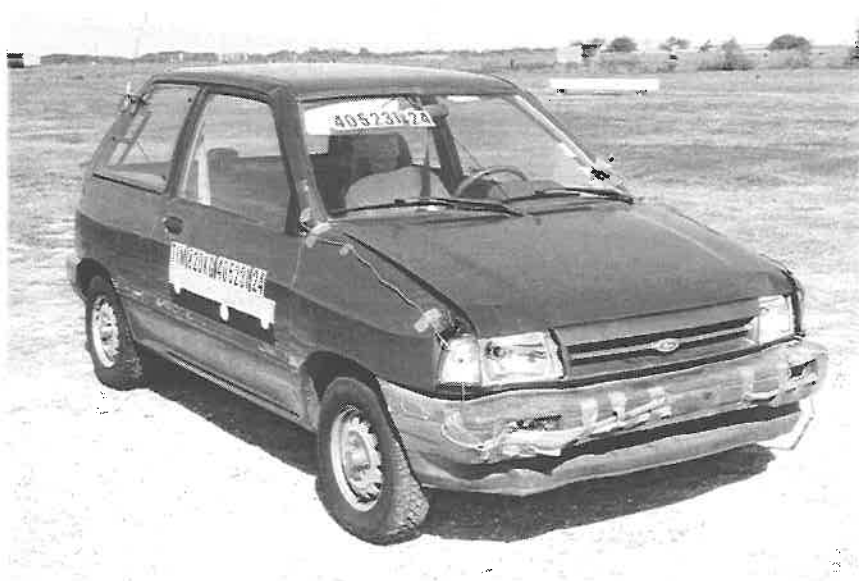
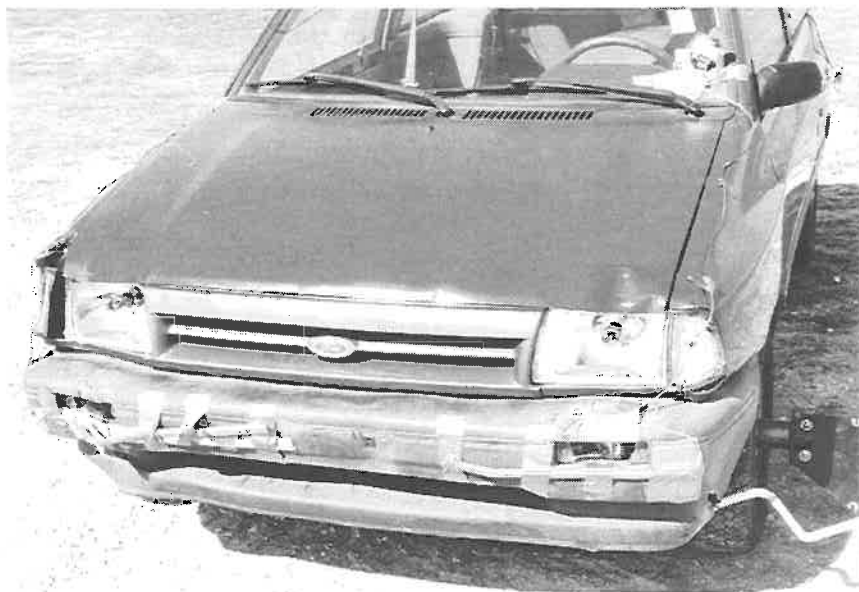
Figure 158. Vehicle after test 405231-24.

bumper only. No measurable deformation to the vehicle was recorded. There was no deformation to, or intrusion into, the vehicle occupant compartment.

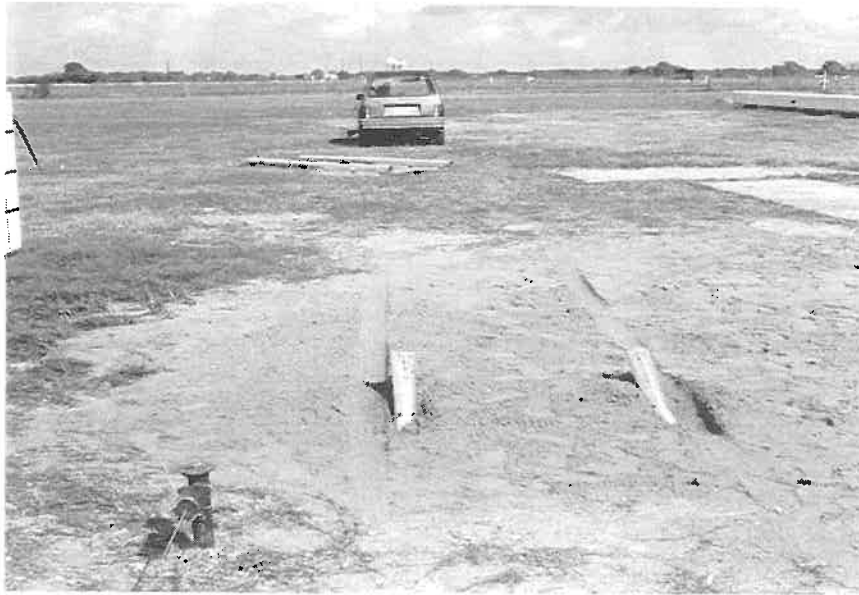
Figure 163 . Final rest position of sign installation and vehicle (test 405231-25).  
241

Upon impact the supports began to deflect at ground level and at bumper height. As the vehicle continued traveling forward, the right and left supports began to fracture near the upper holes at 0.027 and 0.029 seconds, respectively. The sign installation rotated over the front of the vehicle and lost contact with the vehicle at 0.142 seconds. The vehicle came back into contact with the supports at 0.216 seconds. The sign installation continued to rotate over the front of the vehicle and shortly thereafter, the sign panel struck the roof of the vehicle at 0.022 seconds. The vehicle lost contact with the sign panel temporarily at 0.468 seconds. The vehicle exited the installation with the sign panel and supports still in contact with the front of the vehicle. The final rest position of the sign installation was 15.5 m (51.0 ft) from the point of impact. The vehicle came to rest upright 20.1 m (66.0 ft) downstream and 0.6 m (2.0 ft) left of the point of impact. Final rest positions of the vehicle and sign installation are shown in Figure 163. Sequential photographs of the crash test are shown in Appendix B.

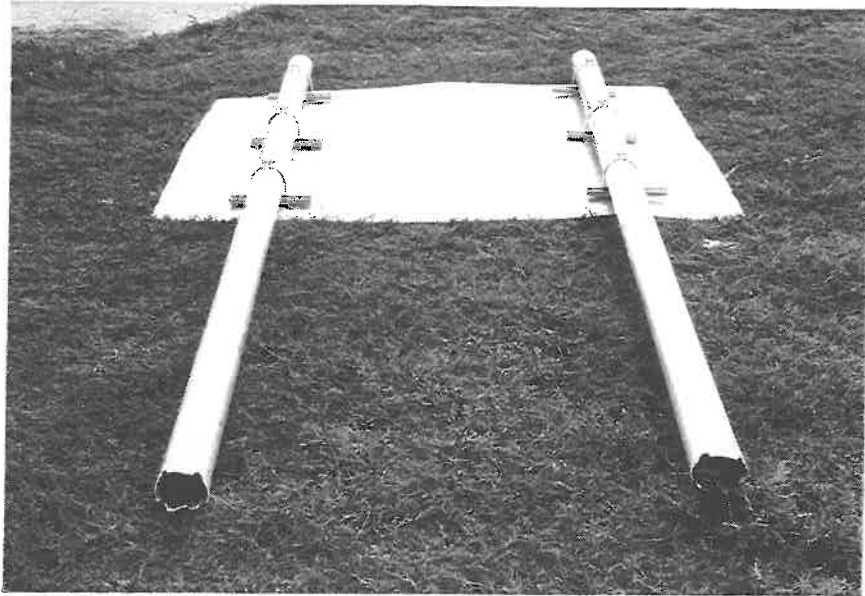
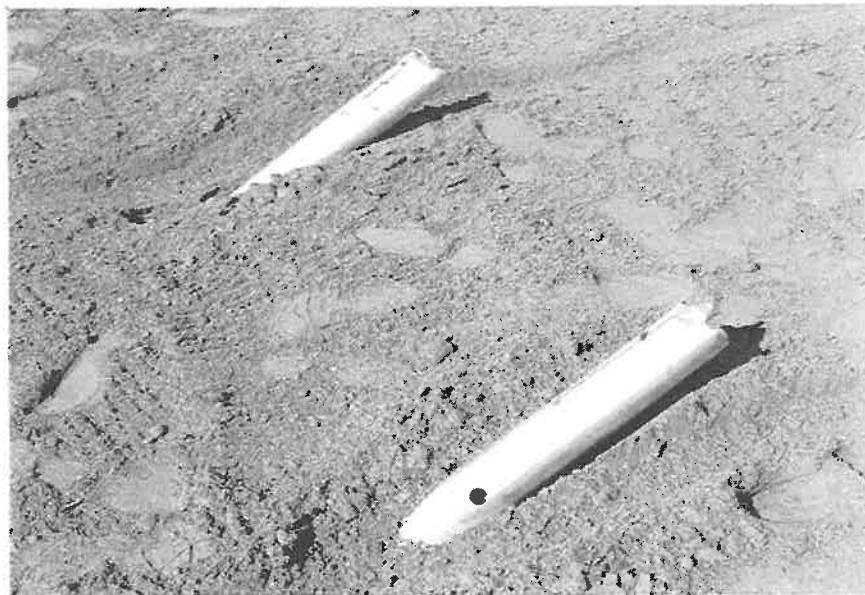
Figure 164 . Dual 4-in with 1-in holes aluminum sign support anchored in weak soil after test 405231-25.

As shown in Figure 164, the supports were bent and fractured. The left and right supports failed in tension across their entire cross-section at the upper holes. At ground level, the supports were displaced rearward 279 mm (11.0 in). The sign panel and all mounting and anchoring hardware received minimal damage and could be reused in field renovation of this installation. Damage sustained by the vehicle during this test is shown in Figure 165. The vehicle sustained

B.	The test article should readily activate in a predictable manner by breaking away, fracturing, or yielding.	The sign supports yielded by fracturing the aluminum tubes at bumper level. In addition, the supports were bent and pushed rearward at ground level.		Pass	
<u>Occupant Risk</u>

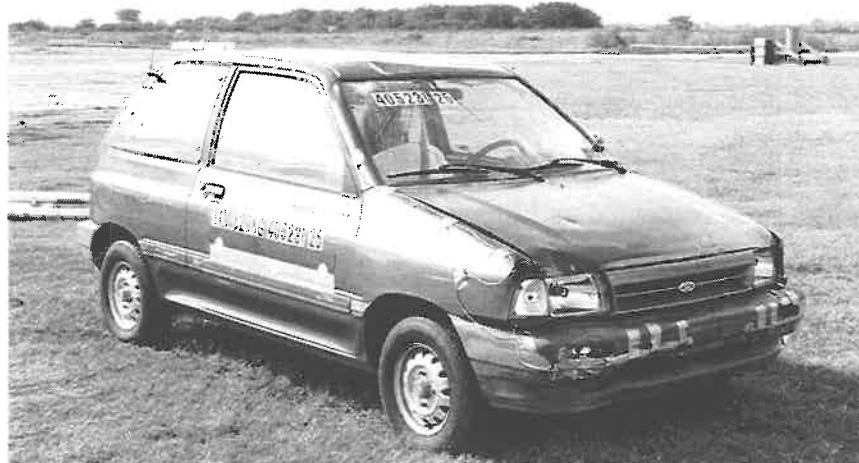
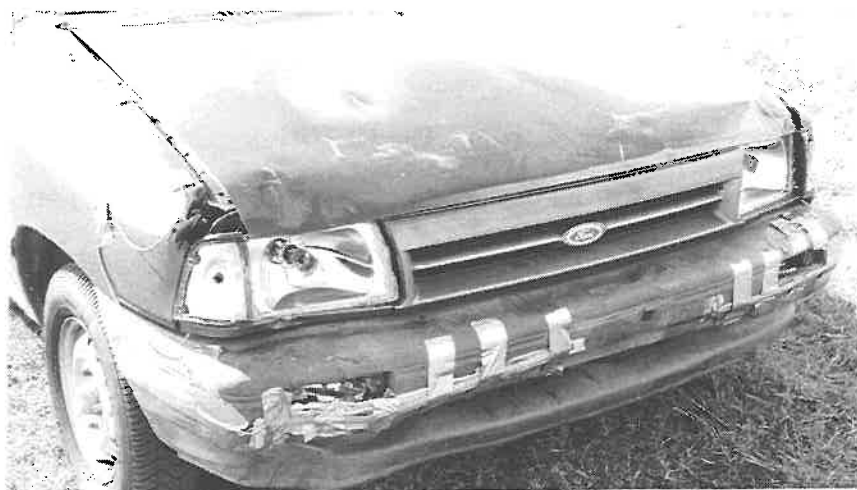
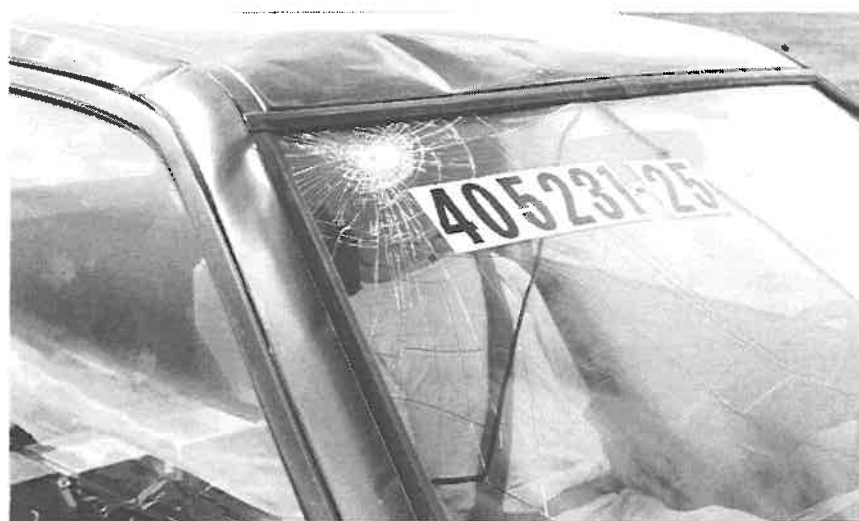
Figure 165 . Vehicle after test 405231-25.  
243

minor damage to the bumper, hood and roof. The upper right side of the windshield was struck and broken. The roof was deformed 7 mm (0.3 in). There was no deformation to, or intrusion into, the vehicle occupant compartment.

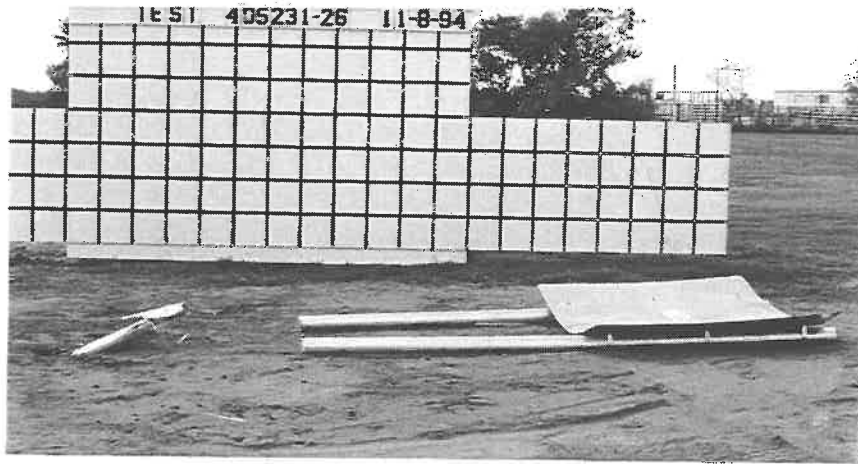
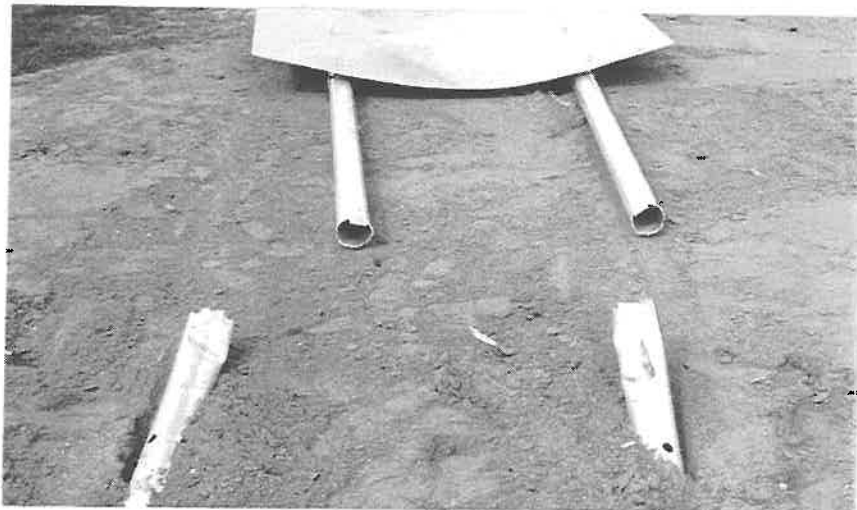
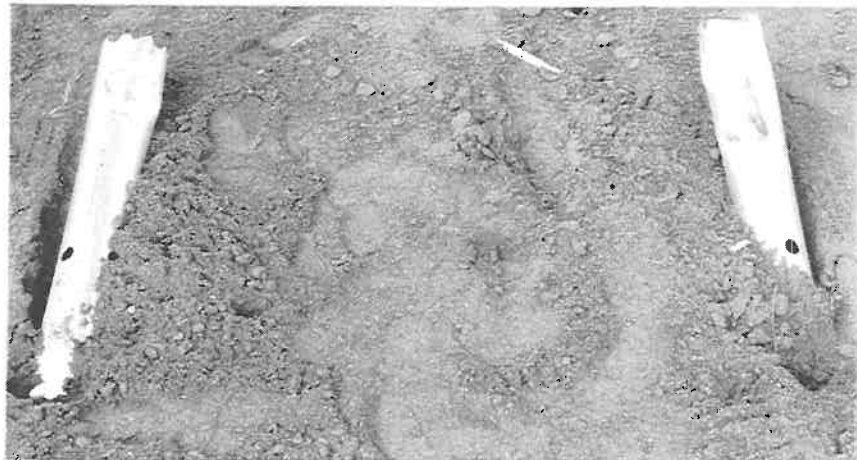
Figure 171. Dual 4-in with 1-in holes aluminum sign support anchored in weak soil after test 405231-26.

As shown in Figure 171, the supports were bent and fractured. The left and right supports failed in tension across their entire cross-section at the upper holes. The sign panel and all mounting and anchoring hardware received minimal damage and could be reused in field renovation of this installation. Damage sustained by the vehicle during this test is shown in Figure 172. The vehicle sustained minor damage to the bumper and hood. No measurable deformation to the vehicle was recorded. There was no deformation to, or intrusion into, the vehicle occupant compartment.
