**BUREAU OF MATERIALS & RESEARCH**

**EXPERIMENTAL FEATURE 2004-2 and 2005-2  
Poly-Carb Flexogrid Bridge Deck Overlay System and Stirling Lloyd SafeTrack HW**

**Interim Report**

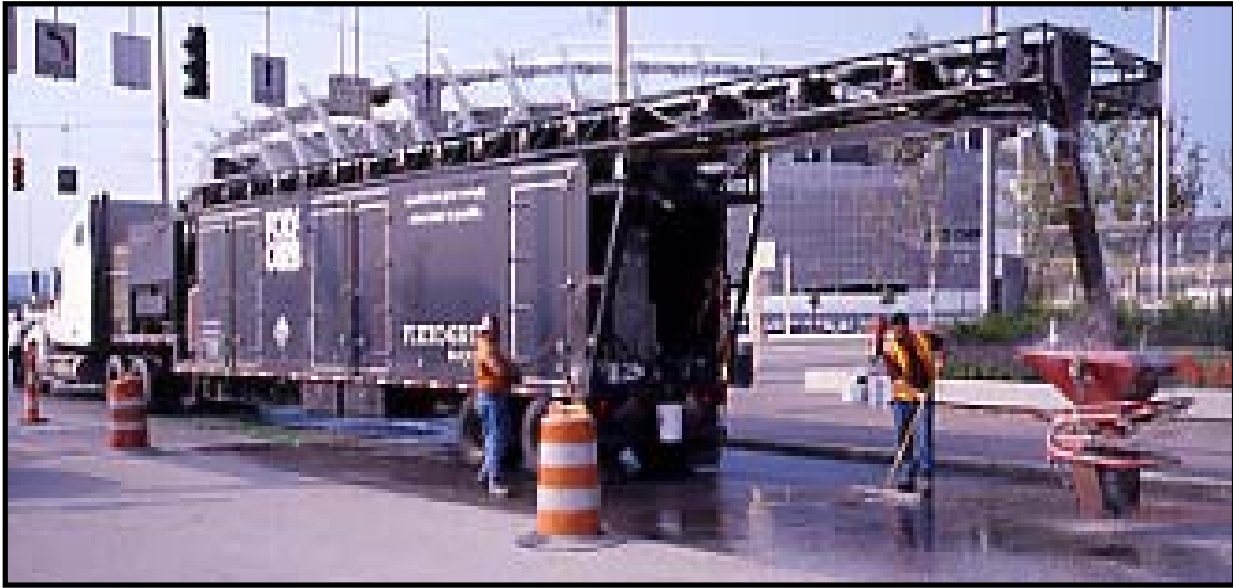
Figure 4 – Poly-Carb distribution unit

The Poly-Carb system was applied to the more easterly bridge, Br. # 042/044, in August 2005. The deck was shot blasted prior to application of the overlay. The design thickness of this installation was 3/8". The manufacturer placed the product using a specialized distribution unit of the type shown in Figure 4.

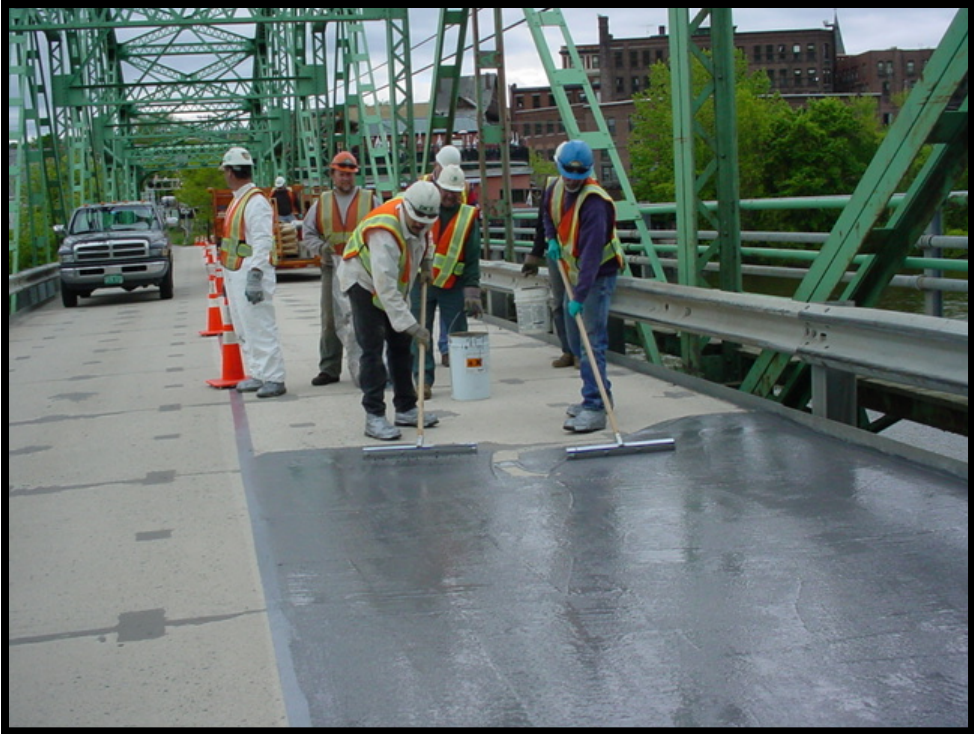
Figure 5 – NHDOT Bridge Maintenance installing Stirling Lloyd product
