**RUMBLE STRIPS** are 18-inch long, 1/2-inch deep depressions milled into the pavement shoulder designed to alert an errant driver that they are about to leave the travel way. They have been

# PREPARATION OF RUMBLE STRIPS BEFORE OVERLAYMENT

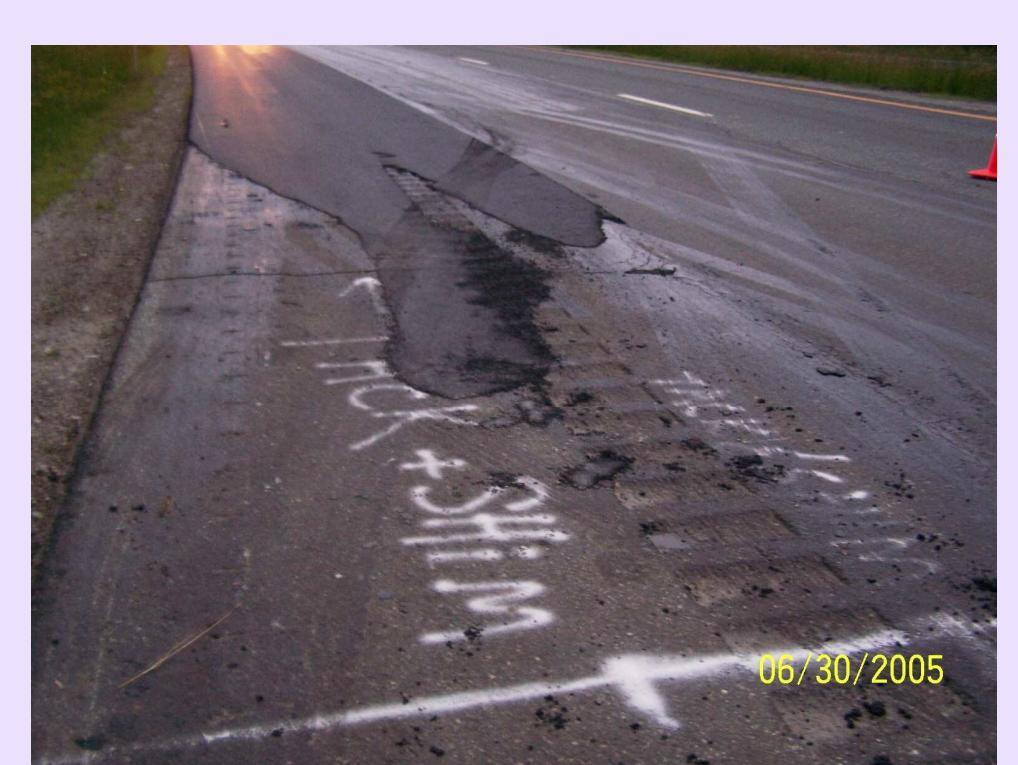
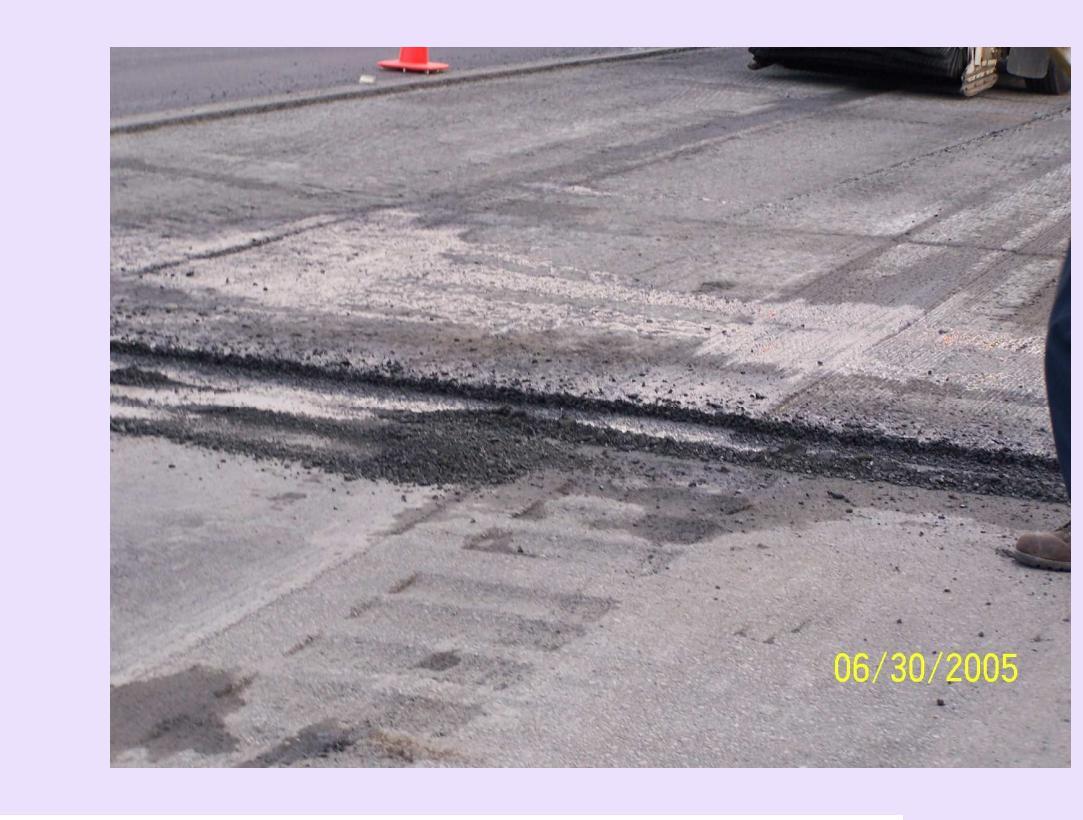
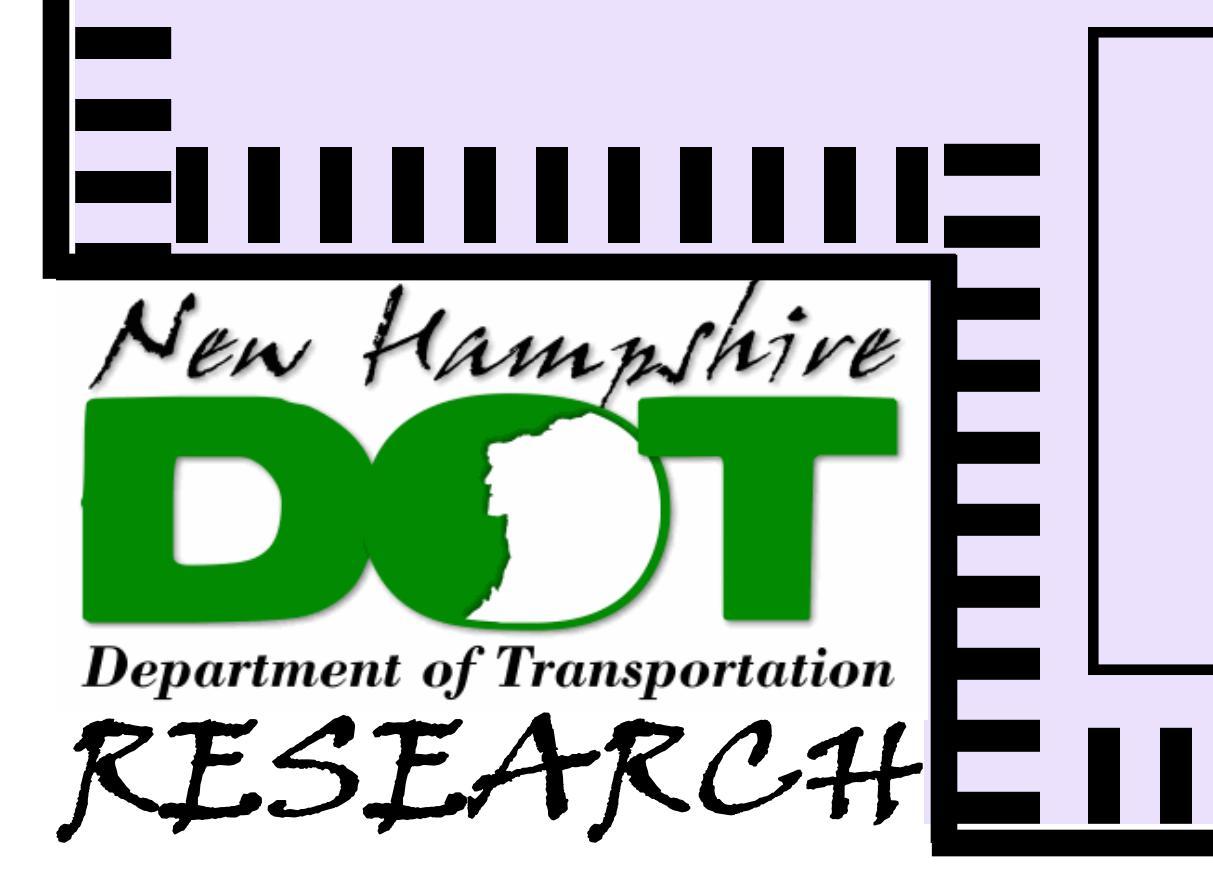
Section A - Shim, overlay: The rumble strip was tack coated and shimmed to fill the rumbles. The shim was compacted, followed by the 1.5-inch overlay.

Initial results showed no indication of rumble strip reflection.

Full-width Shim

Followed By

1.5-Inch Overlay

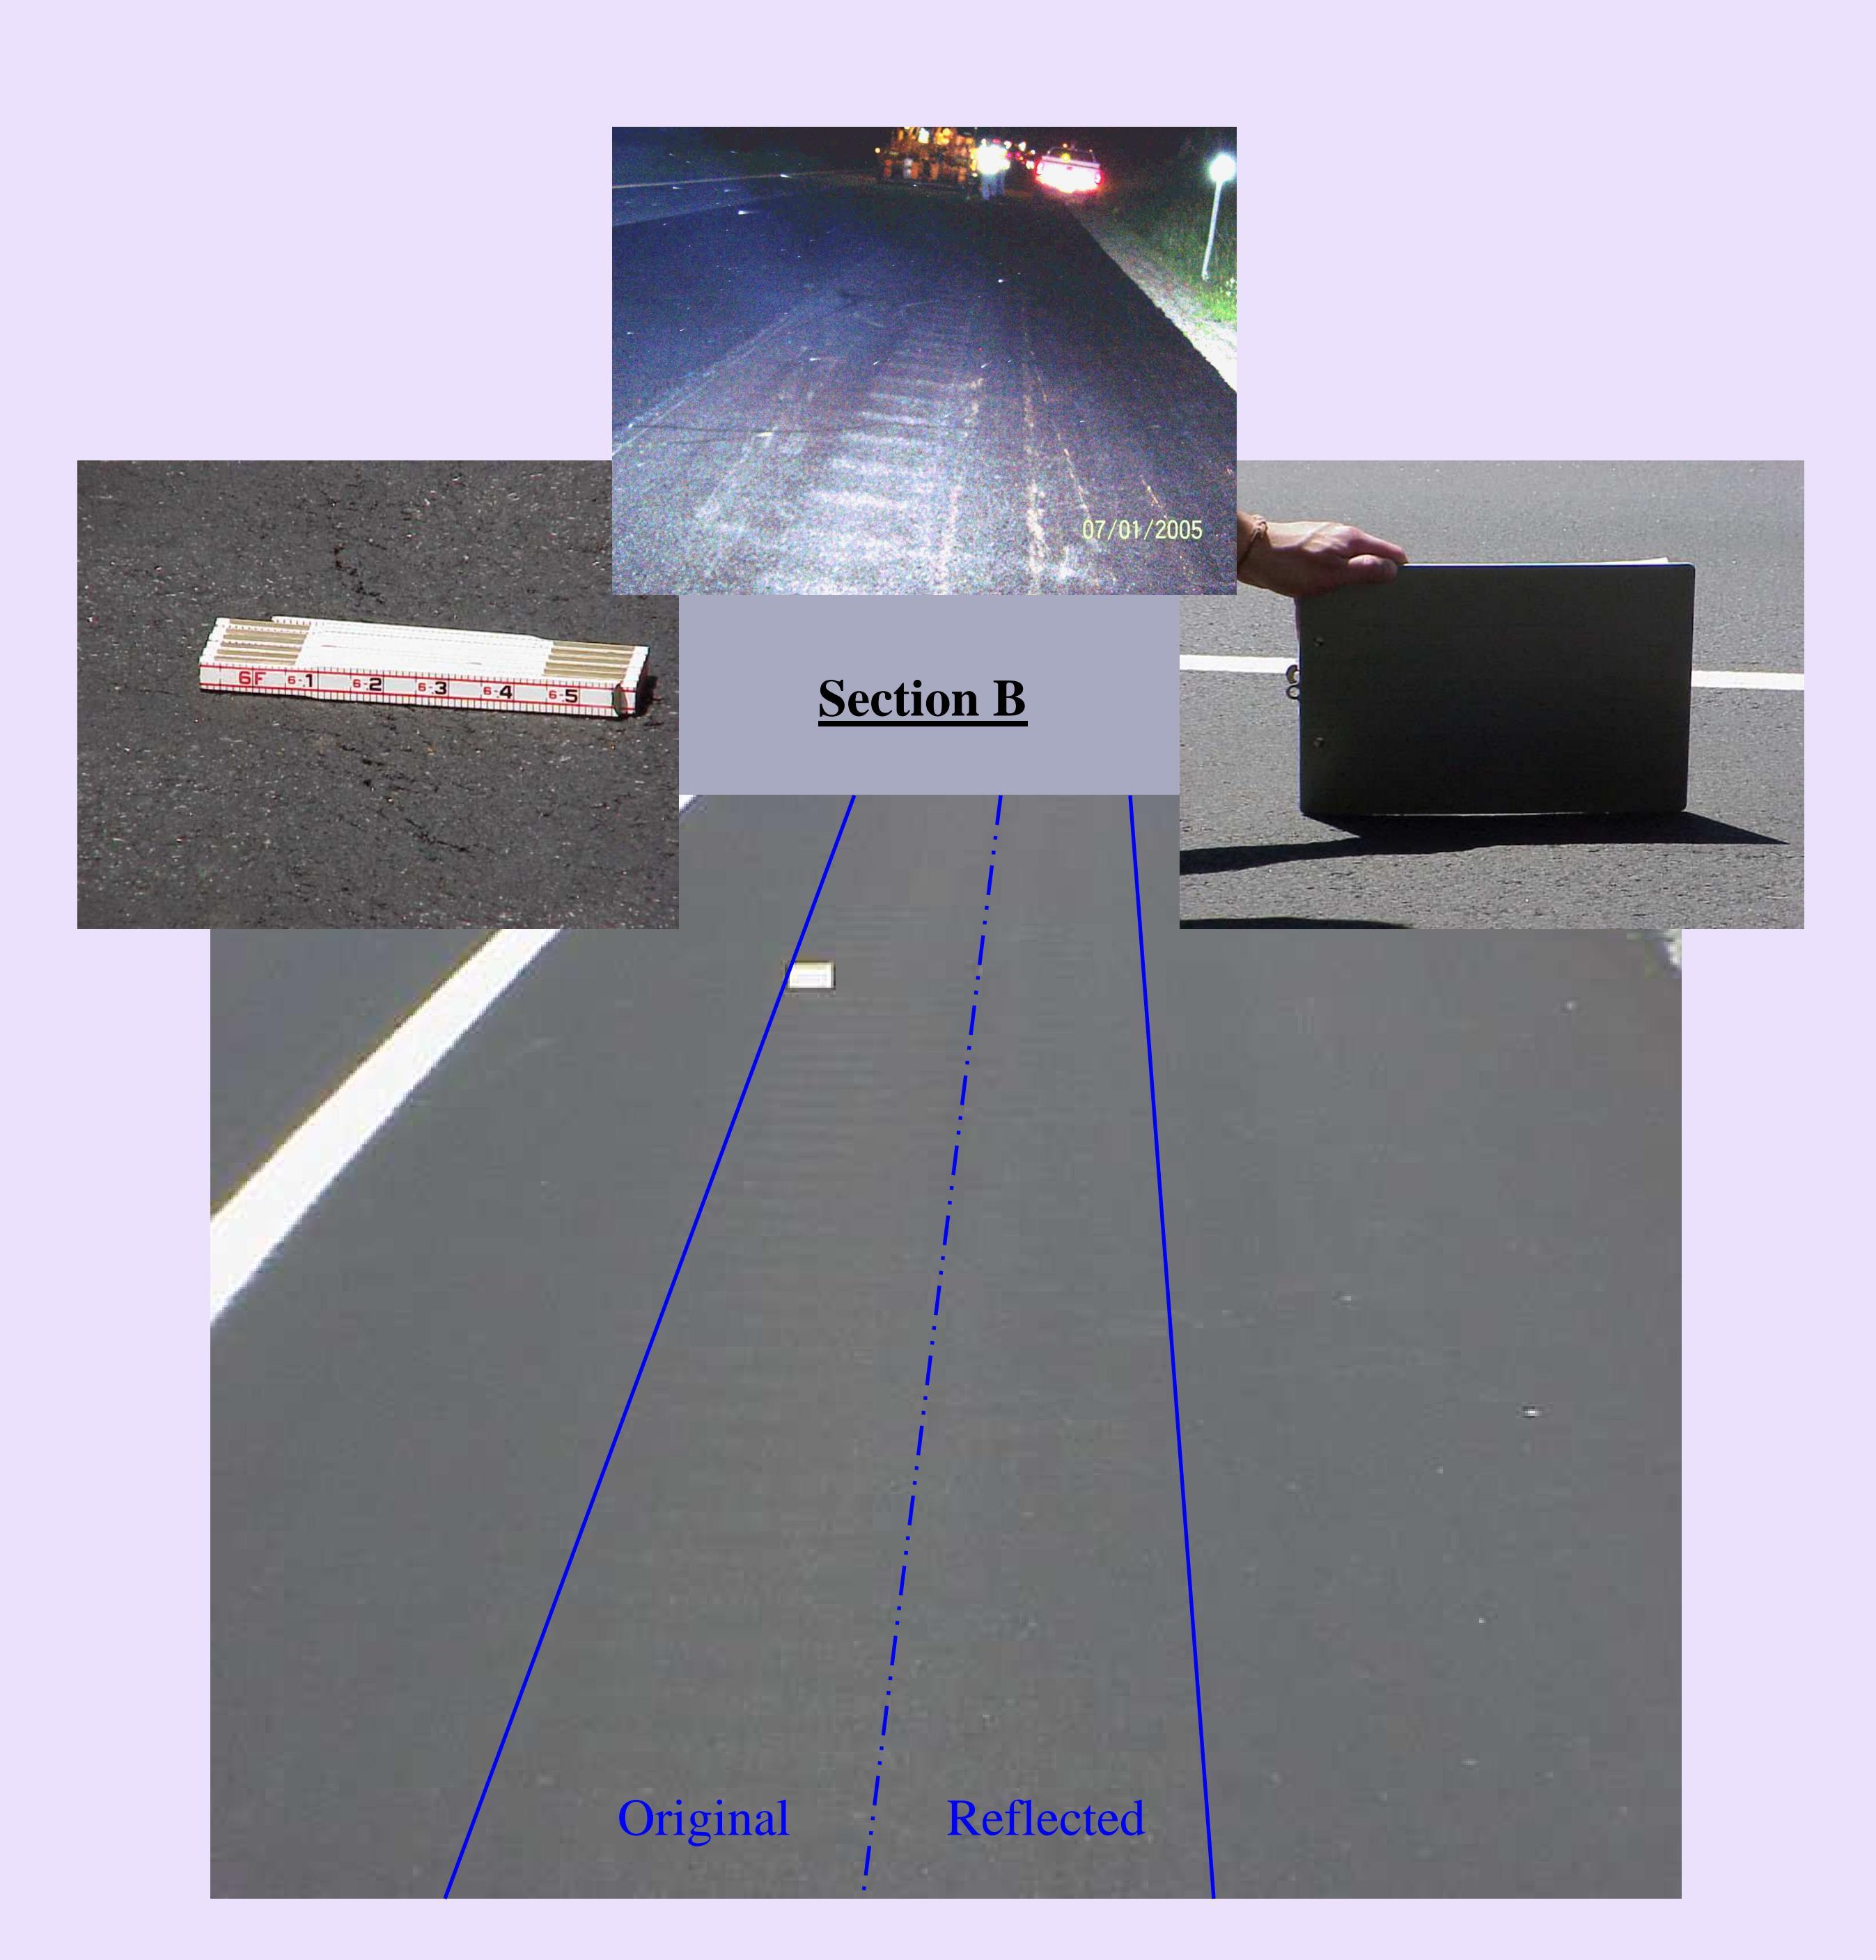
Section B - Overlay: Application of a tack coat was the only preparation prior to the 1.5-inch overlay (resulting in 2-inch depth in rumbles).

This section showed occasional longitudinal cracks along the edge of the rumble strip, indicating movement of the mix. The rumble strip has reflected through the overlay along the entire length of this section. Additionally, a parallel line of "reflected" rumbles was observed in this section. It is interpreted that the vibratory drum roller bounces or rocks due to the alternating mix thickness/density in the rumble strip, resulting in the indentation of the surface alongside of the original rumble strip.

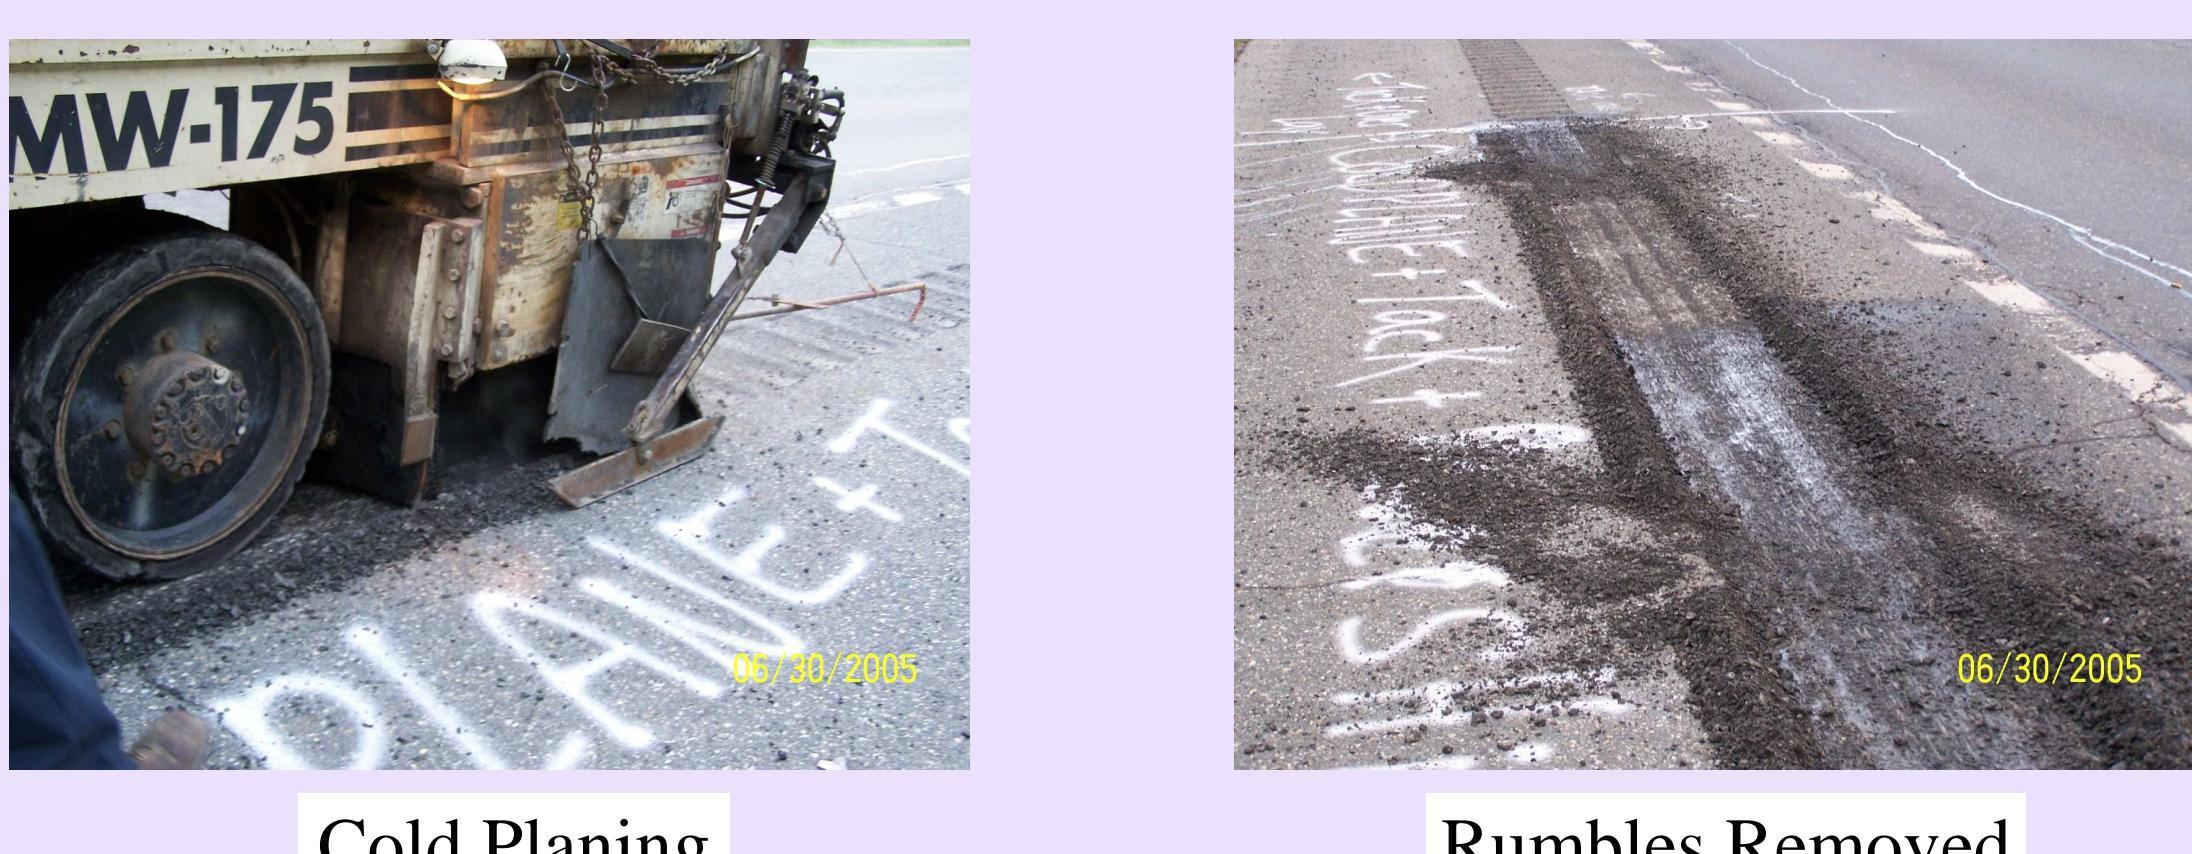
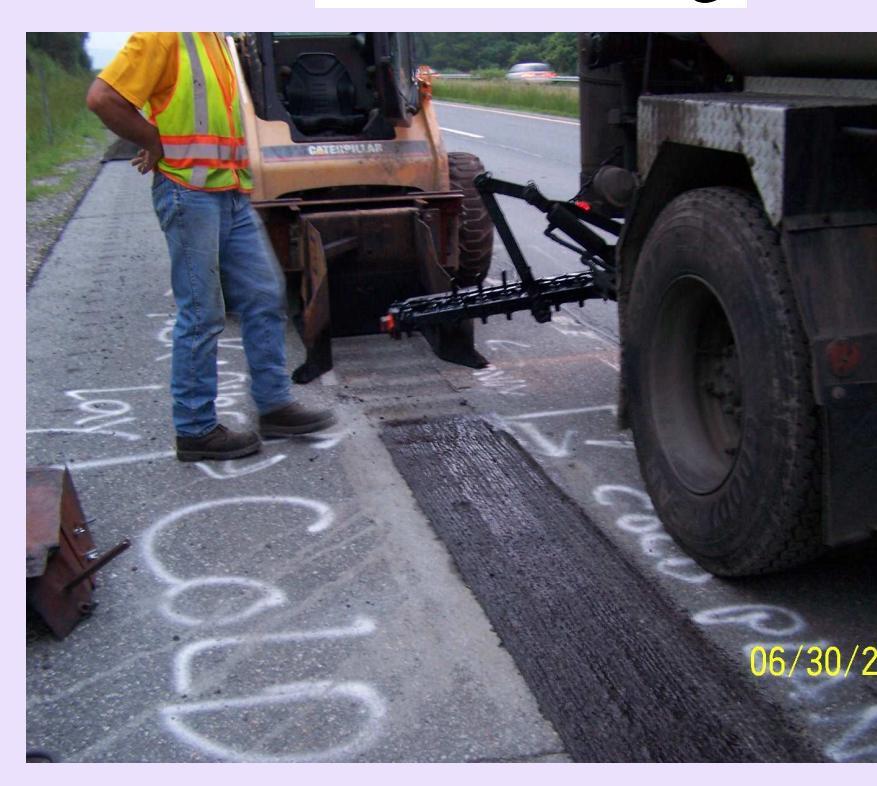
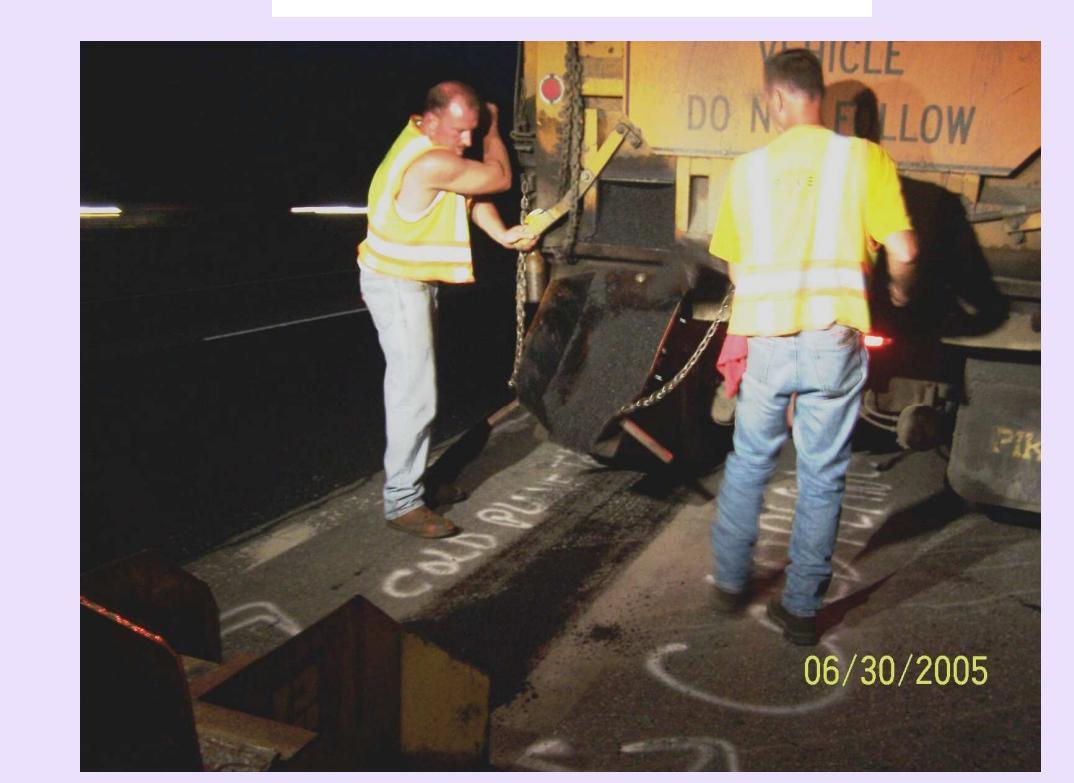
Section C—Mill, inlay, overlay: The rumbles were removed by milling one inch wider than the rumble strip. The area was tacked and inlaid and compacted to the existing pavement surface. The 1.5-inch overlay was then placed over the entire roadway.

Section C showed no reflection of the milling, which would have displayed as a rut.

Cold Planing

Asphalt Inlay

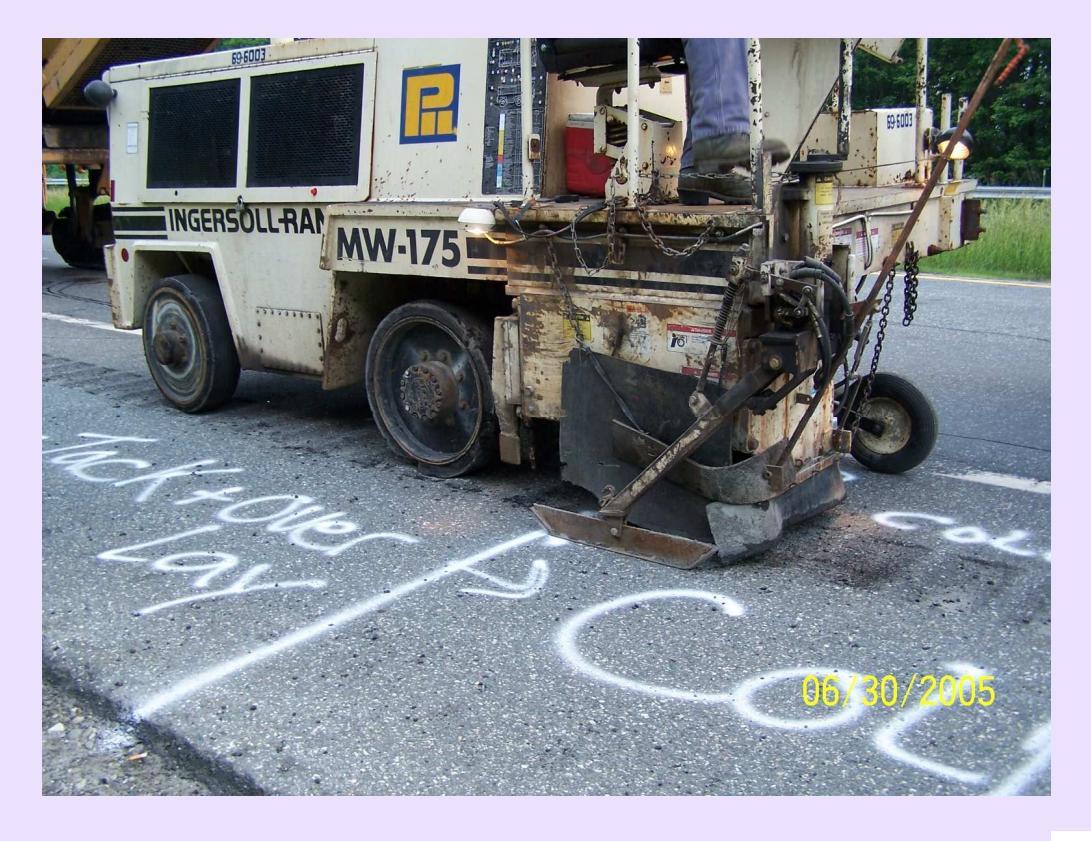
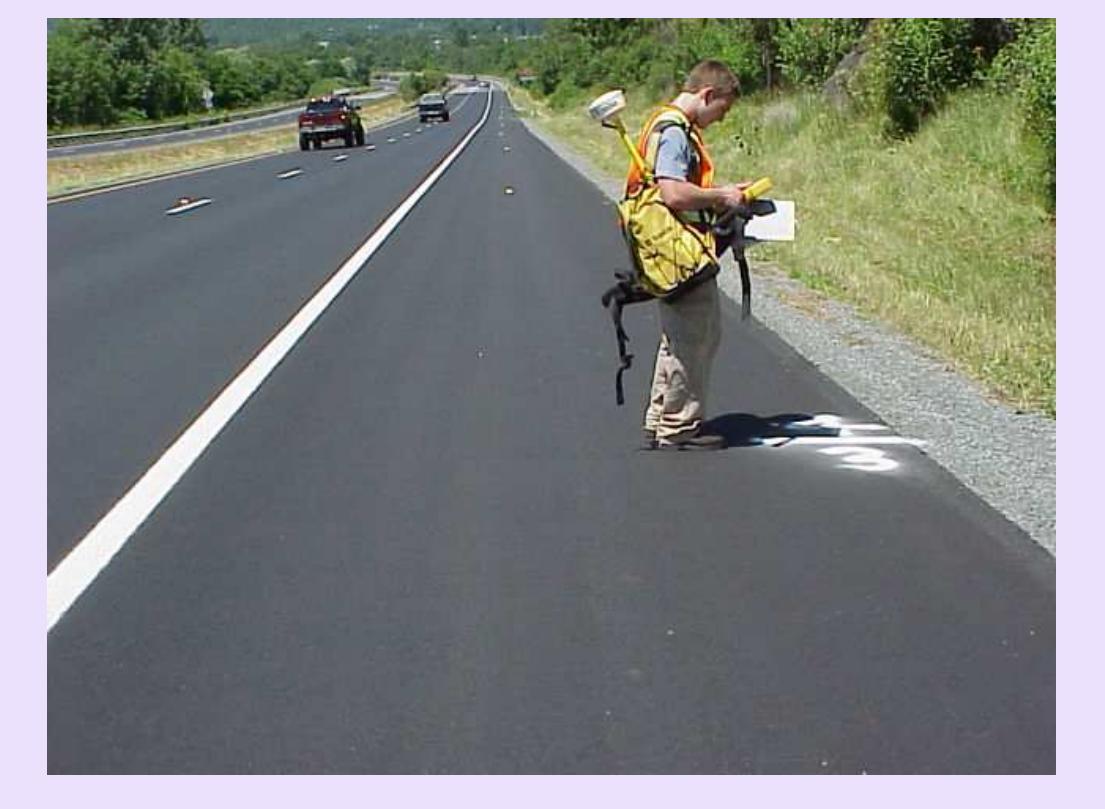
Section D

Section D—Mill, overlay: The rumbles were milled as in Section C, tacked, then overlaid with 1.5 inches of surface mix. This resulted in a single 2-inch lift in the rumble strip.

#### No immediate reflection of the milled rumbles were noted.

**Rumbles Removed**
