INTER-DEPARTMENT COMMUNICATION

Subject **Hinsdale, NH- Brattleboro, VT 12210-C**
Br. No. 041/040 (west) NH 119 / Connecticut R
Br. No. 042/044 (east) NH 119 / Connecticut R

Re: Item 556 Preliminary Bridge Painting Estimate

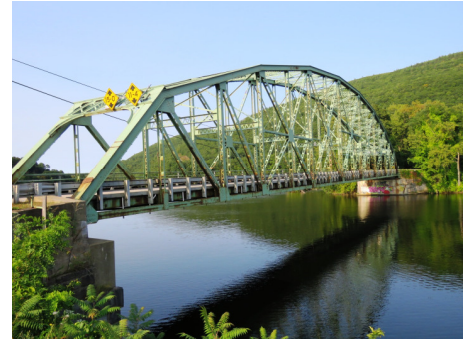
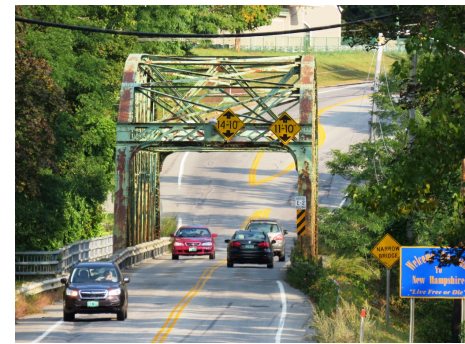
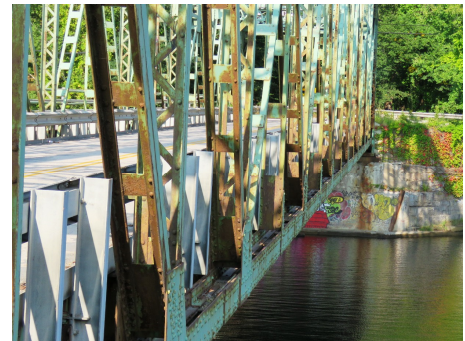
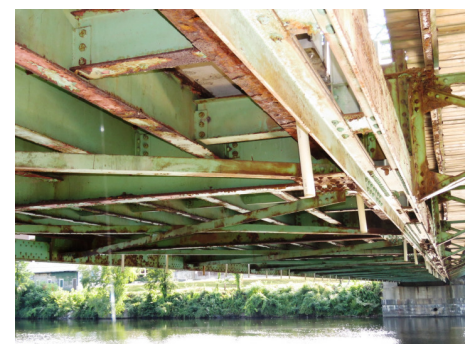
The 1920 bridges have a concrete deck in the roadway and a timber sidewalk cantilevered on the upstream side. The truss structures have built-up riveted members.

The bridge members have not been painted for many years and have suffered considerable deterioration and corrosion. Crevice corrosion and rusting is evident in built-up members particularly within the splash zone near and above the bridge rail, and extensively below the deck in flooring members and bottom chord members. The upper truss coatings are in better condition but exhibit coating delamination and peeling in areas. The easterly (NH-side) truss is in poorer condition than the westerly (VT-side).

It is evident that some steel repair work will be required as well due to the effects of corrosion, with section loss to rivet heads, rust pack and deterioration of members, and rust pack in crevices.

The original coating is an alkyd paint lead (orange primer) containing lead components (lead-bearing paint LBP) and mill scale is present under the coatings. The existing coatings need to be replaced entirely.

I recommend that the existing structural steel be totally repainted, i.e. the existing coating be removed by abrasive blasting to an SP10 Near White finish within Class 1A negative-pressure containment, and repainted with a high-performance system.

The recommended coating system is a four-coat moisture-cured polyurethane system including a penetrating sealer applied over the zinc primer to seep into crevices and provide additional protection. The Department has successfully used this and similar coating systems on a number of bridges and trusses over the years.
