Evaluation of an Automated Bridge
Anti-icing System

Final Report

1. Report No. FHWA-NH-RD-13733G		2. Gov. Accession No.		3. Recipient's Catalog No.	
4. Title and Subtitle EVALUATION OF AN AUTOMATIC BRIDGE ANTI-ICING SYSTEM				5. Report Date JANUARY 2014

EVALUATION REPORT, JUNE 2005 TO JUNE 2008
AUTOMATED BRIDGE ANTI-ICING SYSTEM
I-89, LEBANON, NH

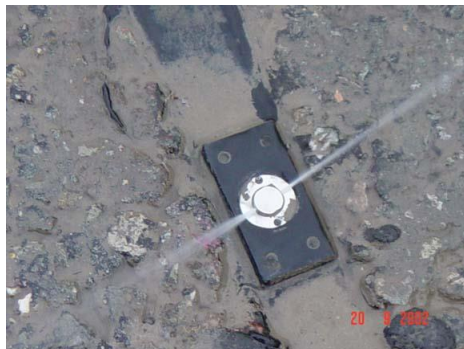
Boschung America Micro Spray Nozzle

An additional advantage of the micro nozzle system was that it is distinctly different from both Boschung's and the competition's standard spray heads. Standard heads are more than two inches thick. Since New Hampshire bridge decks are covered with only two inches of bituminous pavement, penetration of the barrier membrane and the concrete deck would have been required to recess the head into the deck surface. Micro nozzles are only 1.7 inches tall, allowing them to be installed within the existing asphalt surface without damaging the barrier membrane.

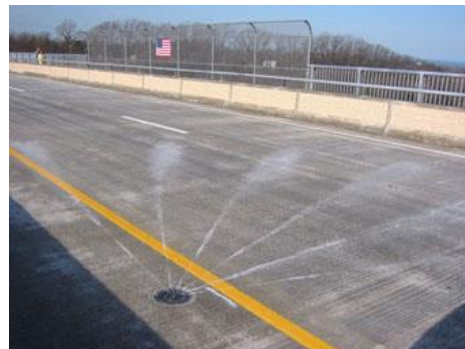
Standard Nozzle

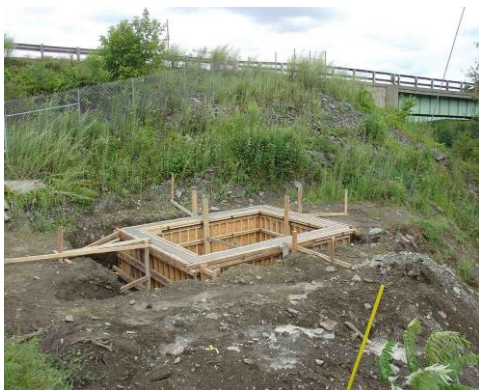
Cast-in-place concrete pump house foundation doubles as secondary containment for single-walled chemical storage tank.

The 2006 construction team consisted of forces from the New Hampshire Department of Transportation (NHDOT), the Vermont Agency of Transportation (VTrans) and Boschung America. VTrans started by clearing the pump house site, and creating a shelf in the steep Interstate embankment where the cast-in-place concrete and concrete masonry structure could be built. They also coordinated permitting with the Town of Hartford and procured the chemical storage tank. NHDOT Bridge Maintenance crews constructed the 12' x 16' pump house, designed with an easily removed wooden roof. This feature would allow for simplified removal of the 10-ft. diameter, 6200-gallon, vertical chemical storage tank, should the need arise.

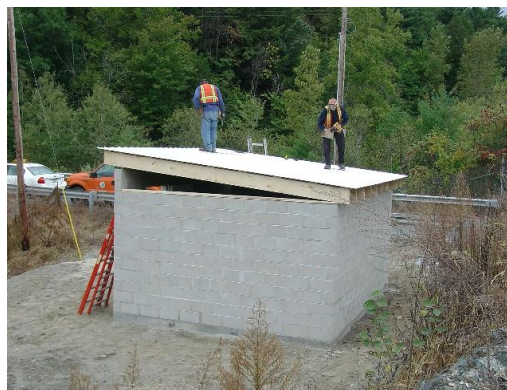
Removable pump house roof system allows for easy storage tank replacement.

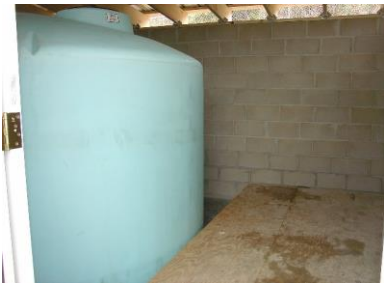
Pump house storage tank and deck.

Pump house construction began in August 2006 with completion during October. It houses the storage tank, which stands on the floor slab of the subsurface foundation, along with a 300-gallon water tank used for flushing the system and summer maintenance. The pump system and control computer are accessed from a small interior deck constructed at approximate ground level.

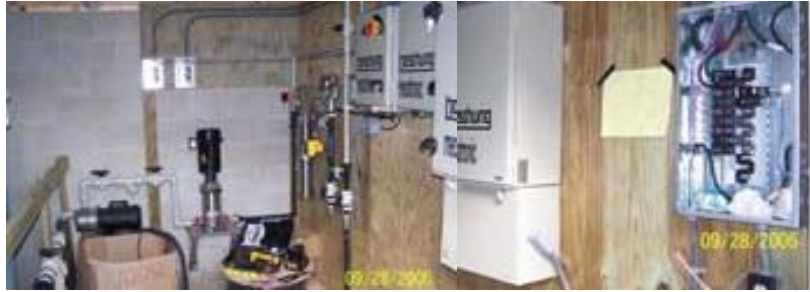
Pump house operational systems: pump, control valves and computer system (closed cabinets).

There are few system controls on site except for piping shut off valves and a manual spray switch. Although the system is designed to operate automatically, manual commands can be made from a computer located at the NHDOT Enfield District Maintenance office.

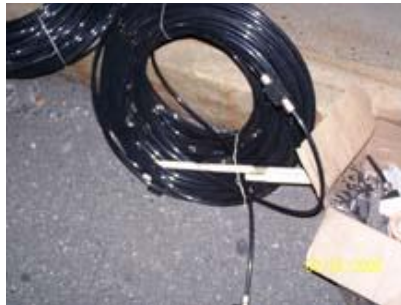
100 m rolls of supply tubing with micro nozzles mounted.

Boschung America pre-assembled the micro nozzle system in 100-meter rolls at the factory. The 8 mm polyethylene tubing is laid into a 1/2-inch wide, 1-5/8 inch deep groove, cut into the pavement with conventional pavement cutting equipment. The groove was chiseled to open it to 1-3/8 inch wide and 3-9/16 inch long to accommodate each micro nozzle. A 3/4-inch wide groove serves the 18-mm tubing that supplies de-icing liquid from the median bridge rail.

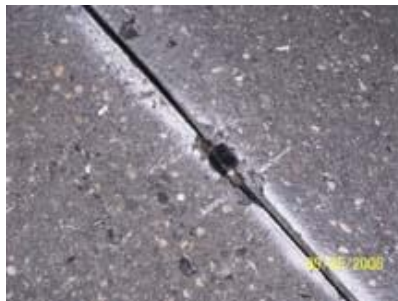
Micro nozzle and tubing laid into pavement groove.

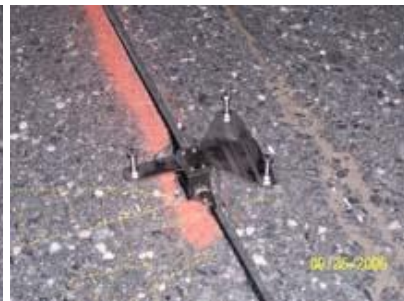
Installation bracket attached to micro nozzle.

An installation bracket was temporarily mounted on each nozzle to set its position slightly below the pavement surface. An epoxy product was then poured around the nozzle and once cured, held the nozzle permanently in place. Foam backer rod was pressed into the groove over the supply tubing, followed by crack sealer to hold it in place.

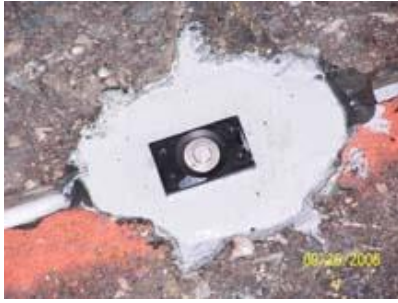
Completed nozzle installation, held in place by epoxy product.

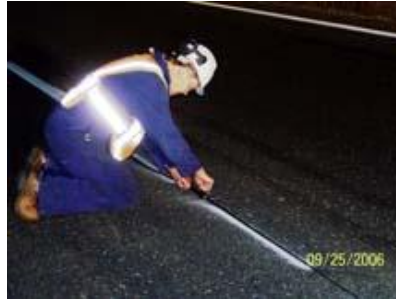
Backer foam is inserted over the tubing to protect it from crack sealant.

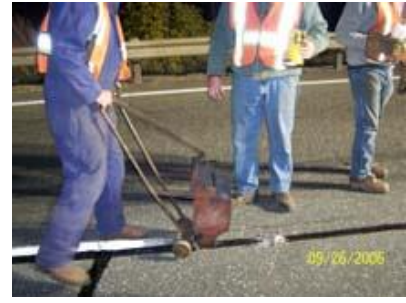
Crack sealant being placed over backer rod and supply tubing.

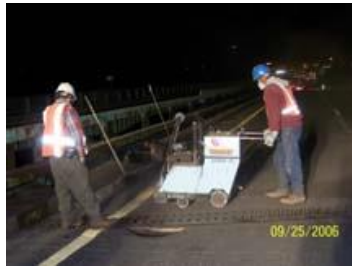
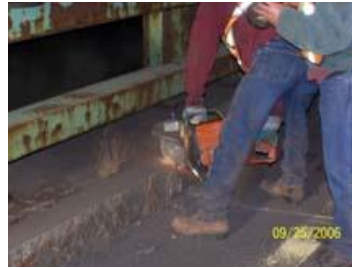
Lateral pavement and curb cuts make way for supply tubing from the median side bridge rail.

Conduit and control valve installation on the median side of the bridge. Two control boxes are located on the bridge, and one at the westerly abutment to house the control valves that operate each nozzle zone.

Electrical conduit and chemical supply piping was laid in a shallow subsurface trench from the pump house to the bridge abutment where it was attached to the abutment face to reach the median side of the bridge. Brackets were fabricated and attached to the guardrail posts to support the conduit, piping and control valves.

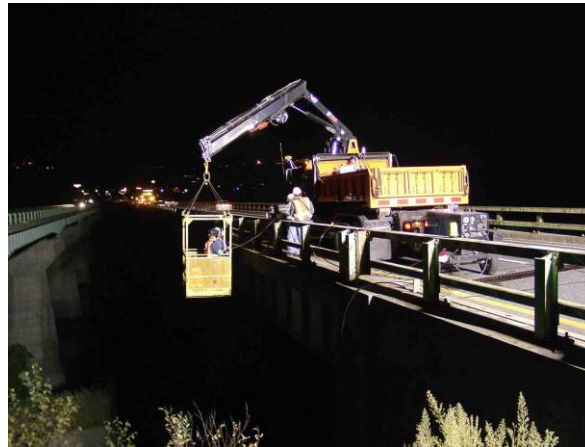
A Boso III sensor and an Arctis sensor were installed in the high speed lane at the approximate midpoint of the bridge. These sensors report deck conditions back to the computer in the pump house. The Boso III is comprised of an active/passive sensor design. It calculates the pavement freeze temperature and activates the deicing chemical spray system. The Arctis sensor works along with the Boso III sensor to determine the actual freeze temperature.

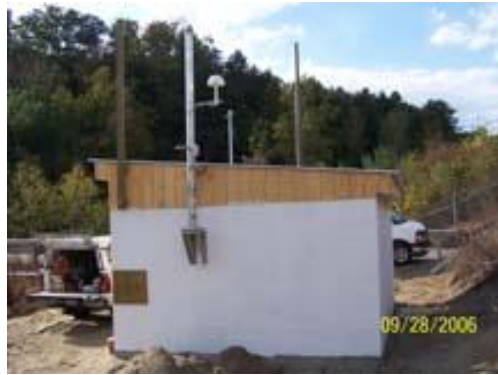
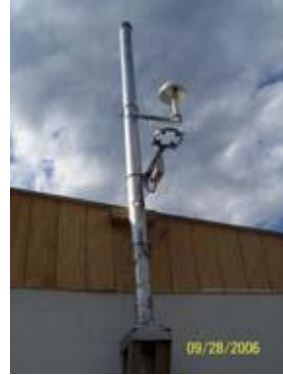
Roadway Weather Information System is installed at pump house. The system measures ambient air temperature, relative humidity and rainfall.

The system is controlled by a computer system and road weather information system (RWIS) located at the pump house near the abutment on the Vermont side. Active and active-passive pavement sensors communicate the deck temperature and projected freeze temperature to the
