Evaluation of an Alternative Deicing
Chemical vs. Conventional Sodium Chloride

Final Report

Prepared by the New Hampshire Department of Transportation, in cooperation with the
U.S. Department of Transportation, Federal Highway Administration

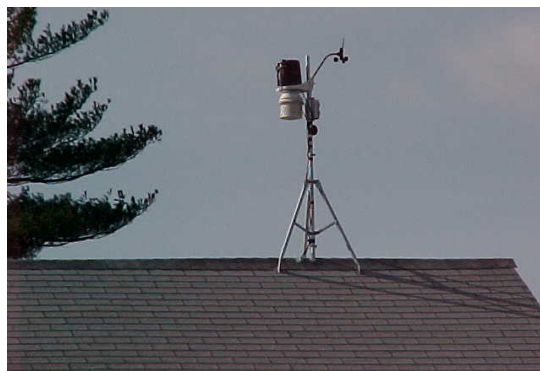
Figure 3: Weather Station at Bristol Maintenance Shed

Figure 3 shows the weather station in Bristol. Weather information recorded during the study included: date, time, temperature, humidity, dew point, wind speed, wind direction, wind chill, heat and thaw indices, barometric pressure, rain and rate (water equivalent, through heating of snow), and other data. The instruments do not record the type of precipitation or snow depth.

Weather Data. In addition to the regular, statewide weather forecasting resources utilized by NHDOT, weather data were collected and recorded at 30-minute intervals by weather stations mounted on the roof of the Bristol and Sunapee patrol sheds (Appendix D).

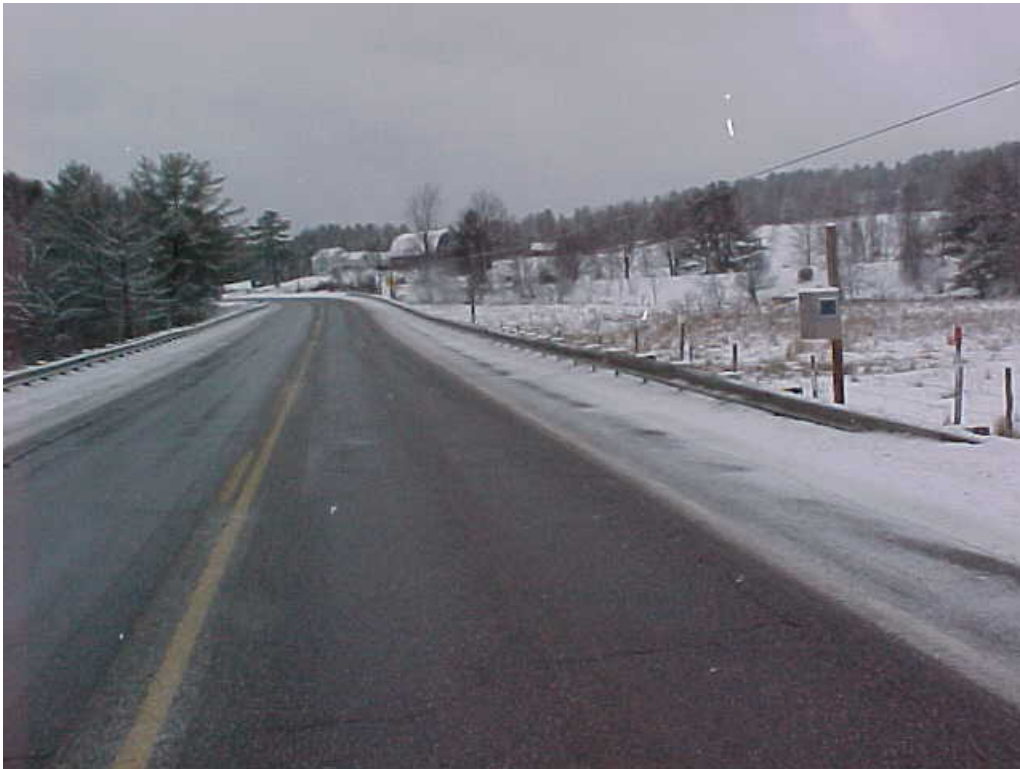
Figure 4: Traffic Counter Site on Route 103 in Sunapee

Traffic Data. NHDOT personnel installed and maintained traffic monitoring stations at both test sites. Traffic counts and vehicle speeds were recorded every 30 minutes. Collected data were transmitted to the District 2 office approximately once a week. Locations monitored include the eastbound and westbound lanes of the Bristol East test section, the westbound lane of the Bristol West section, and the westbound lane of both Sunapee sections. Figure 4 shows the traffic data collection station at the Sunapee test site.

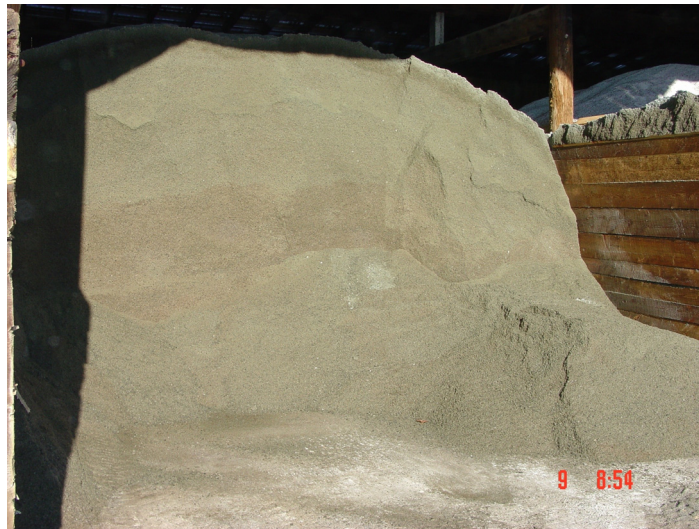
Figure 5: Leaching of Additive Observed in Bristol Stockpile

Contrary to claims appearing in the product literature, apparent leaching of the test material’s liquid additive was observed in both stockpiles. Figure 5 is a photograph of the Bristol stockpile. It was observed that the top four to six inch layer of the stockpile was white, the next 18 to 24 inch layer light brown, and the rest of the stockpile a darker brown. While partial remixing of the stockpile did occur as the plow trucks were loaded, it was felt that the color difference indicated a non-uniformity of material that could affect its performance.

- The type of material used (i.e. the test material or conventional sodium chloride) did not appear to affect average vehicle speed.
- At 0°F and below, neither the test material nor sodium chloride were effective; while liquid calcium chloride was effective under those conditions.
- The patrolmen believed the test material to perform “slightly better” in some conditions.
- Contrary to the producer’s claim, some leaching of liquid additive was experienced in the stockpiled product.
