NH119 over CONNECTICUT RIVER

Owner: NHDOT Inspection Team: B Bridge Maintenance Crew: 7

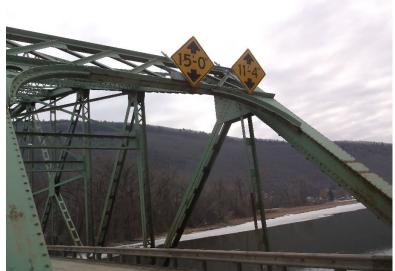
B609 42

SIGNS AT WEST

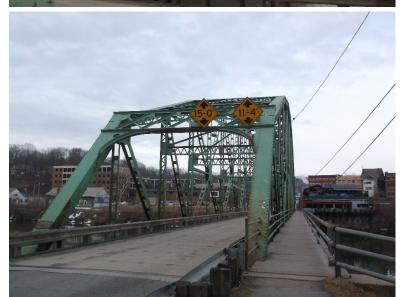
B609 43

SIGNS AT EAST

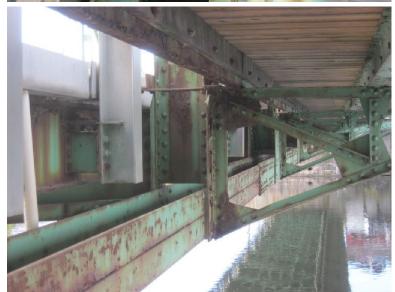
B571 05

SIDE VIEW OF SIDEWALK BRACKET

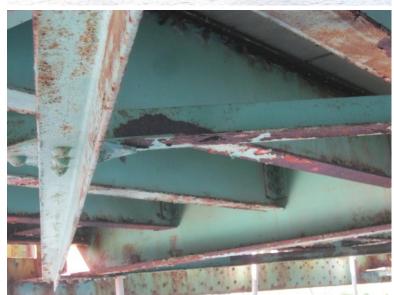
B561 29

HOLE IN BRACING

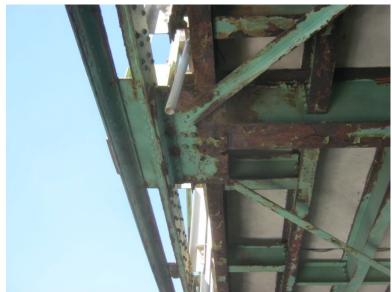
B561 31

HOLE IN CONNECTION PLATE

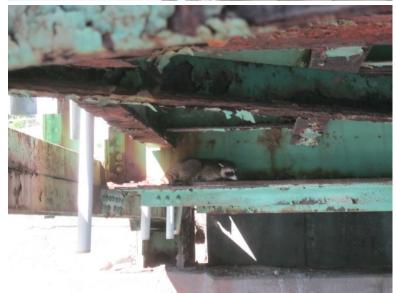
RACCOON ON FLOORBEAM FLANGE

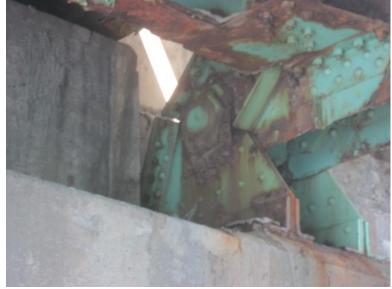
B561 33

BEARING AT NORTHWEST

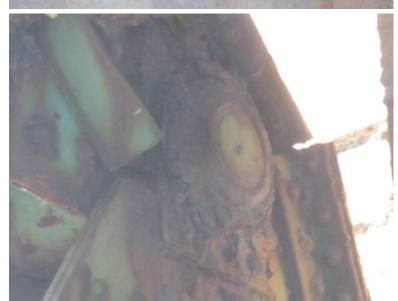
B561 34

BEARING AT SOUTHWEST

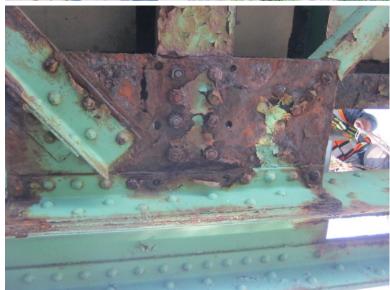
B506 02

CROSS BRACE CONNECTION PLATE HOLED, TYPICAL OF SEVERAL.

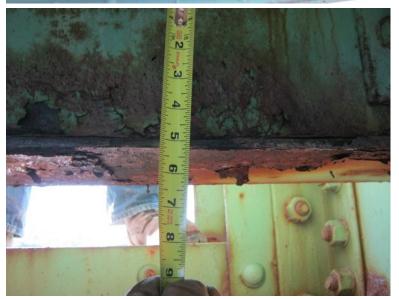
BOTTOM FLANGE OF EXTERIOR STRINGER, 1/4" REMAINING.

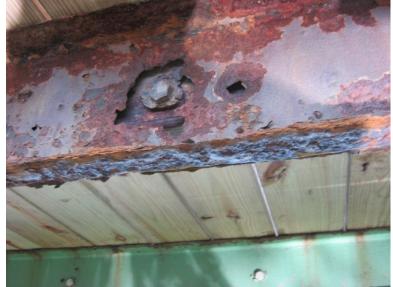
B506 04

WEB HOLED UNDER SIDEWALK STRINGER # 1, MIDSPAN.

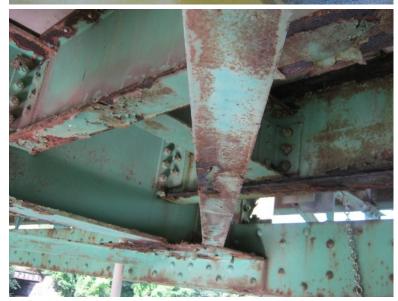
CROSS BRACING ANGLE HOLED, TYPICAL OF FEW.

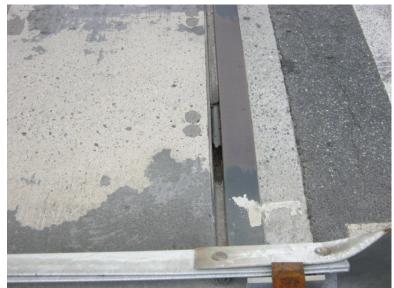
B506 11

JOINT SEAL HOLED AT WEST.

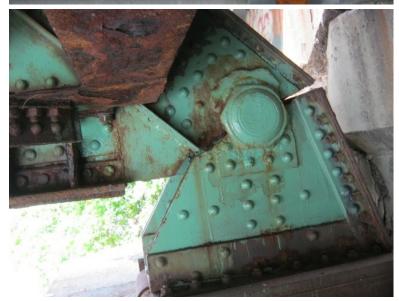
BEARING AT NORTHEAST

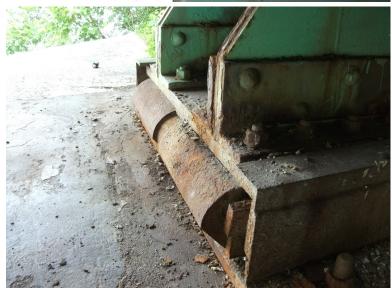
X009 14

ROLLERS MOVING OUT OF POSITION AT NORTHEAST BEARING

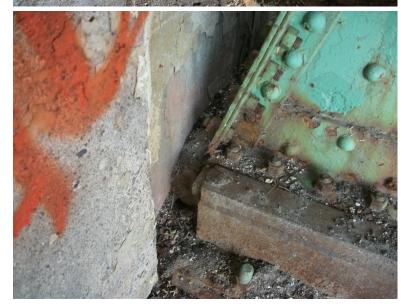
X009 15

ROLLERS MOVING OUT OF POSITION AT NORTHEAST BEARING

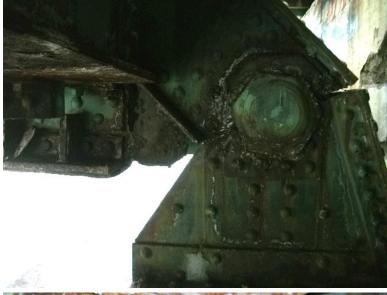
B456 01

INTERIOR VIEW OF NORTHEAST ROLLER BEARING.

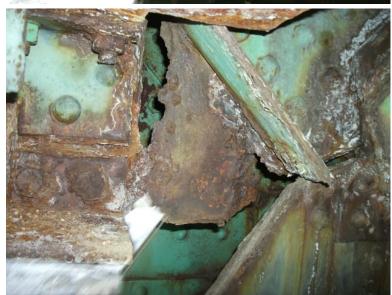
B456 02

PLATE HOLED AT NORTHEAST ROLLER BEARING.

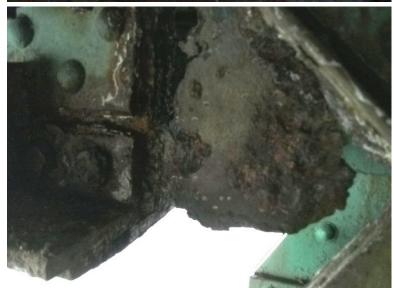
B456 05

PLATE HOLED AT NORTHEAST ROLLER BEARING.

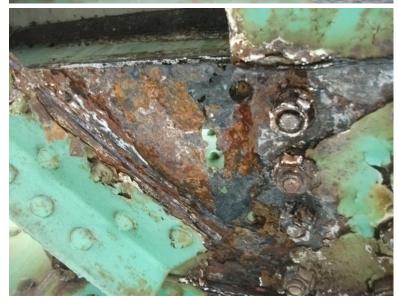
LOWER LATERAL BRACING CONNECTION PLATE HOLED AT EAST.

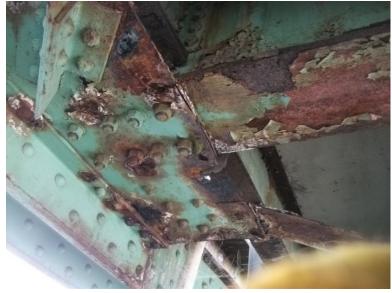
B456 10

LOWER LATERAL BRACING CONNECTION PLATE HOLED AT EAST.

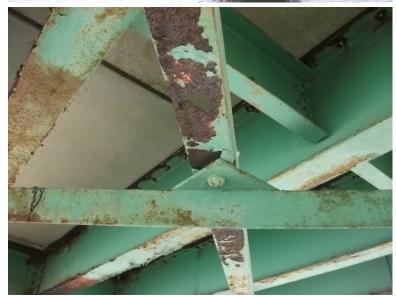
HOLES IN LOWER LATERAL BRACE AT MIDSPAN.

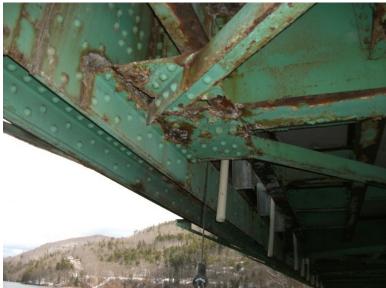
B456 14

LOWER LATERAL BRACING CONNECTION PLATE HOLED AT BAY 2 AT WEST.

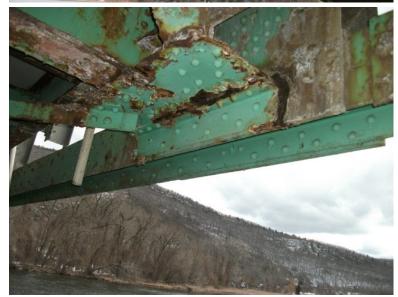
LOWER LATERAL BRACING CONNECTION PLATE HOLED AT BAY 2 AT WEST.

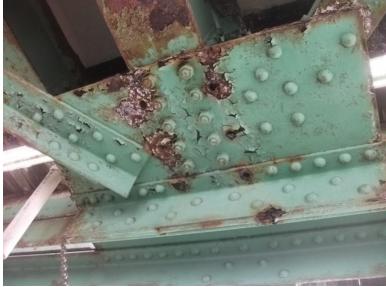
B456 16

LOWER LATERAL BRACING CONNECTION PLATE AT BAY 2 AT WEST.

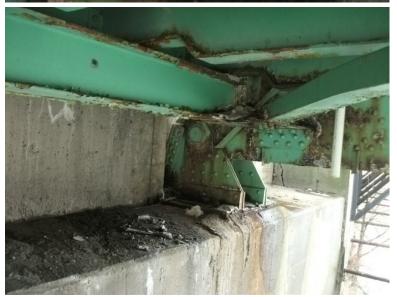
NORTHWEST ROLLER BEARING.

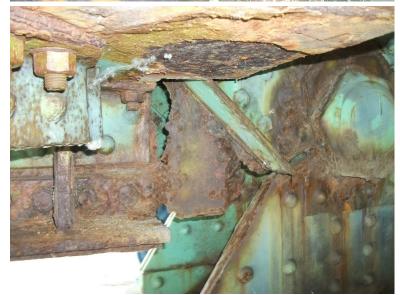
PLATE HOLED AT NORTHEAST ROLLER BEARING.

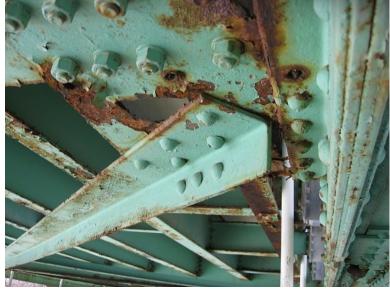
B332 35

LATERAL BRACING CONNECTION PLATE HOLED, WEST SIDE OF FLOORBEAM TWO

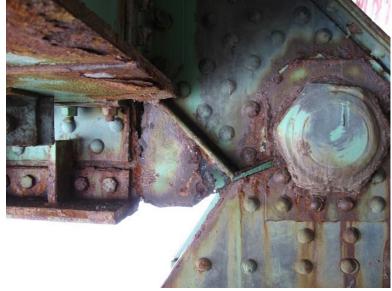
B332 31

CONNECTION PLATE AT NORTHEAST BEARING HOLED

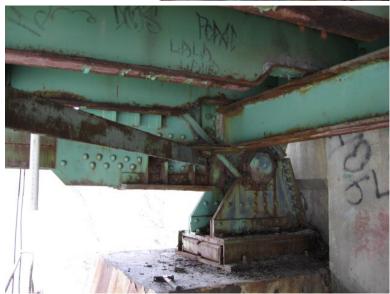
B332 32

CONNECTION PLATE AT NORTHEAST BEARING HOLED

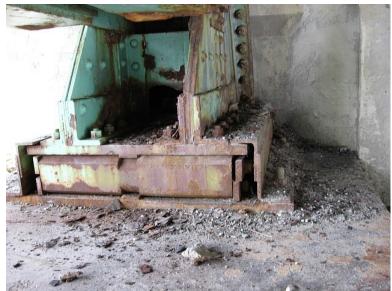
B332 33

NORTHEAST ROLLER BEARING, SIDE PLATE TIPPED

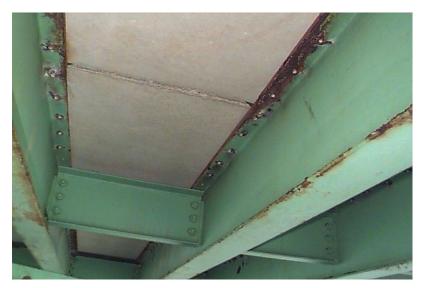
B228 04

UNDERSIDE VIEW OF NEW SLABS AND TOP FLANGE OF STRINGER WITH HOLES AND FLAME CUTS

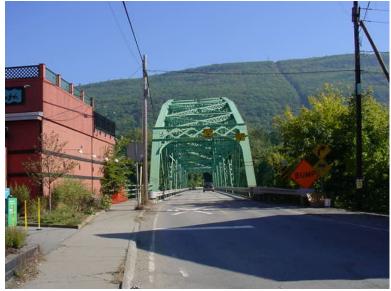
B189 11

WEST APPROACH

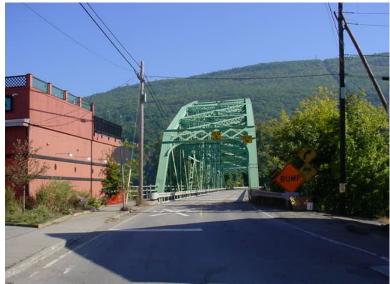
B189 12

WEST APPROACH

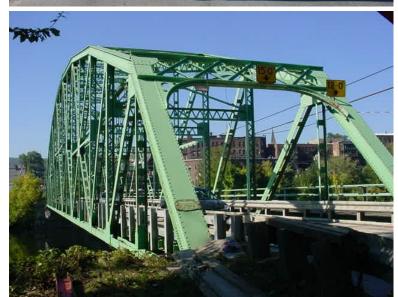
B189 13

SOUTHEAST ELEVATION

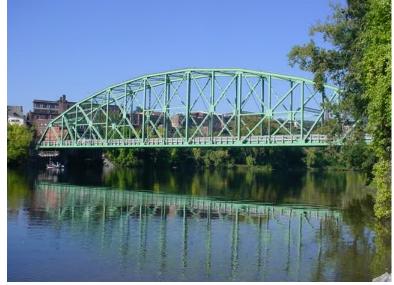
B189 14

SOUTH ELEVATION

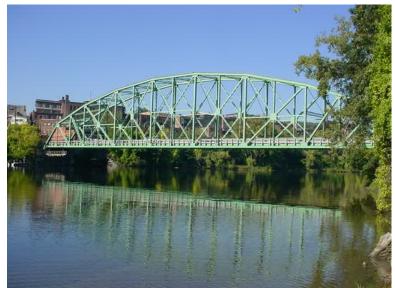
B189 15

SOUTH ELEVATION

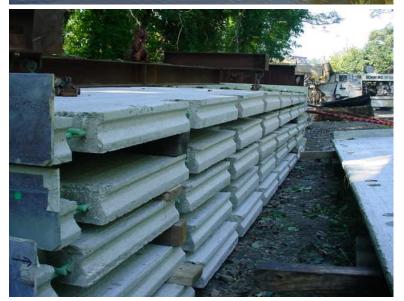
B189 16

PRE-CAST DECK PANELS READY FOR INSTALLATION.

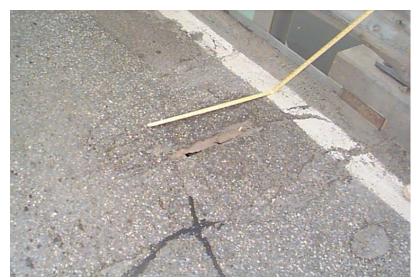
B146 21

BRIDGE PLANK TORN AND HOLED AT WEST END.

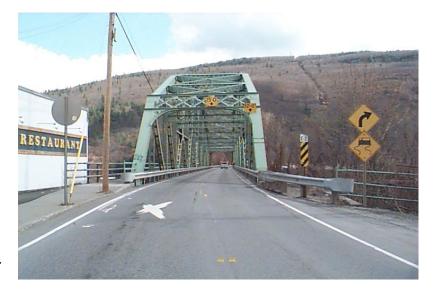
B032 07

WEST APPROACH.

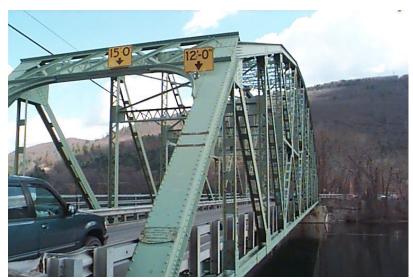
B032 08

SOUTH ELEVATION.

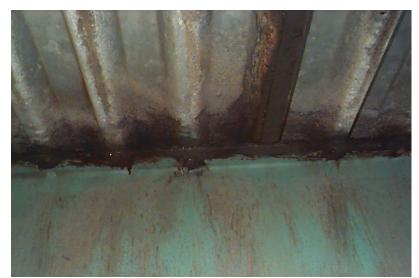
B032 23

TOP FLANGE OF STRINGER #4, WITH SECTION LOSS, IN BAY # 6.

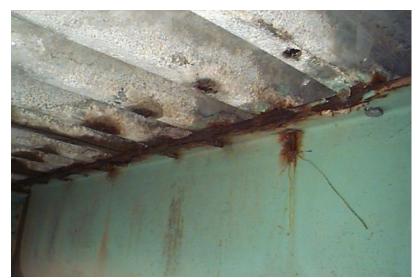
B032 29

STRINGER #7 CUT, NEAR FLOORBEAM #11.

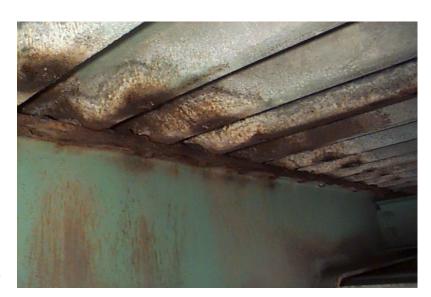
STRINGER #4 AT EAST END BAY.

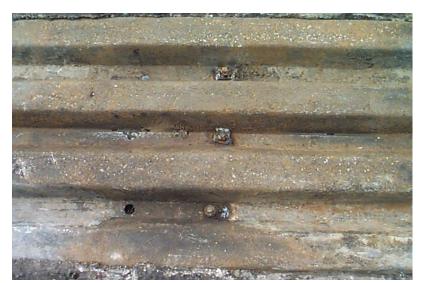
B018 05

DETERIORATED AREA OVER FB#6 @N. W/ FLEX CRACKS & HOLES THROUGH BRIDGE PLANK.

HOLES THROUGH BRIDGE PLANK @ N . OVER FB#6.

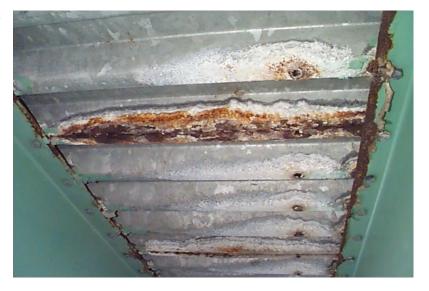
B018 16

BAY#8, CENTER SPAN

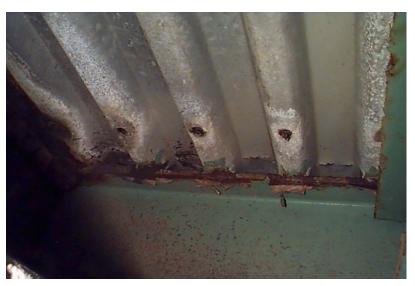
B018 17

BAY#1, @ SOUTH W/ DENTS IN BRIDGE PLANK.

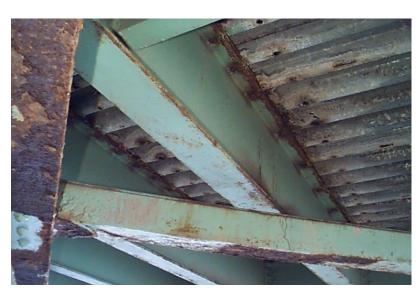
Tuesday, November 03, 1998 BAY#1, BRIDGE PLANK.

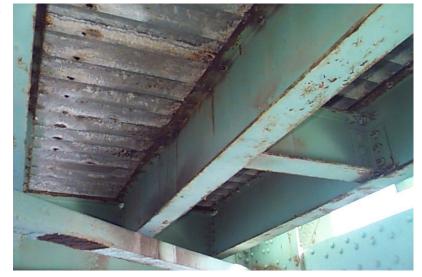
B018 19

BAY#2.

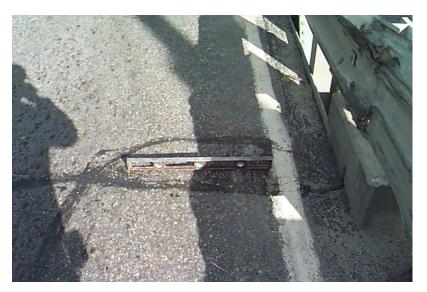
B018 20

SOUTH WEST END OF DECK @ VT. HAS ONE INCH OF SETTLEMENT.

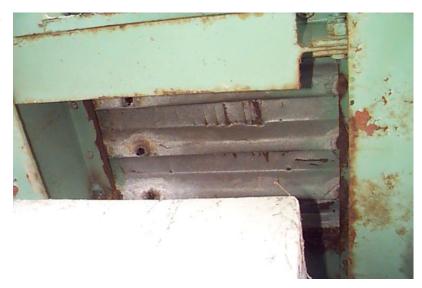
NH END HAS SCARIFIED BRIDGE PLANK.

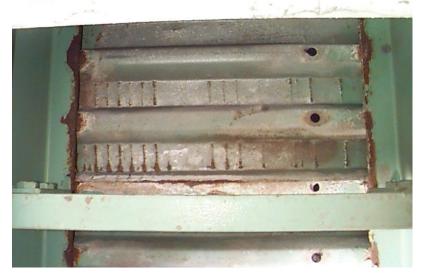
B018 22

NH END HAS SCARIFIED BRIDGE PLANK.

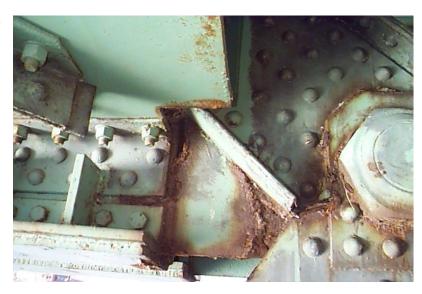
NH END HAS A HOLE @ NORTH BEARING.

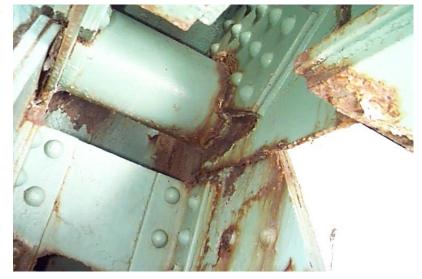
B018 25

NH END HAS A HOLE @ NORTH BEARING.
