HINSDALE 041/040
NH119 over CONNECTICUT RIVER

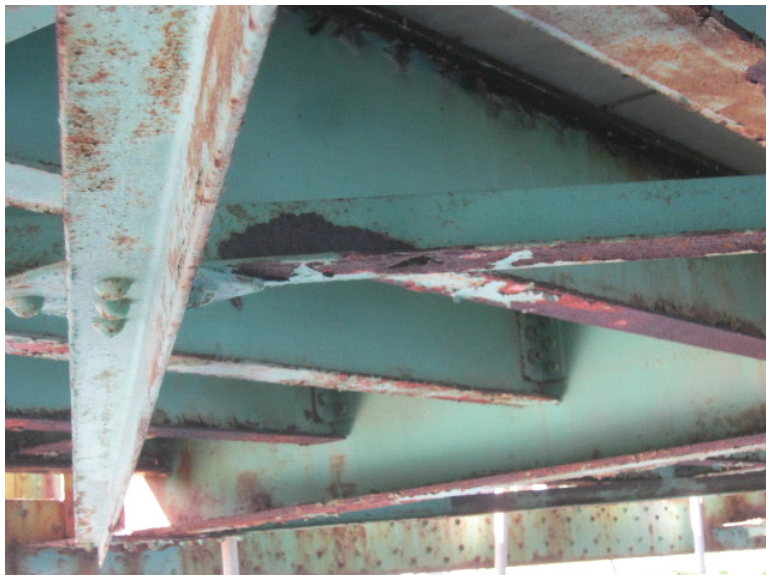
B561 29

HOLE IN BRACING

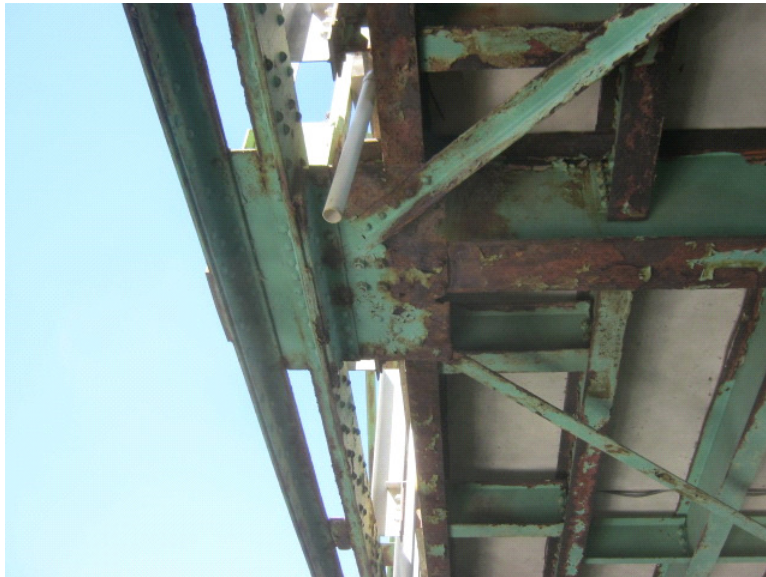
B561 31

HOLE IN CONNECTION
PLATE

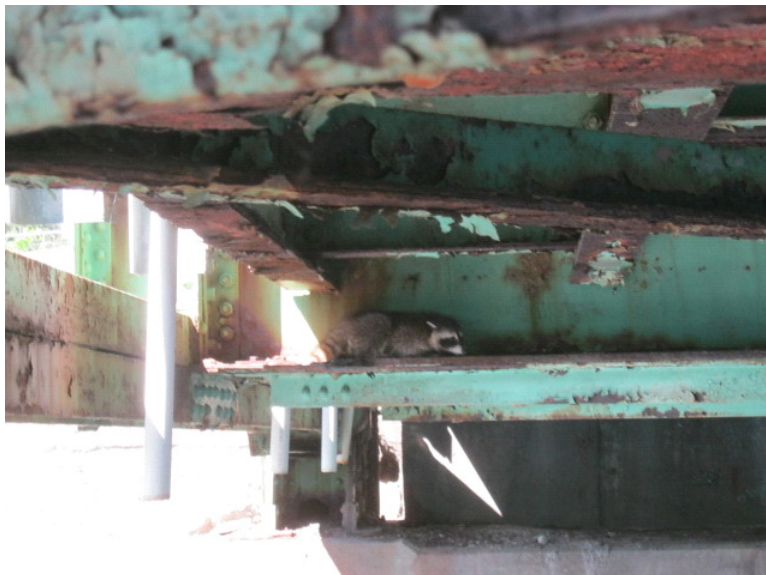
B561 32

RACCOON ON FLOORBEAM
FLANGE

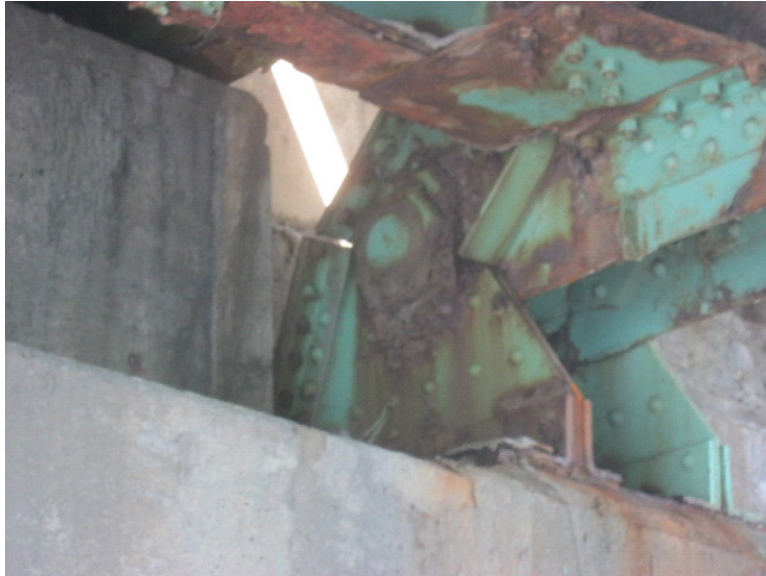
B561 33

BEARING AT NORTHWEST

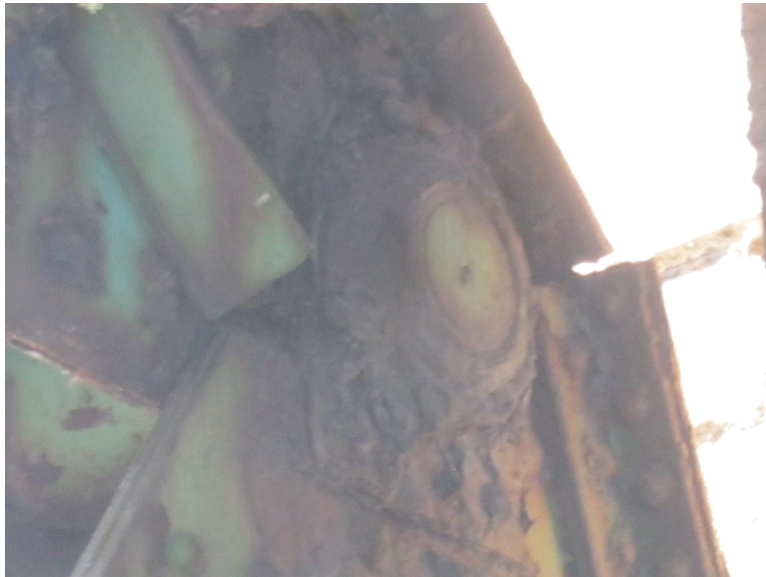
B561 34

BEARING AT SOUTHWEST

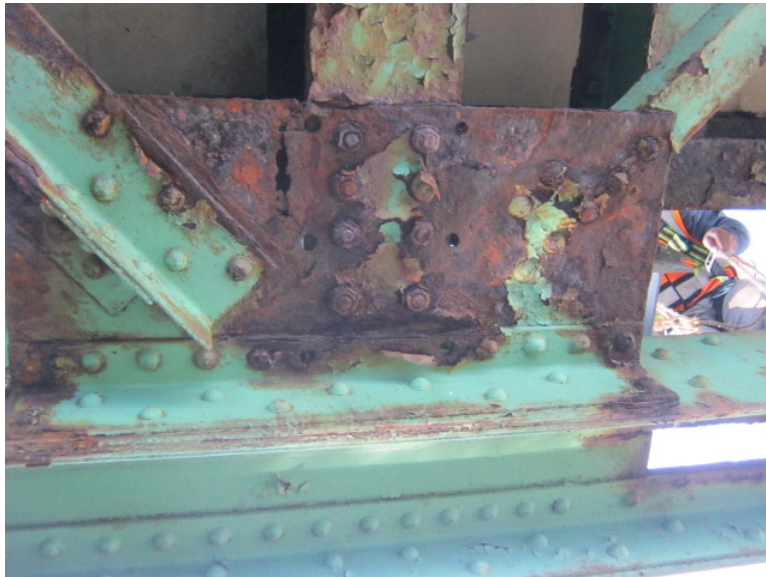
B506 02

CROSS BRACE
CONNECTION PLATE
HOLED, TYPICAL OF
SEVERAL.

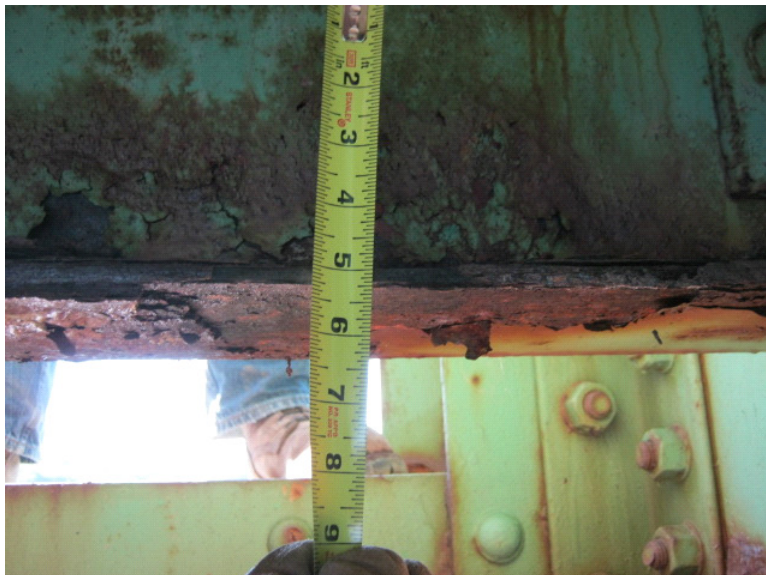
B506 03

BOTTOM FLANGE OF
EXTERIOR STRINGER, 1/4"
REMAINING.

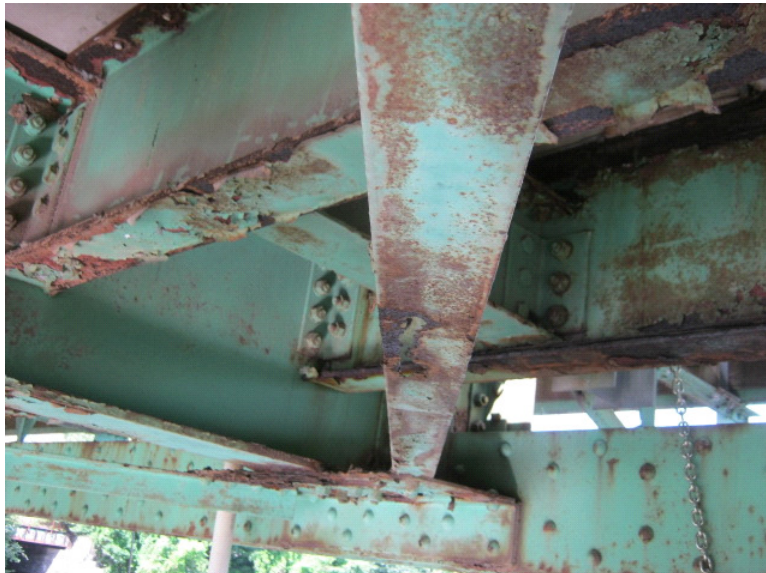
B506 06

CROSS BRACING ANGLE
HOLED, TYPICAL OF FEW.

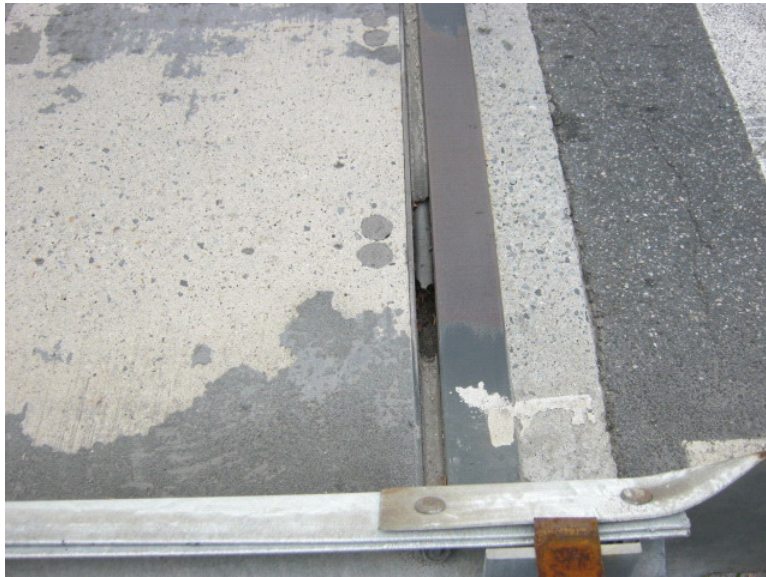
B506 11

JOINT SEAL HOLED AT
WEST.

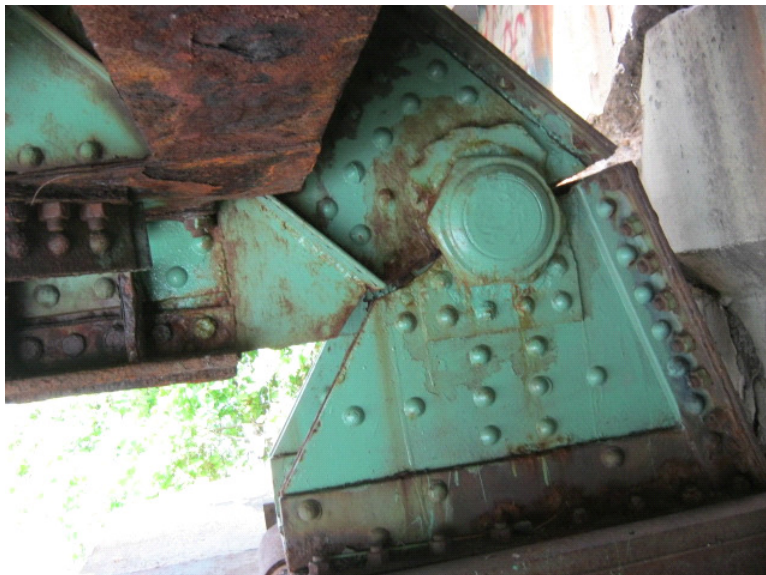
B506 12

BEARING AT NORTHEAST

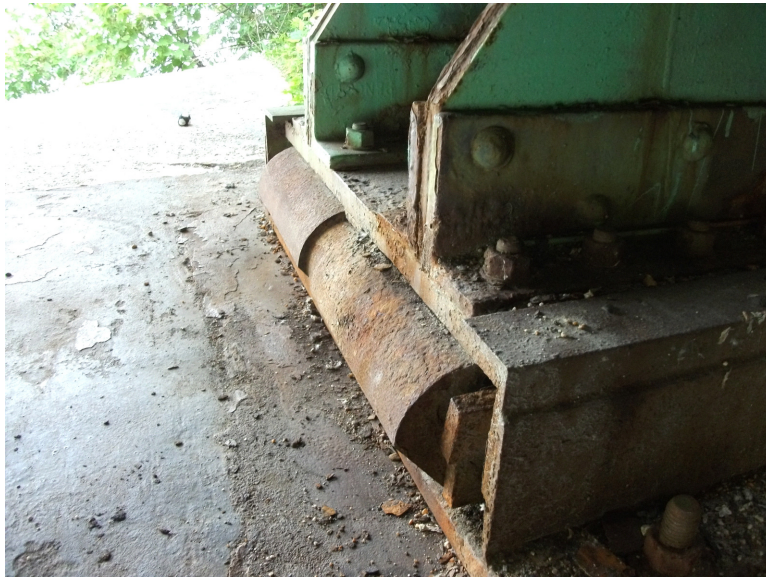
X009 14

ROLLERS MOVING OUT OF
POSITION AT NORTHEAST
BEARING

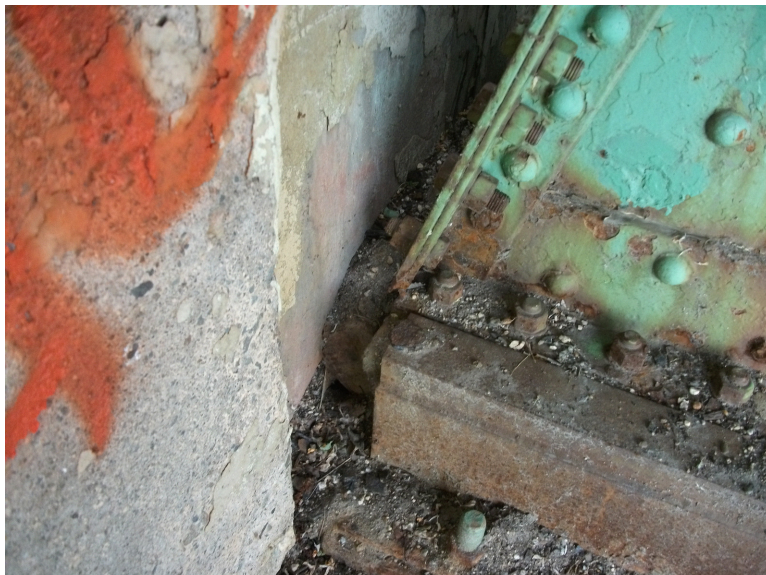
X009 15

ROLLERS MOVING OUT OF
POSITION AT NORTHEAST
BEARING

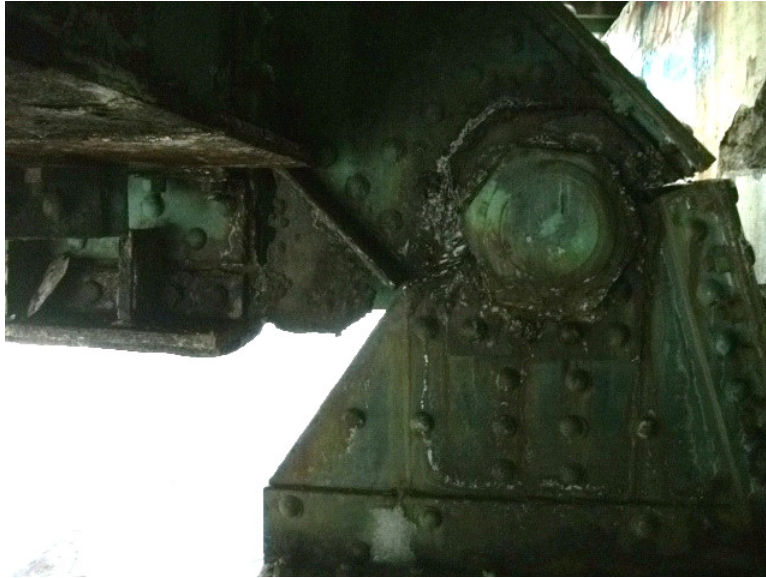
B456 01

INTERIOR VIEW OF
NORTHEAST ROLLER
BEARING.

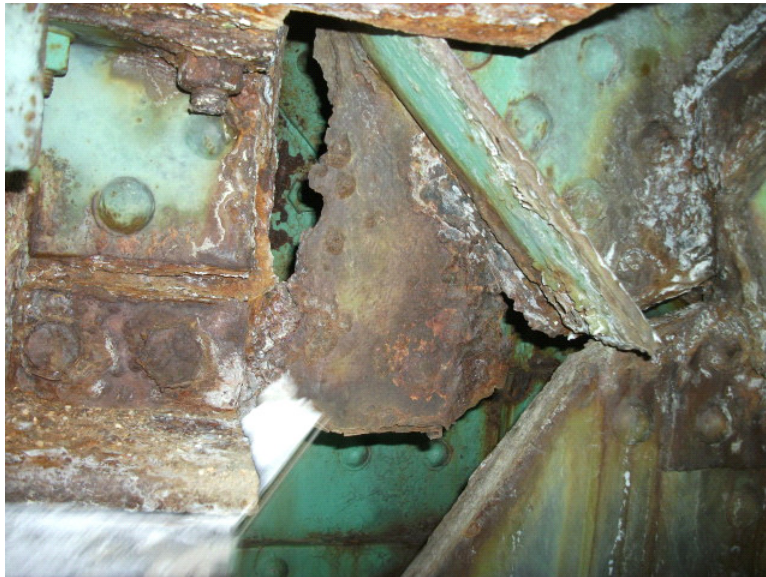
B456 02

PLATE HOLED AT
NORTHEAST ROLLER
BEARING.

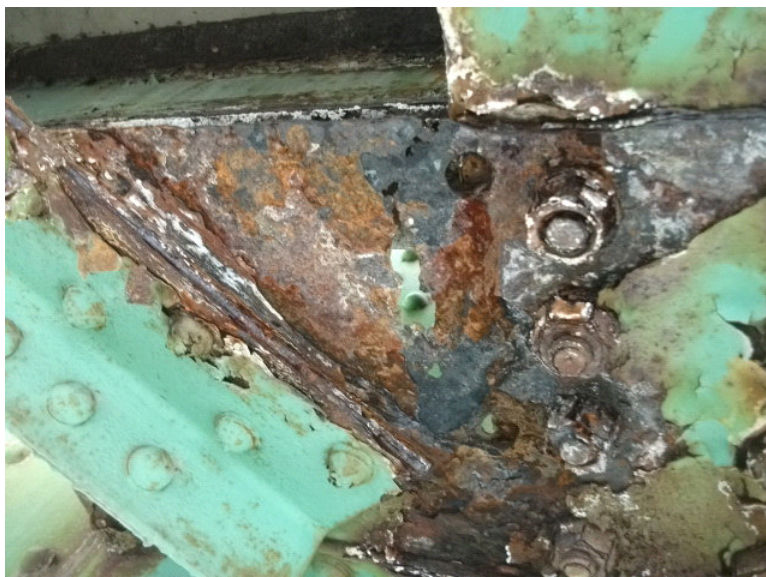
B456 09

LOWER LATERAL BRACING
CONNECTION PLATE
HOLED AT EAST.

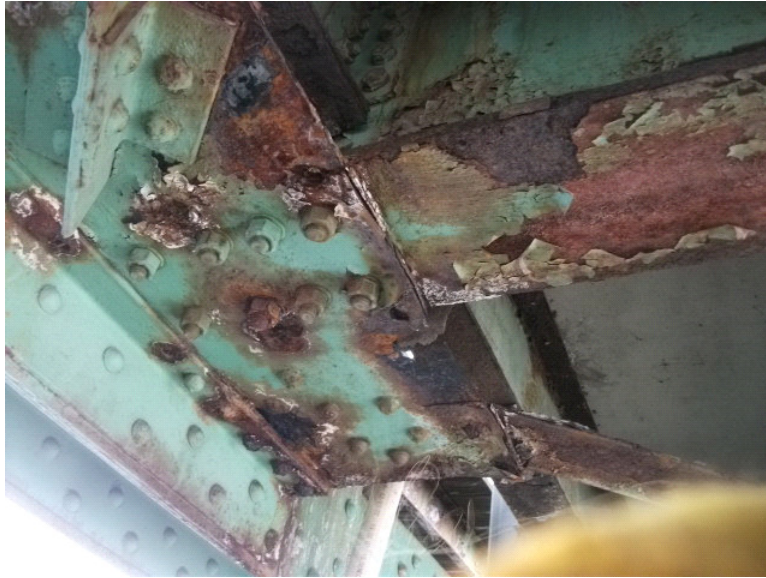
B456 10

LOWER LATERAL BRACING
CONNECTION PLATE
HOLED AT EAST.

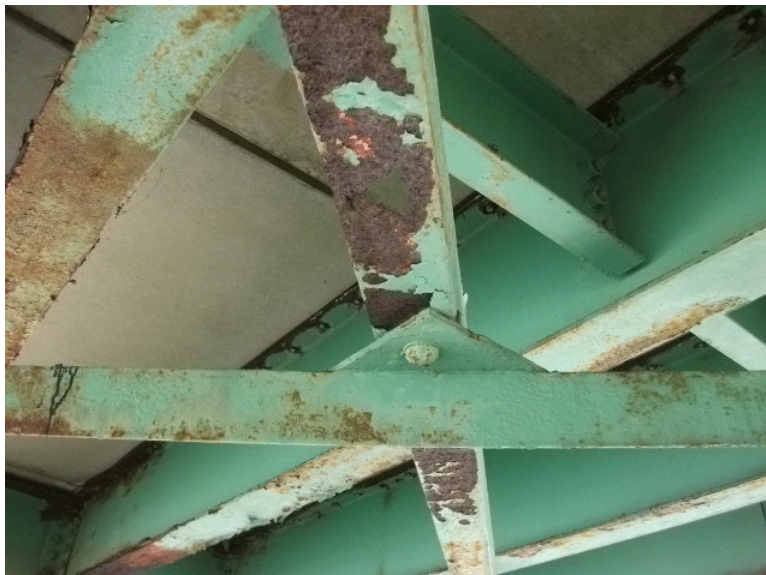
B456 12

HOLES IN LOWER LATERAL
BRACE AT MIDSPAN.

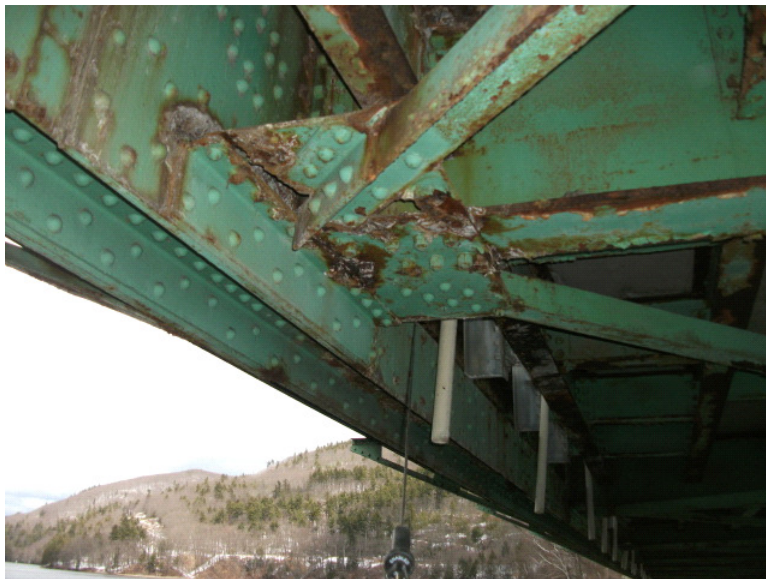
B456 14

LOWER LATERAL BRACING
CONNECTION PLATE
HOLED AT BAY 2 AT WEST.

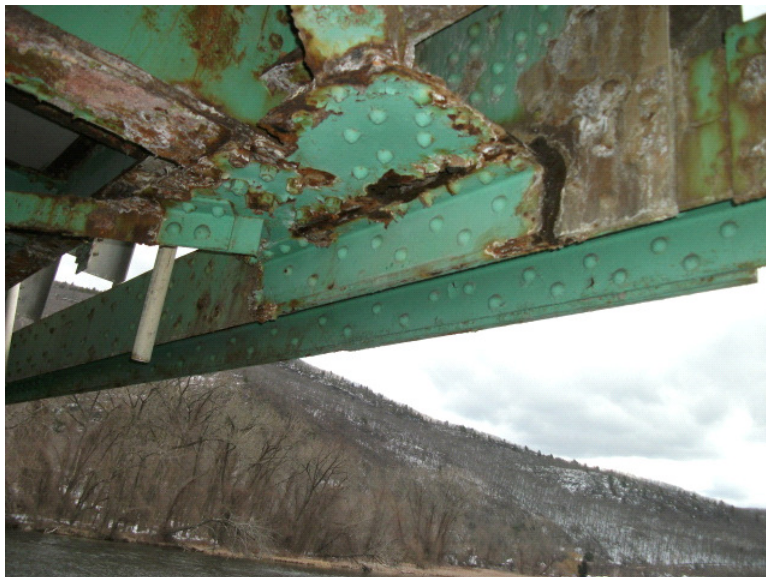
B456 15

LOWER LATERAL BRACING
CONNECTION PLATE
HOLED AT BAY 2 AT WEST.

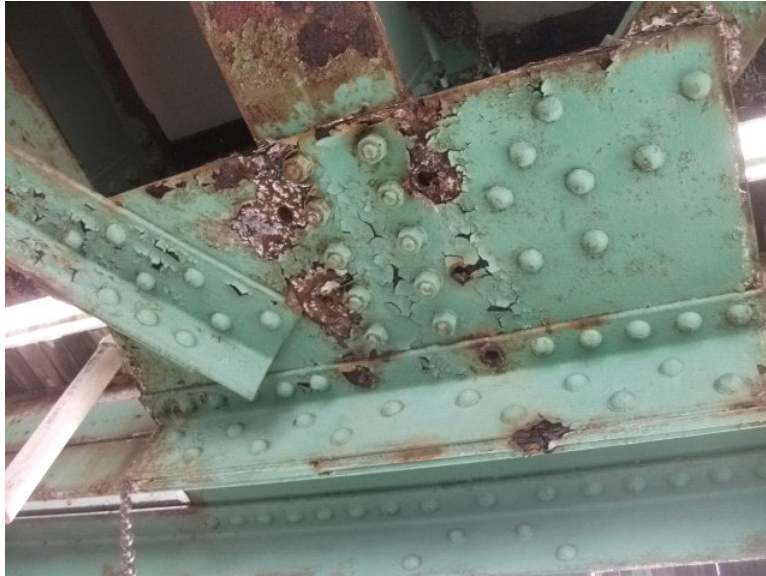
B456 16

LOWER LATERAL BRACING
CONNECTION PLATE AT
BAY 2 AT WEST.

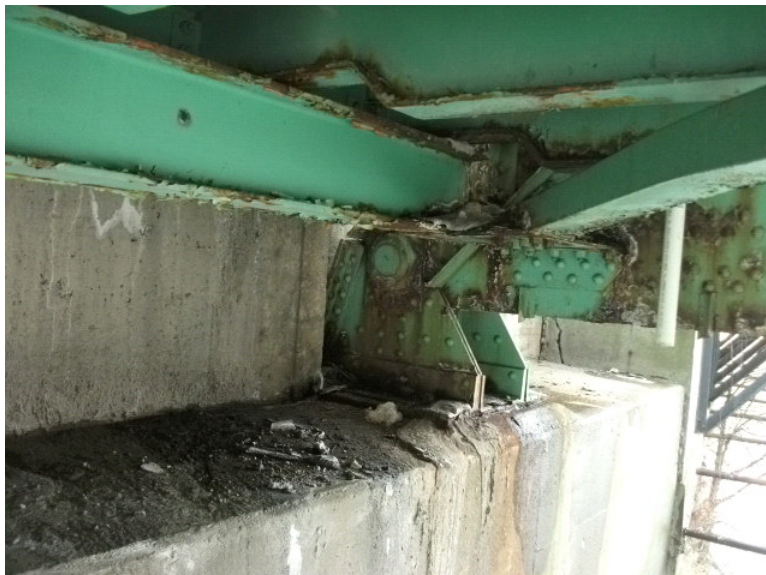
B456 18

NORTHWEST ROLLER
BEARING.

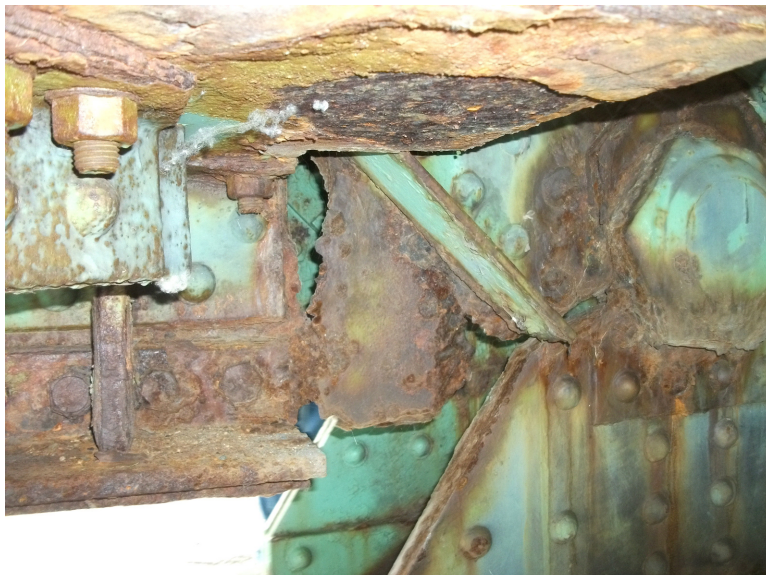
B434 39

PLATE HOLED AT
NORTHEAST ROLLER
BEARING.

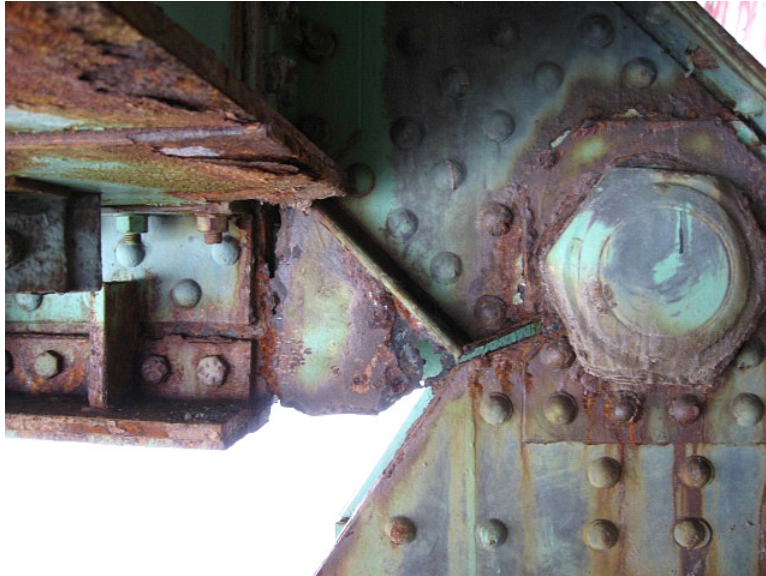
B332 31

CONNECTION PLATE AT
NORTHEAST BEARING
HOLED

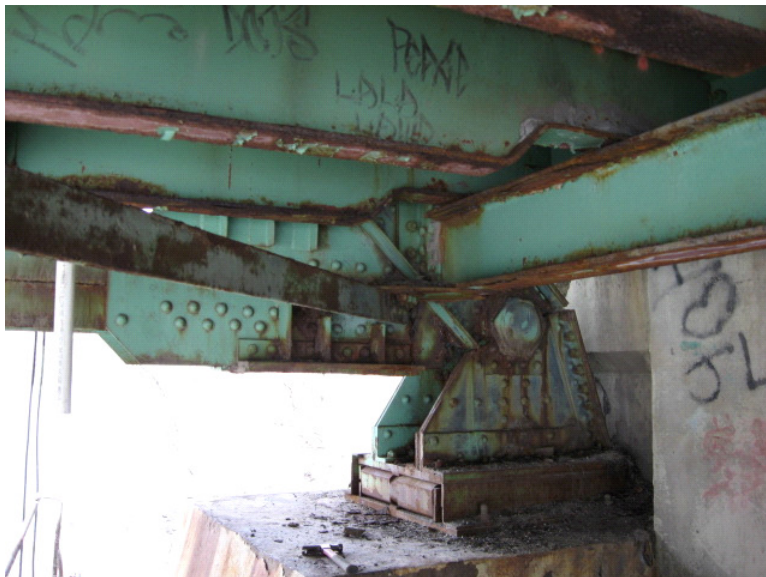
B332 32

CONNECTION PLATE AT
NORTHEAST BEARING
HOLED

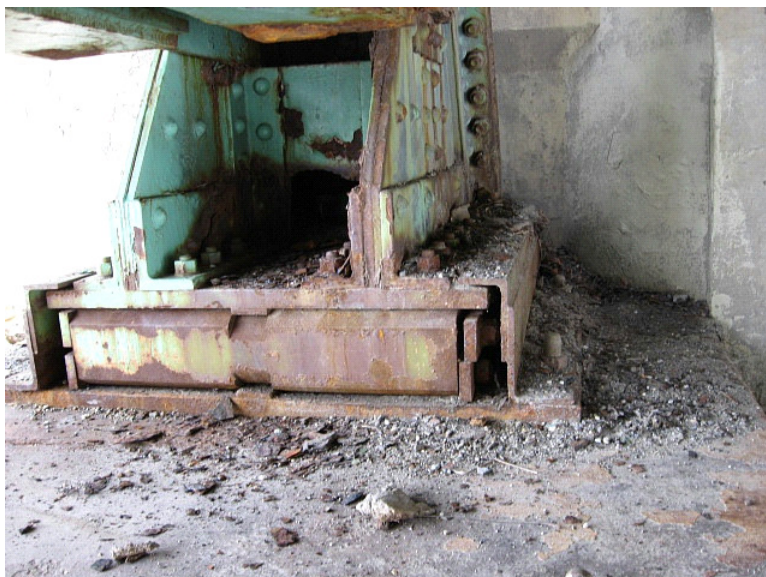
B332 33

NORTHEAST ROLLER
BEARING, SIDE PLATE
TIPPED

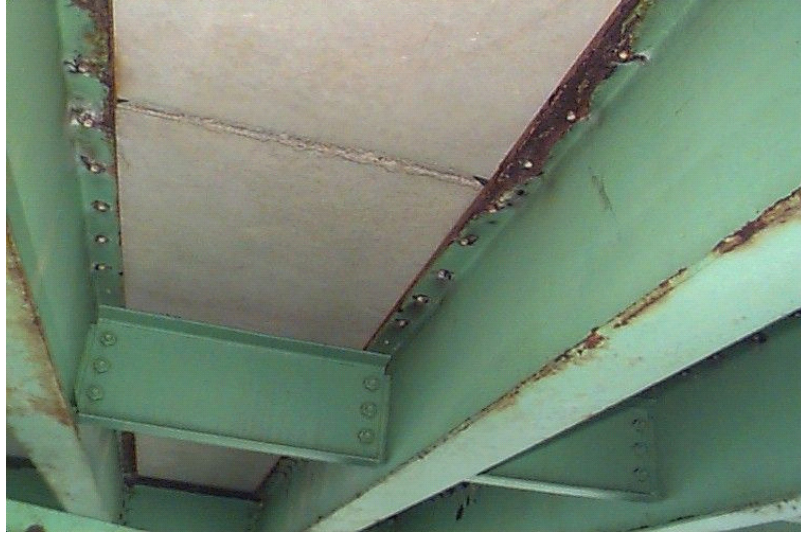
B228 04

UNDERSIDE VIEW OF NEW
SLABS AND TOP FLANGE
OF STRINGER WITH HOLES
AND FLAME CUTS

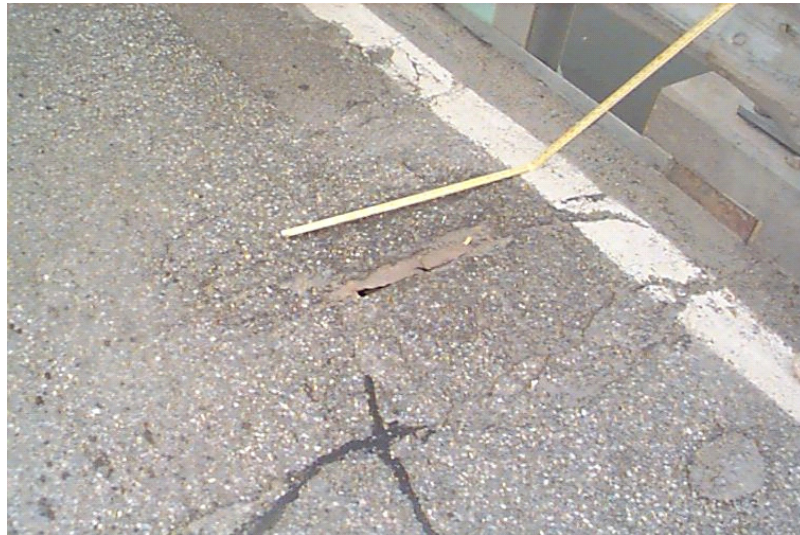
B146 21

BRIDGE PLANK TORN AND
HOLED AT WEST END.

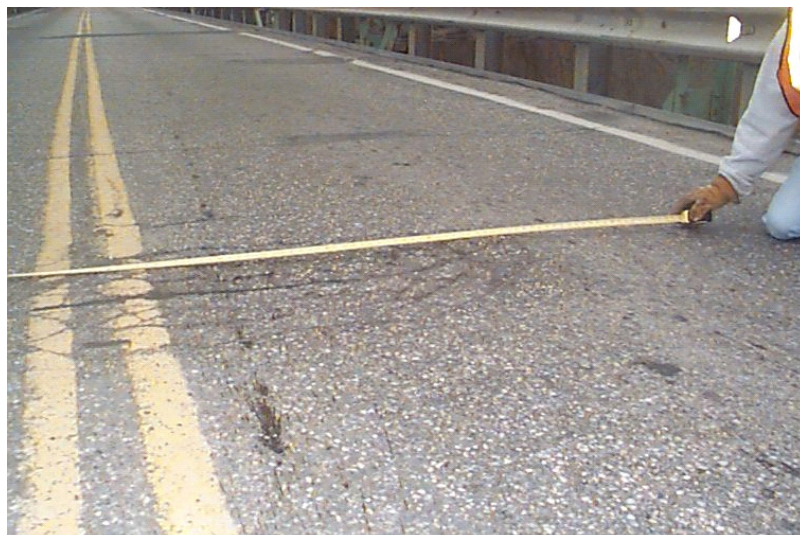
B146 22

ASPHALT SETTLED AND
HUMPED UP 3 INCHES, 20
FEET FROM WEST END.

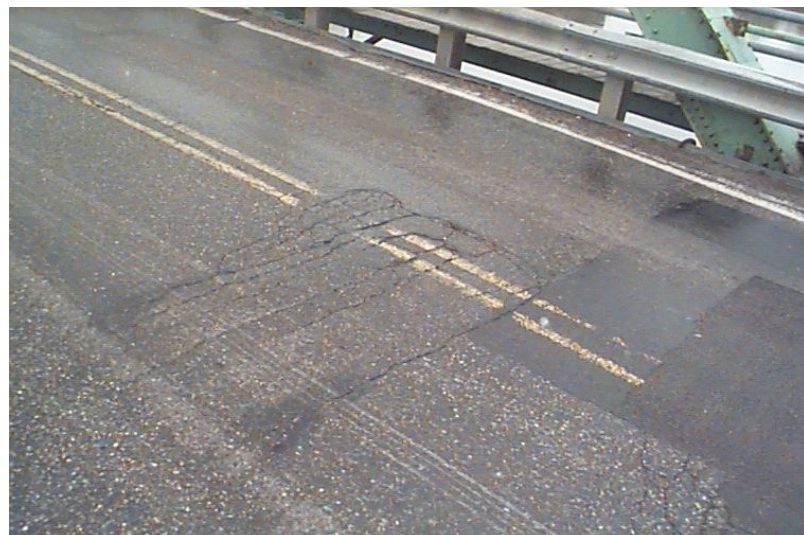
B146 25

AREA TOPSIDE OF
PREVIOUS PICTURE B146-
24.

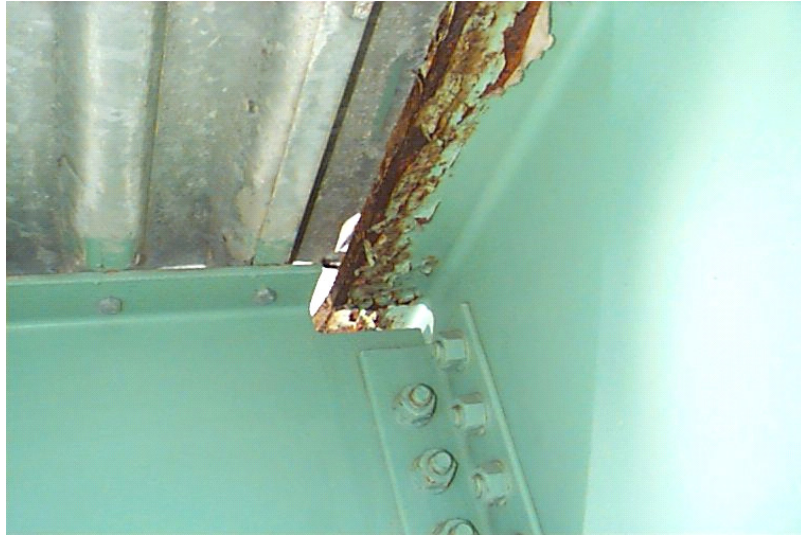
B032 19

BRIDGE PLANK HOLED
THROUGH OVER
FLOORBEAM #2, BAY 2.

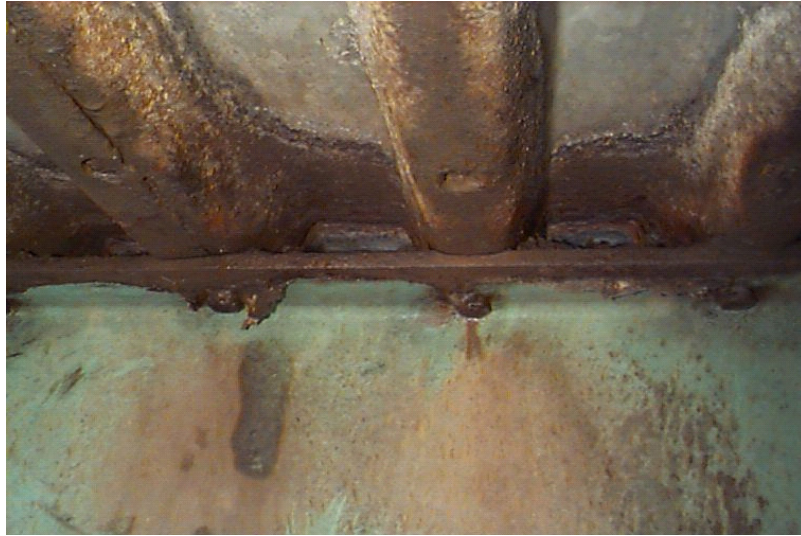
B032 22

TOP FLANGE OF STRINGER
#5, WITH SECTION LOSS, IN
BAY # 6.

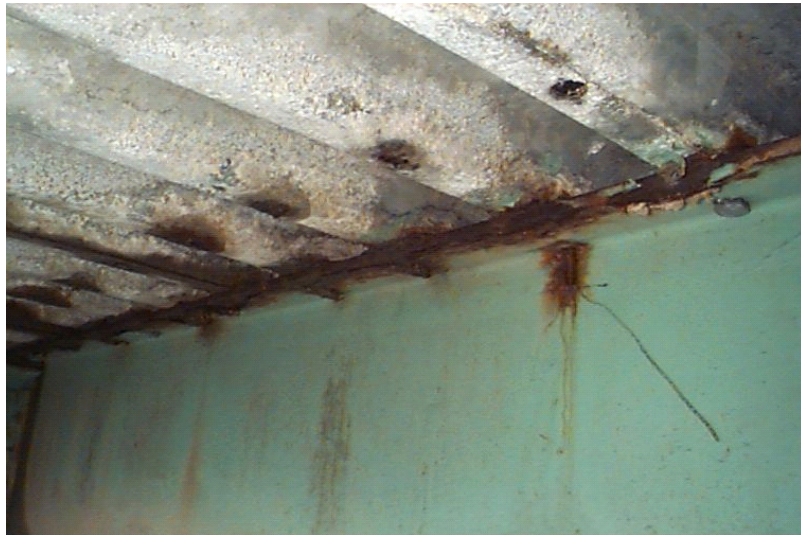
B032 29

STRINGER #7 CUT, NEAR
FLOORBEAM #11.

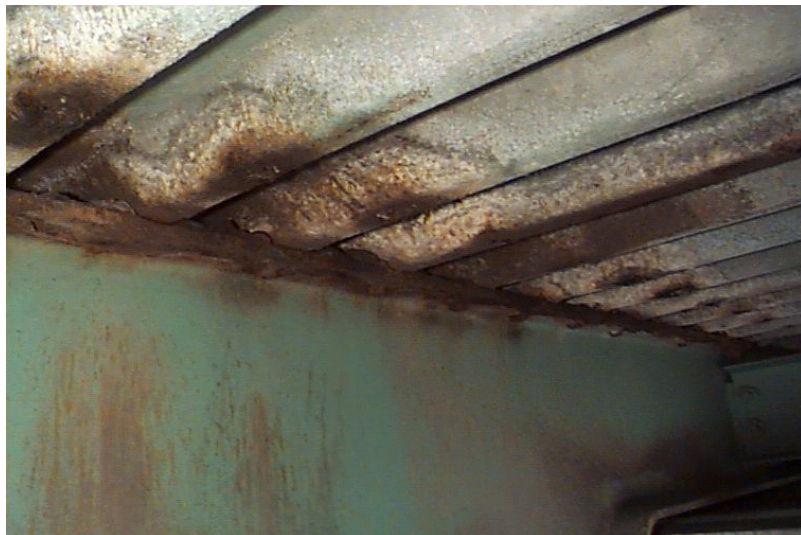
B032 30

STRINGER #4 AT EAST END
BAY.

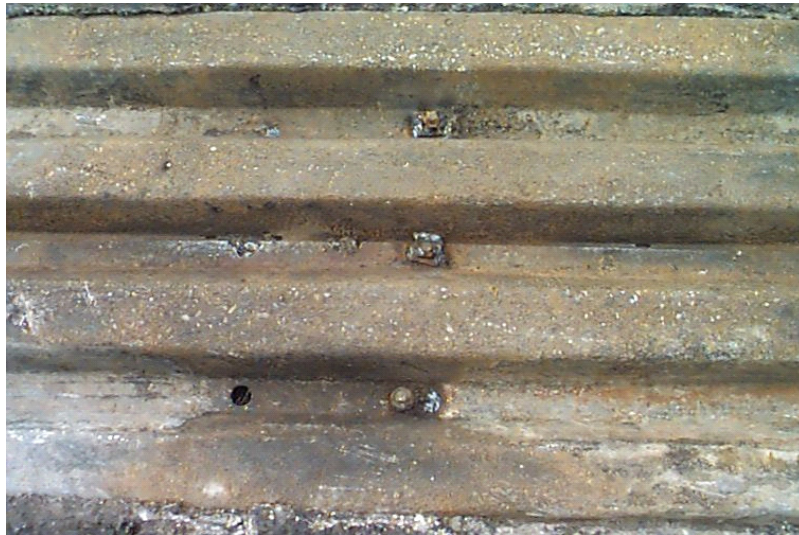
B018 05

HOLES THROUGH BRIDGE
PLANK @ N . OVER FB#6.

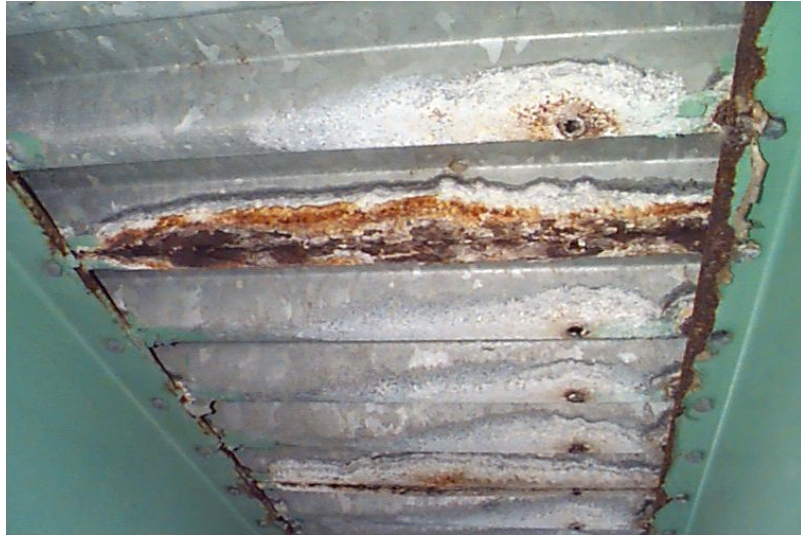
B018 16

BAY#8, CENTER SPAN

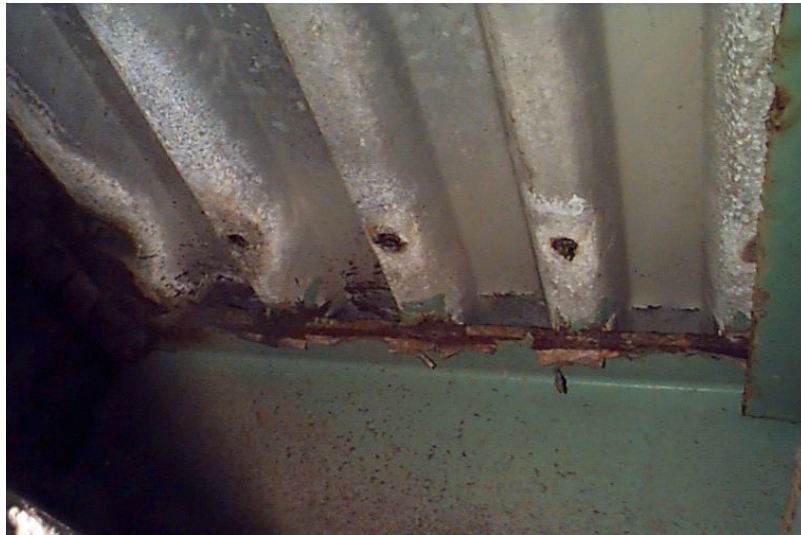
B018 17

BAY#1, @ SOUTH W/ DENTS
IN BRIDGE PLANK.

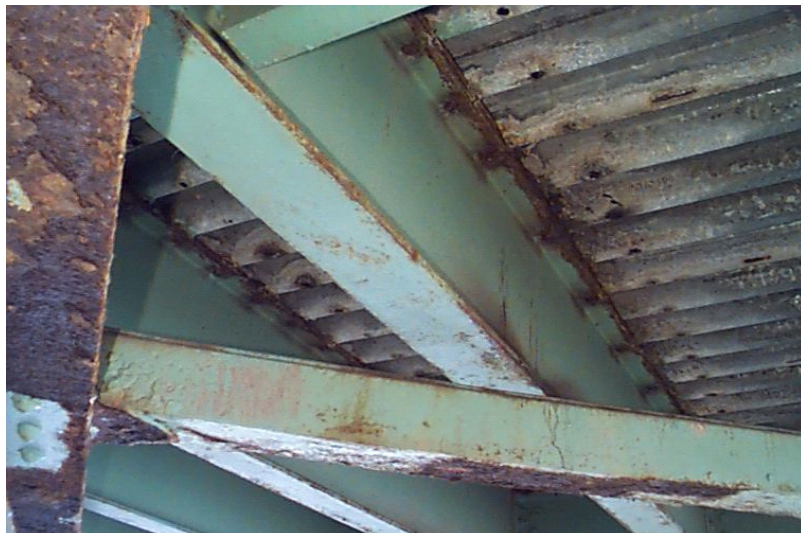
B018 18

BAY#1, BRIDGE PLANK.

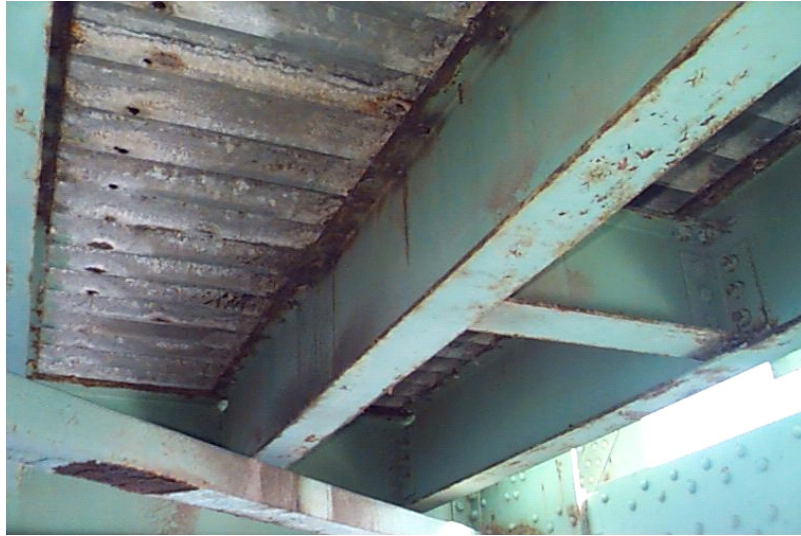
B018 19

BAY#2.

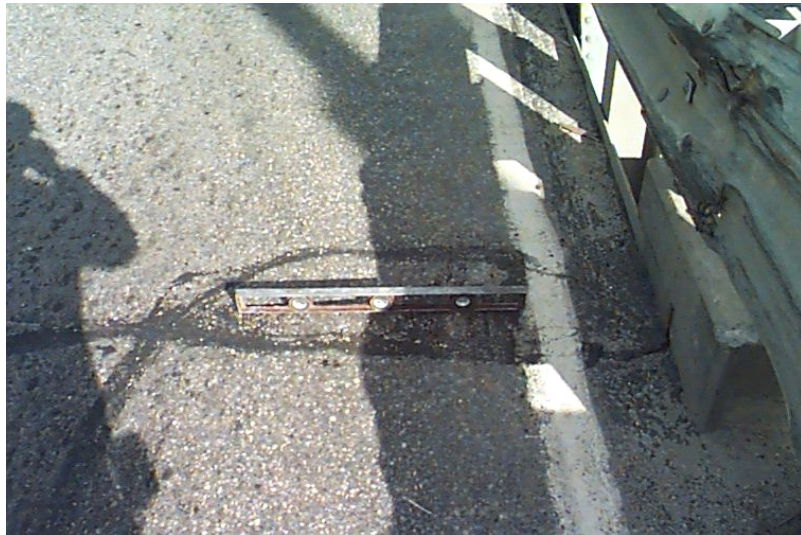
B018 20

SOUTH WEST END OF DECK
@ VT. HAS ONE INCH OF
SETTLEMENT.

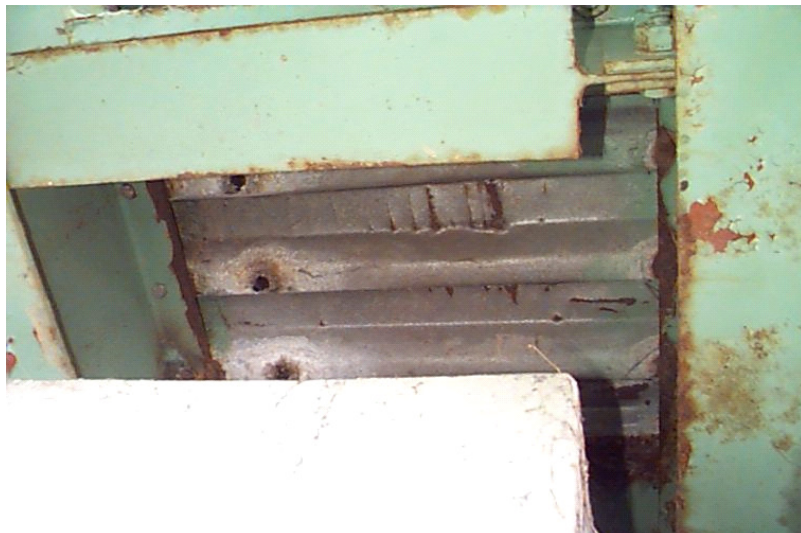
B018 21

NH END HAS SCARIFIED
BRIDGE PLANK.

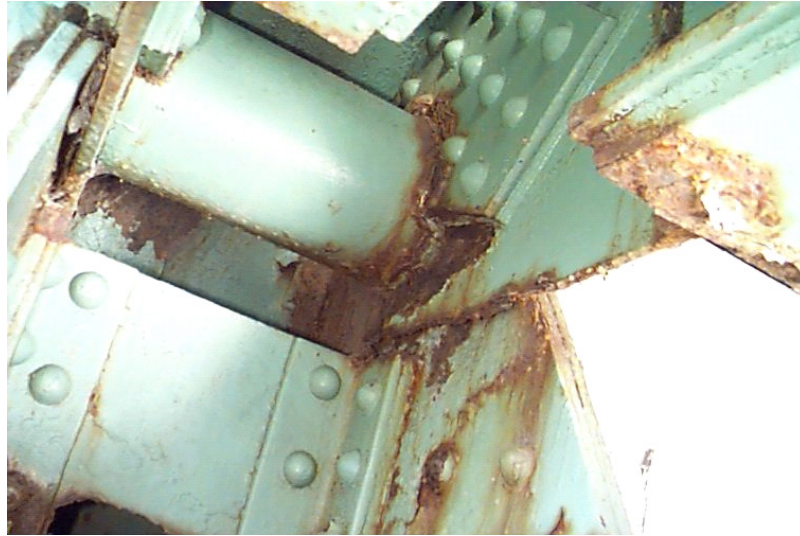
B018 25

NH END HAS A HOLE @
NORTH BEARING.
