Barron Mountain
Rock Reinforcement Evaluation – Phase I
I-93, Woodstock, New Hampshire

| 4. Title and Subtitle PHASE I: CONDITION ASSESSMENT AND EVALUATION OF ROCK REINFORCEMENT ALONG I-93, BARRON MOUNTAIN ROCK CUT, WOODSTOCK, NEW HAMPSHIRE | | 5. Report Date February 18, 2004 | |
| 7. Author(s) Kenneth L. Fishman, Ph.D., P.E. | | 8. Performing Organization Report No. | |

Project No. 03-024

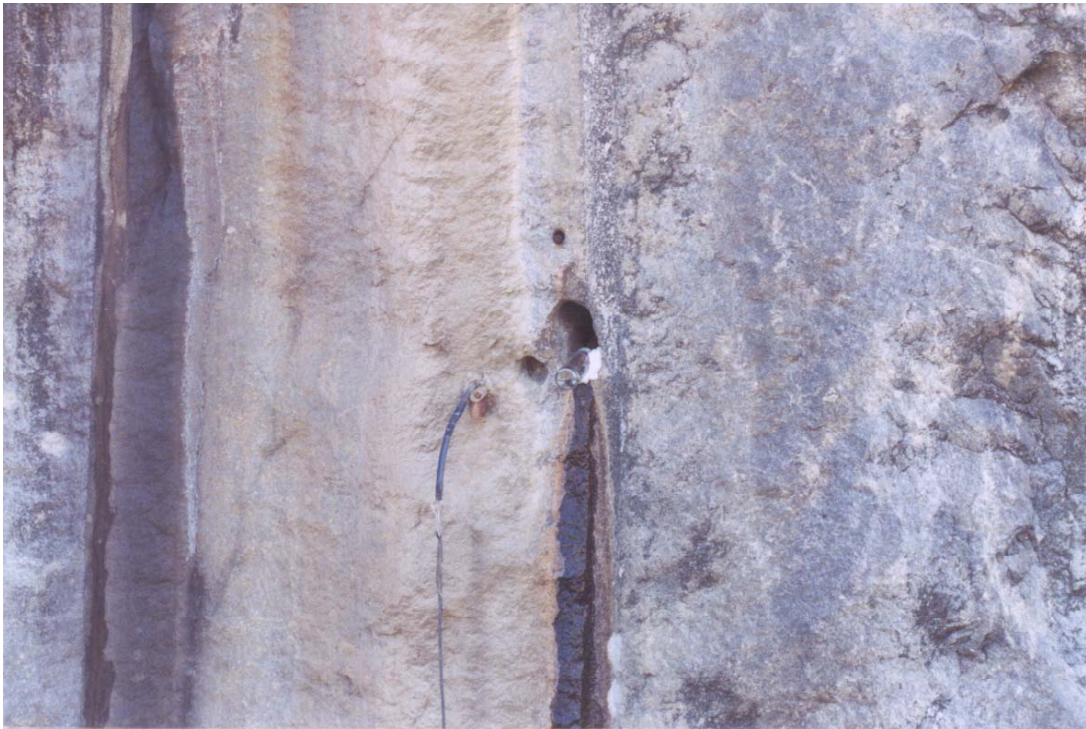
the end of the rock bolt as shown in Figure 7.

Figure 7. Source of Groundwater Sample #1

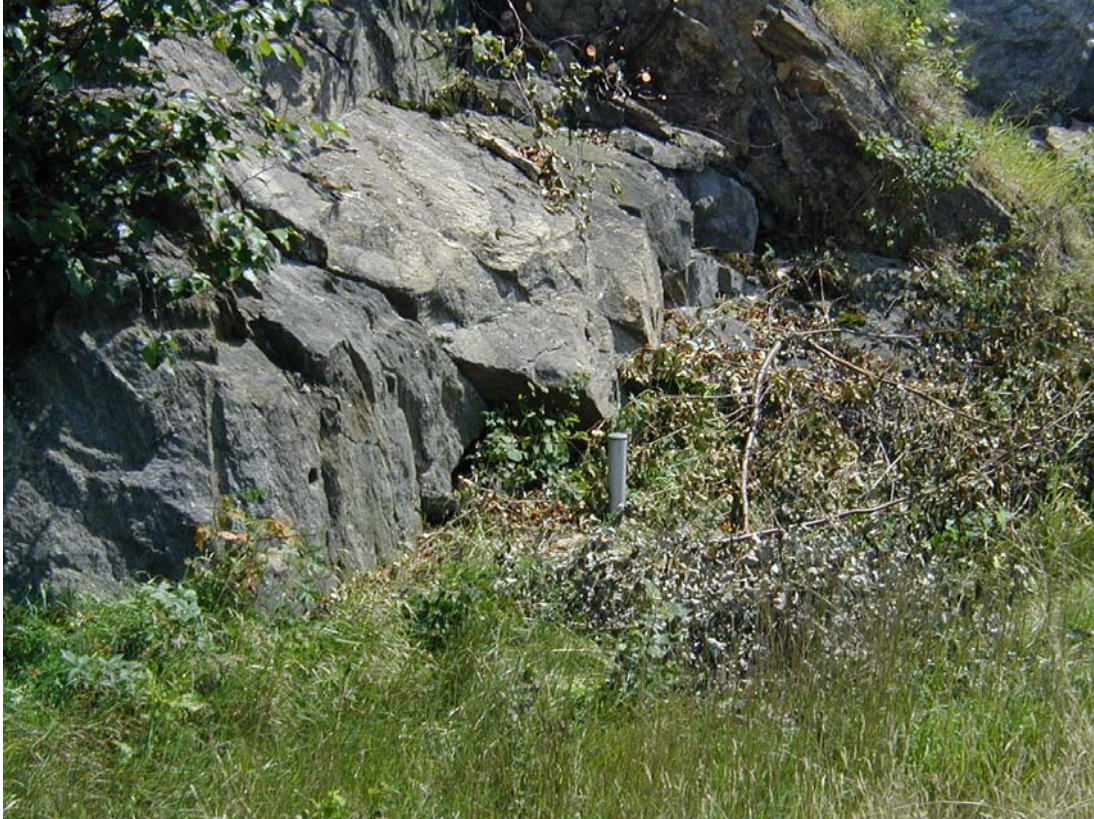
Figure 8. Well Used for Groundwater Sample #2

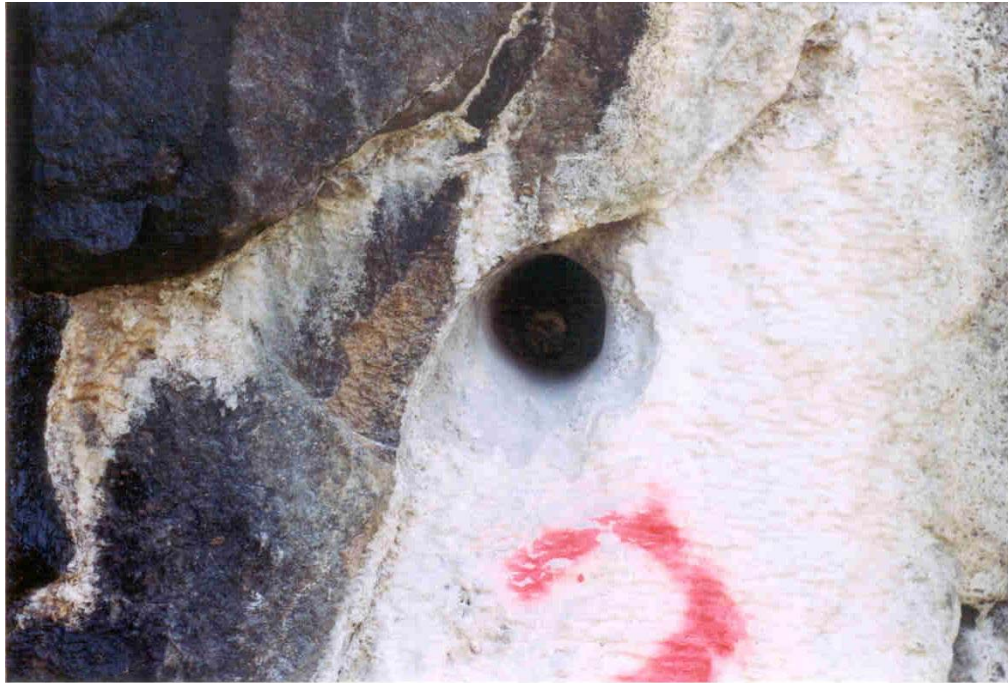
Photograph 3 – Exposed end of Tendon 2-2 after chipping

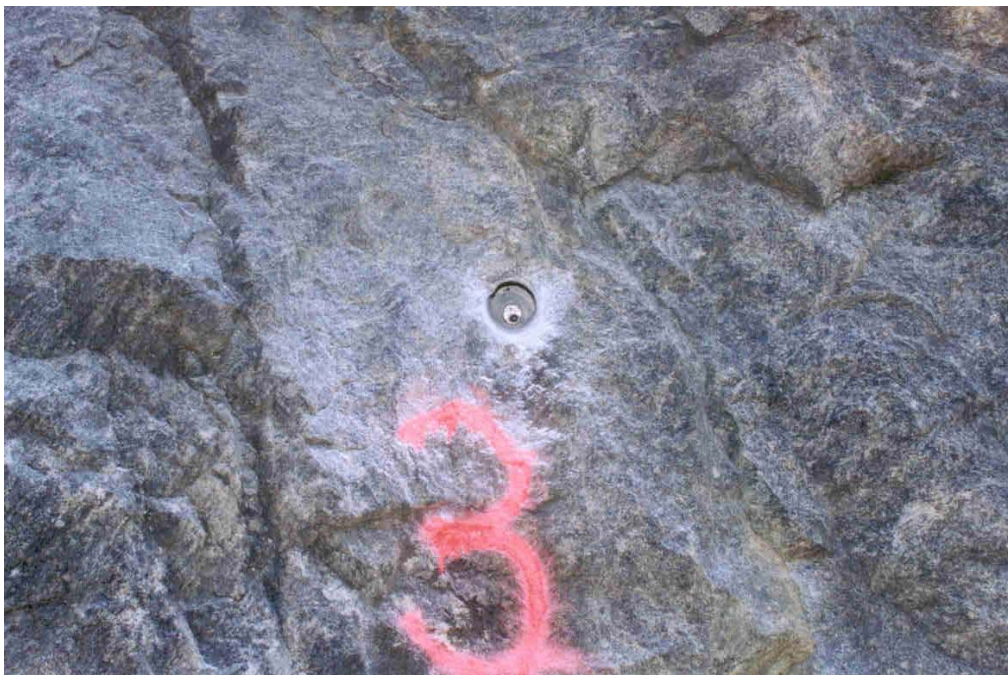
Photograph 4 – Exposed end of Tendon 3-1 after chipping
