Improve the Quality and Service Life of
Water-based Pavement Marking Paints on
Pavements with High-Iron Aggregates
Final Report

Prepared by Jacobs Engineering Group Inc. for the
New Hampshire Department of Transportation in cooperation with the
U.S. Department of Transportation, Federal Highway Administration

1. Report No. FHWA-NH-RD-15680J	2. Government Accession No.	3. Recipient's Catalog No.	
4. Title and Subtitle Improve the Quality and Service Life of Water-based Pavement Marking Paints on Pavements with High-Iron Aggregates		5. Report Date August 2015

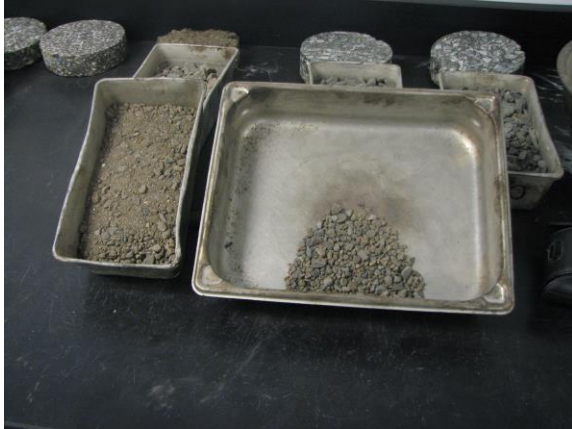
Figure 4 - NHDOT Lab – Separated Magnetic Particles

After the pavement cores were extracted, the NHDOT inserted a magnet into the sand size and smaller particles of the sample. The “magnet test” confirmed the presence of iron in the sand aggregate. Figure 4 shows the round pavement cores, the extracted magnetic aggregate. Further discussion of this testing is presented in Section III. The NHDOT laboratory testing results are provided in Appendix C.

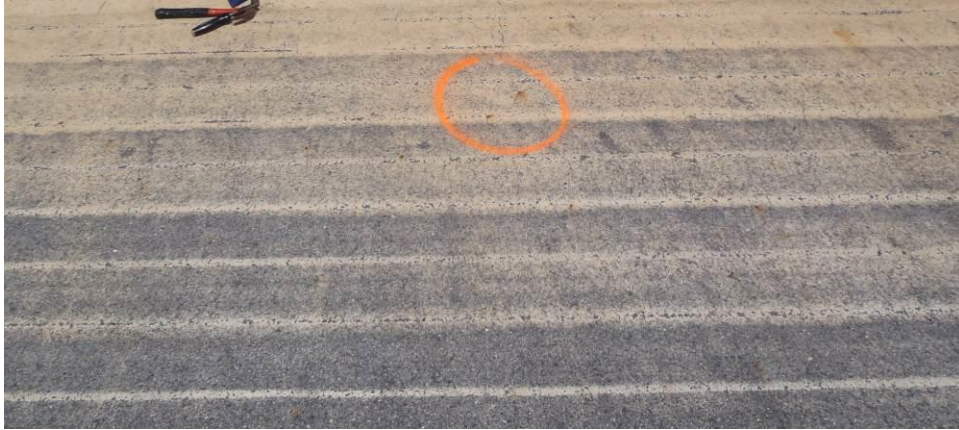
Photo 7 – Aiming point marking south side runway 10. Proposed core location 3

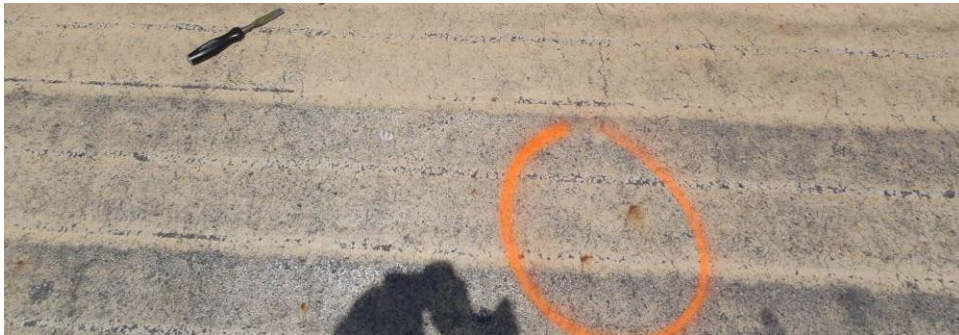
Photo 8 - Aiming point marking south side runway 10 paint sample location 6

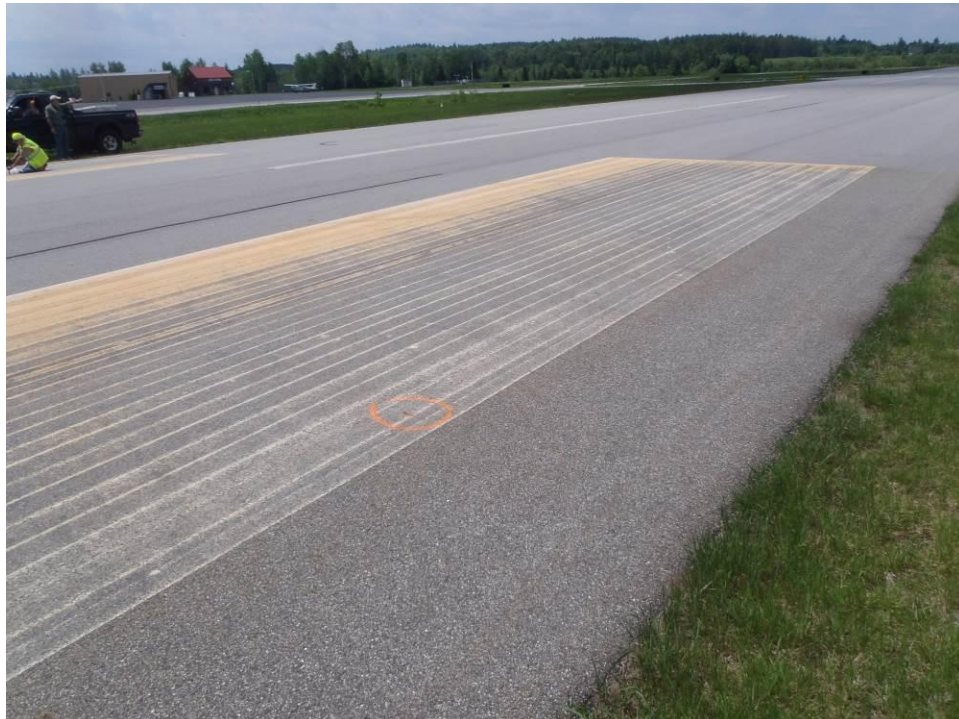
Photo 10 - Aiming point marking north side runway 10 proposed core location 4

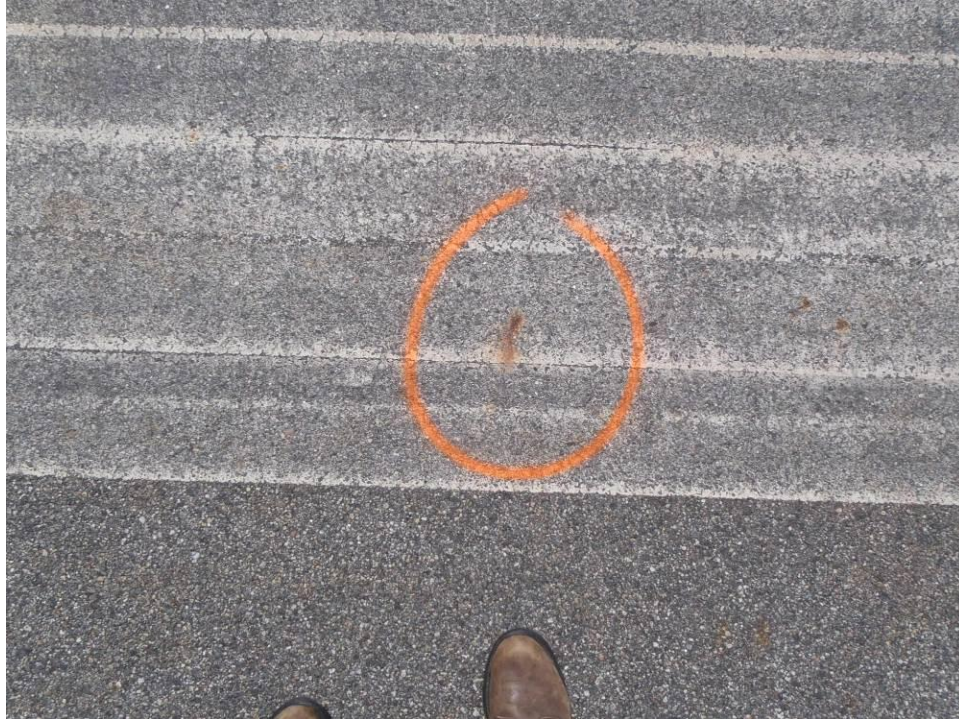
Photo 11 – Close up of proposed core 4.

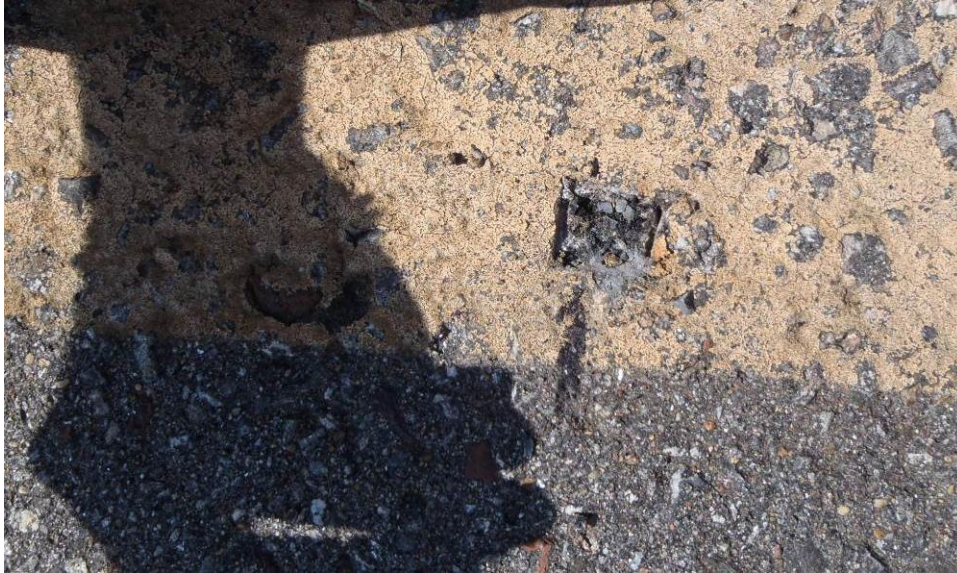
Photo 1 – Close up of sample 1 after sample was removed.

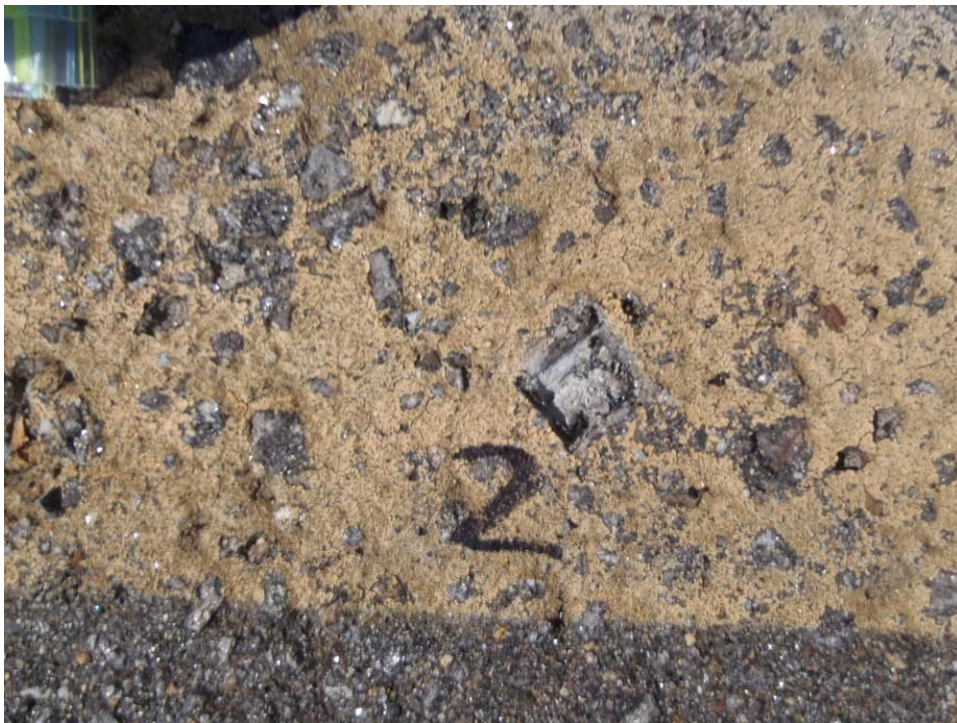
Photo 2 – Close up of sample 2 after sample was removed

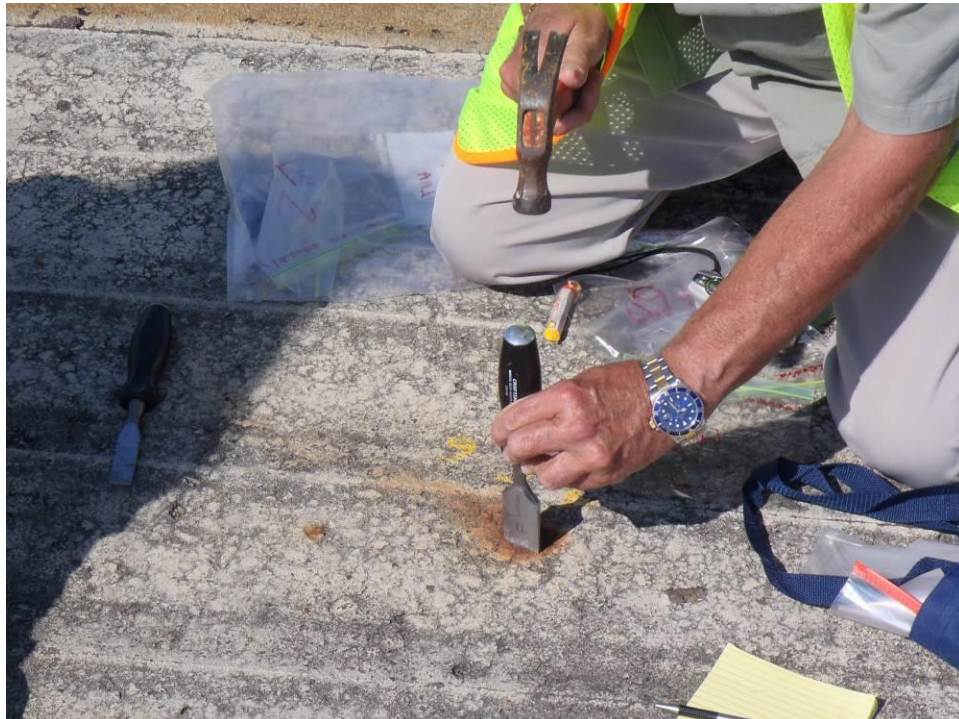
Photo 4 – Samples 4, 5 and 6 in threshold bar Runway 8

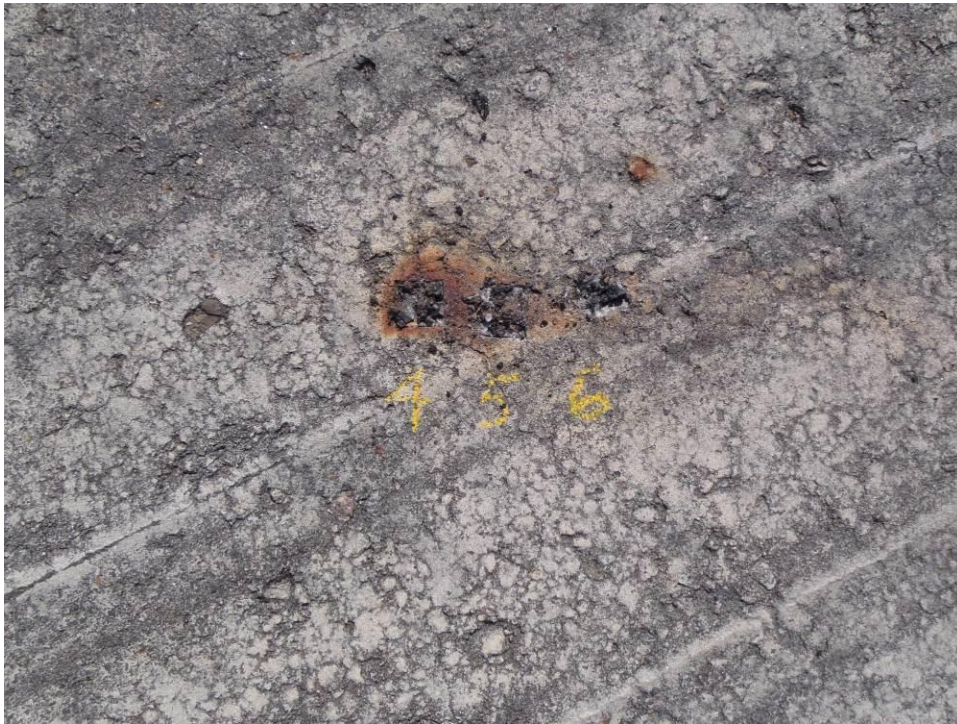
Photo 5 – Close up of paint sample locations 4, 5 and 6

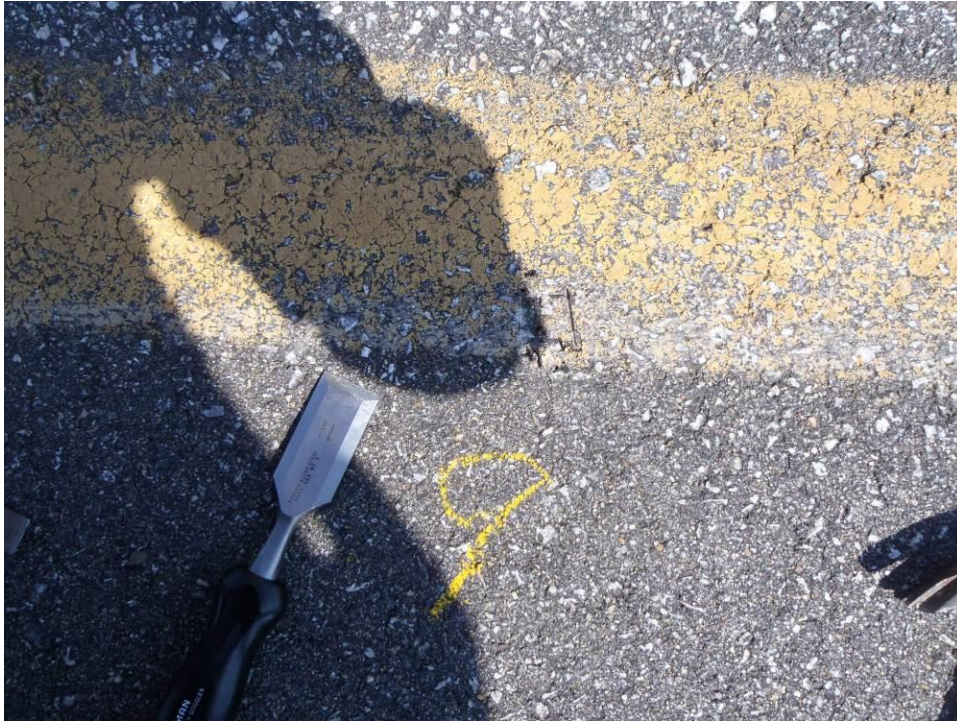
Photo 9 – Close up of paint sample 9 before removal.

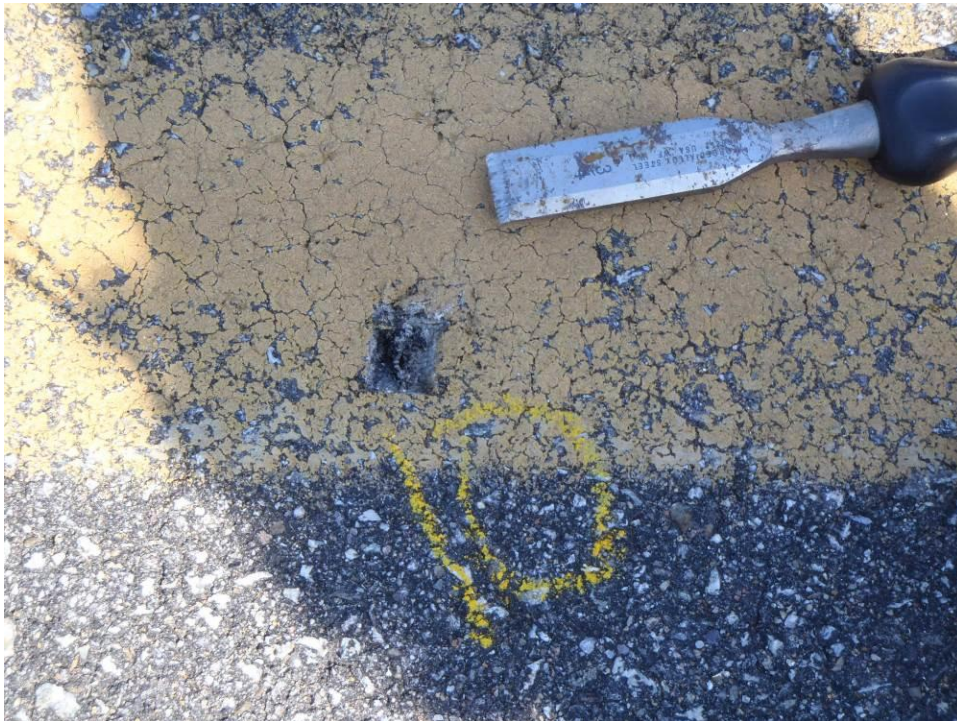
Photo 10 – Paint sample 10 after removal.

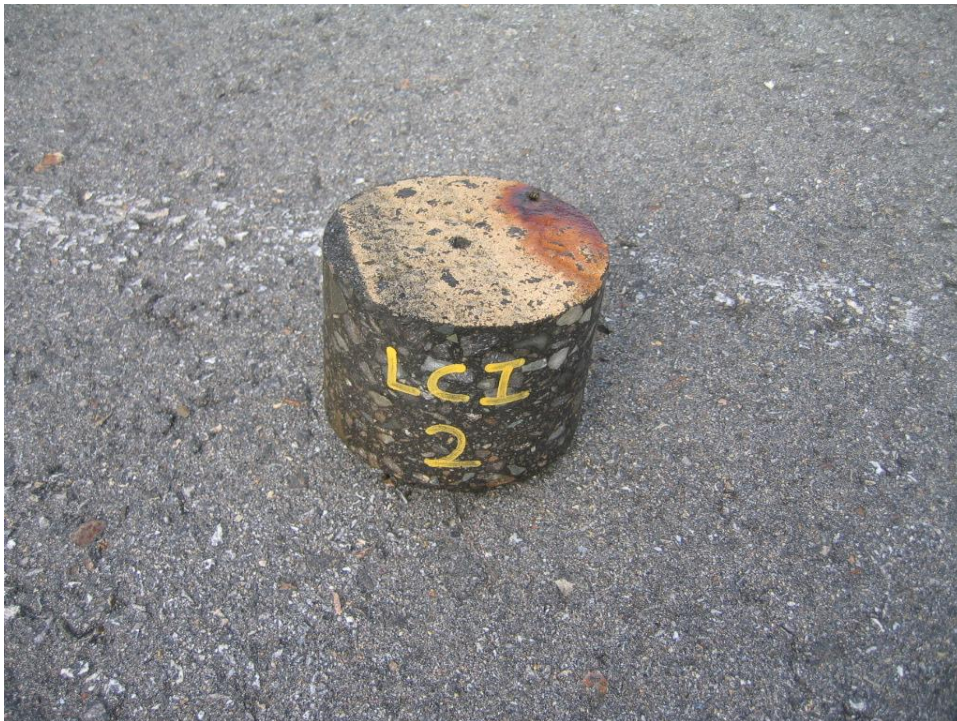
Photo 12 LCI Core 2 - blast pad right side runway 8

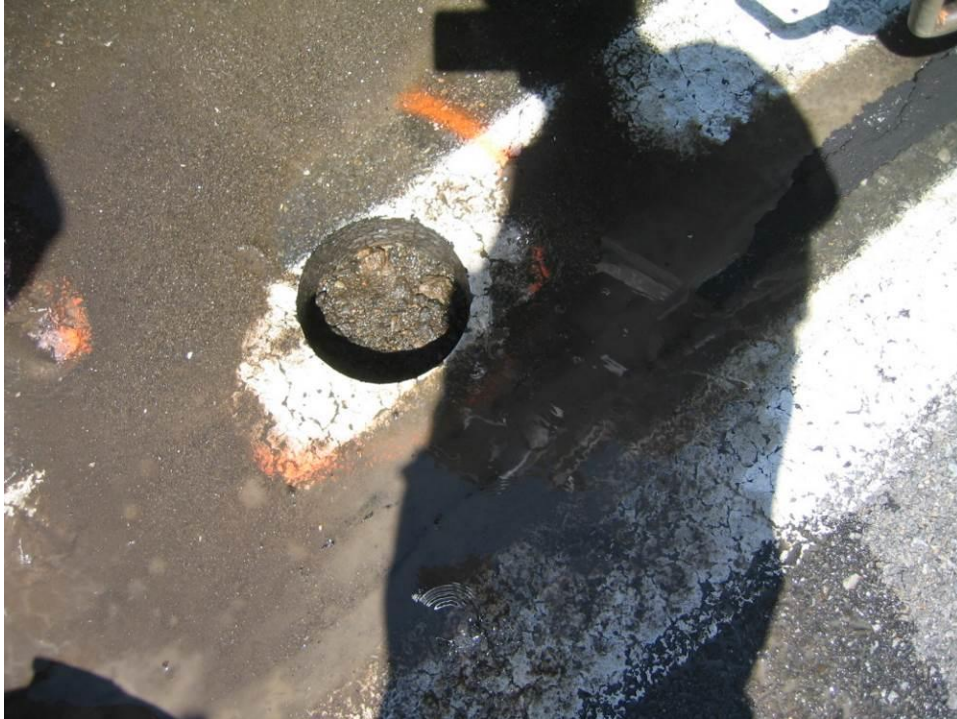
Photo 3 –Core hole

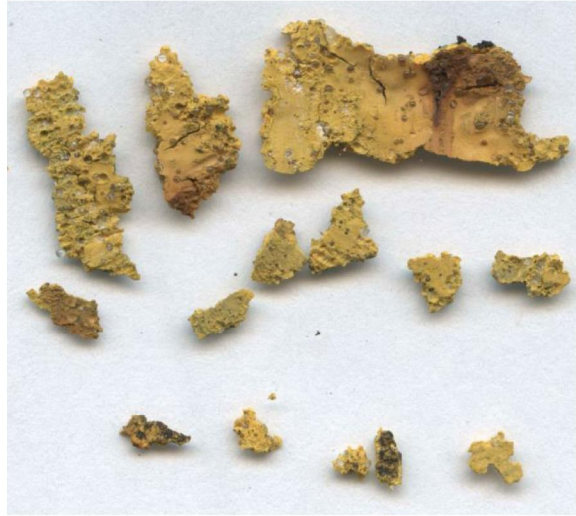
Figure 11 Keene paint chips

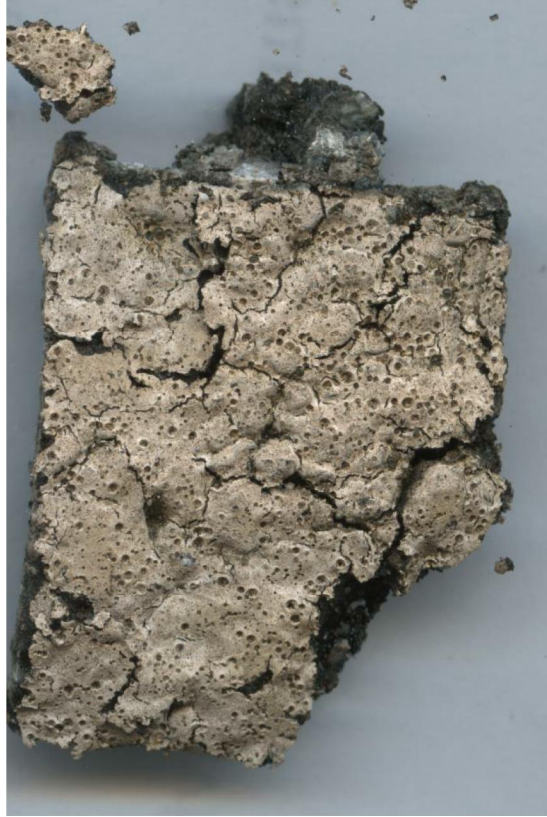
Figure 24 Whitefield paint chip showing little staining

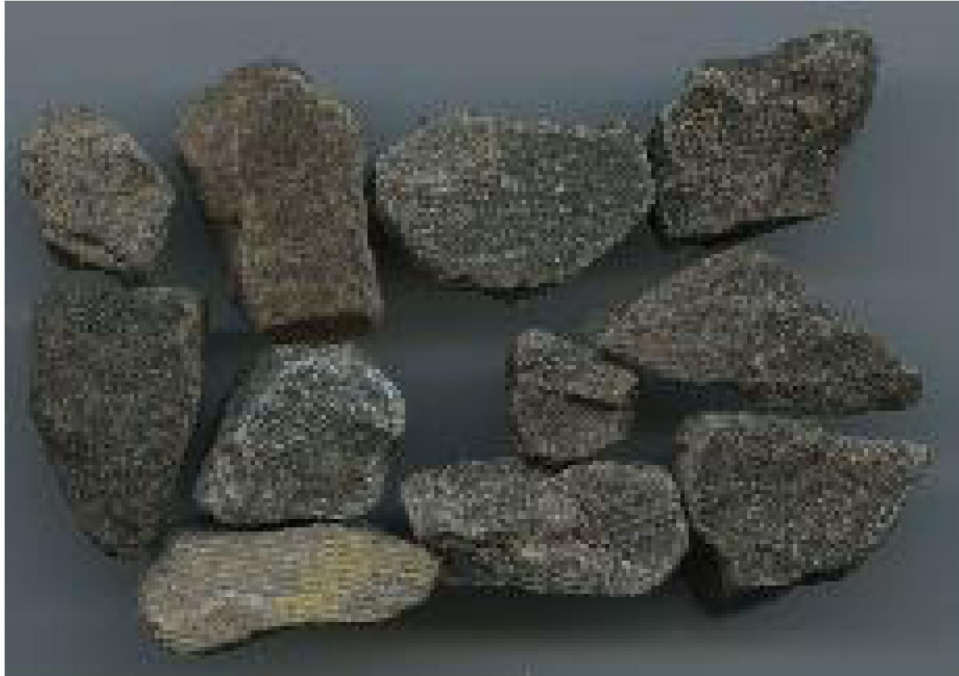
A group of the coarse size magnetic aggregates from each airport were compiled from the extracted from the cores. Figure 81 shows the ½” magnetic aggregates from Concord. The Claremont ½” magnetic aggregates are shown on Figure 82. Keene, Laconia, and Whitefield ½” magnetic aggregates are shown on Figures 83 through 85 respectively. Color, texture, visual crystallinity, grain size and shape were used to select unique aggregates for petrographic analysis. The rocks in general were variable so to make sure all possible minerals were included a total 38 different aggregate particles were selected for petrographic analysis. A selection of aggregates from each source based on visual differences discussed above included twelve from Claremont, five from Concord and fifteen from Whitefield. None were selected from Laconia for two

Figure 81 Concord magnetic aggregates

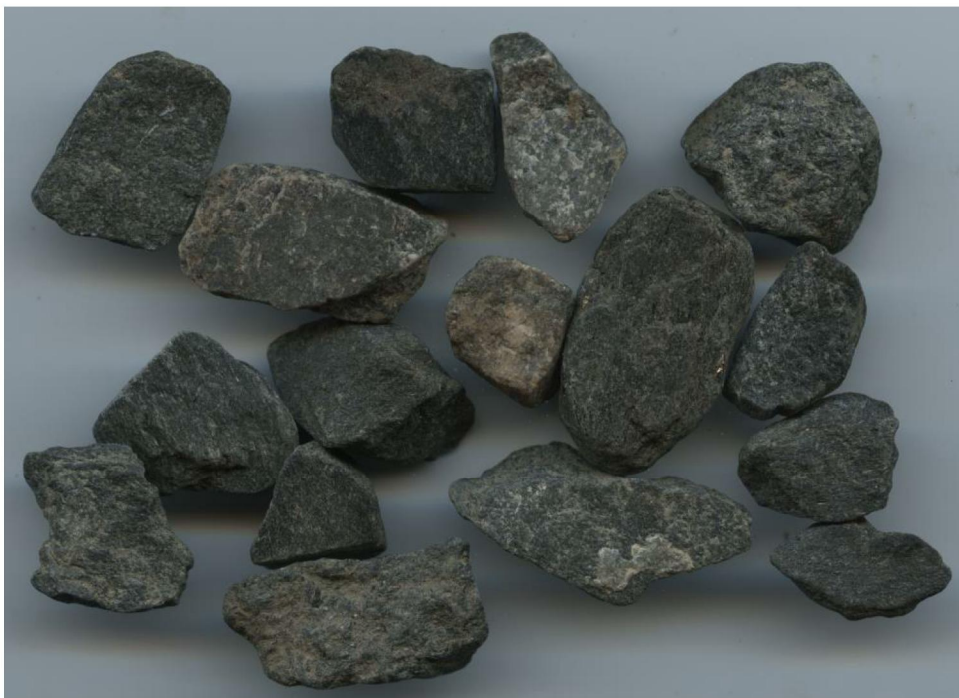
Figure 82 Claremont magnetic aggregates

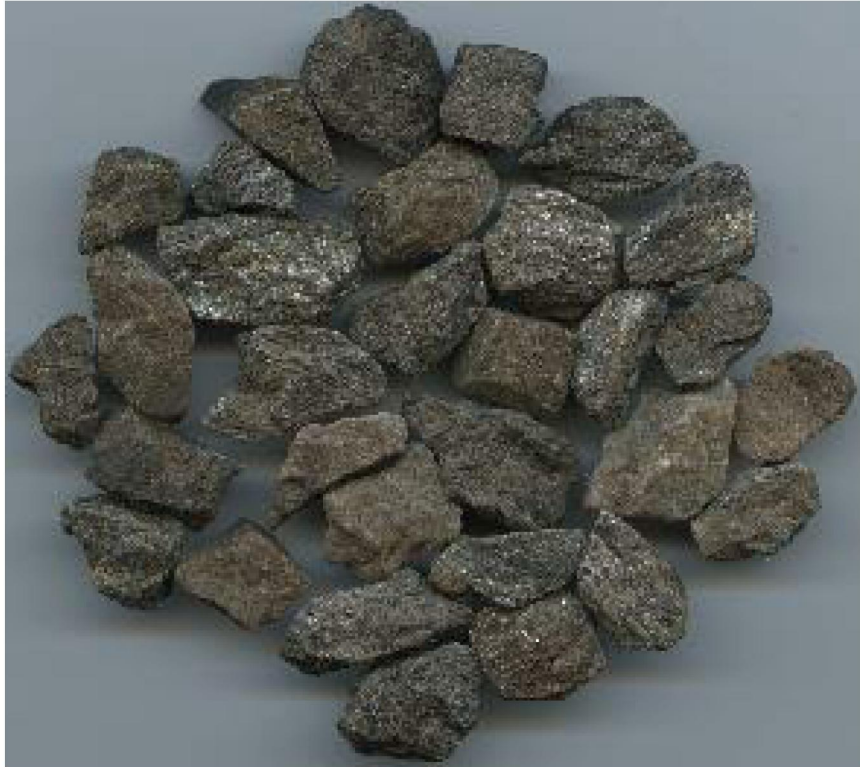
Figure 83 Keene magnetic aggregates

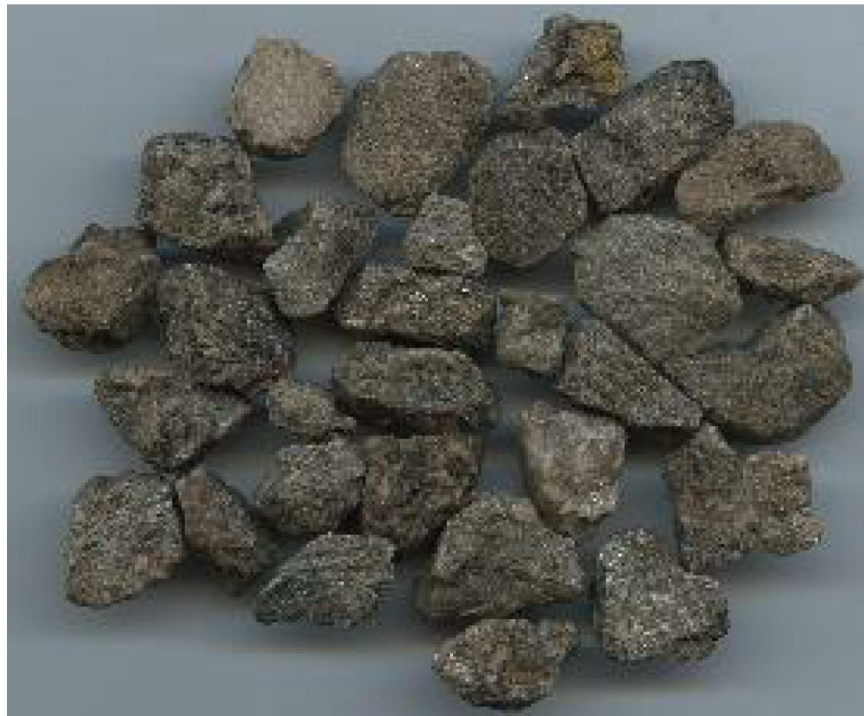
Figure 84 Laconia magnetic aggregates

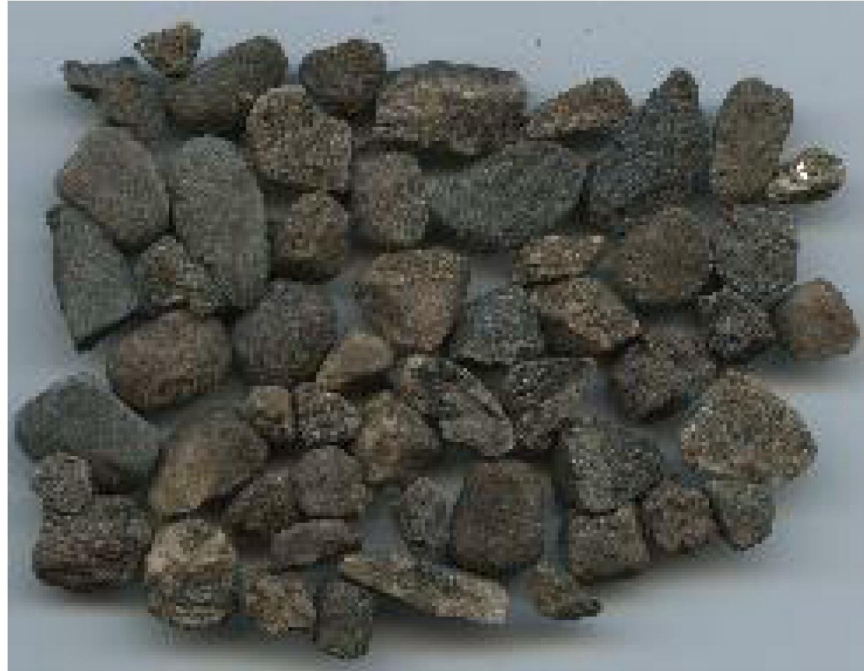
Figure 85 Whitefield magnetic aggregates

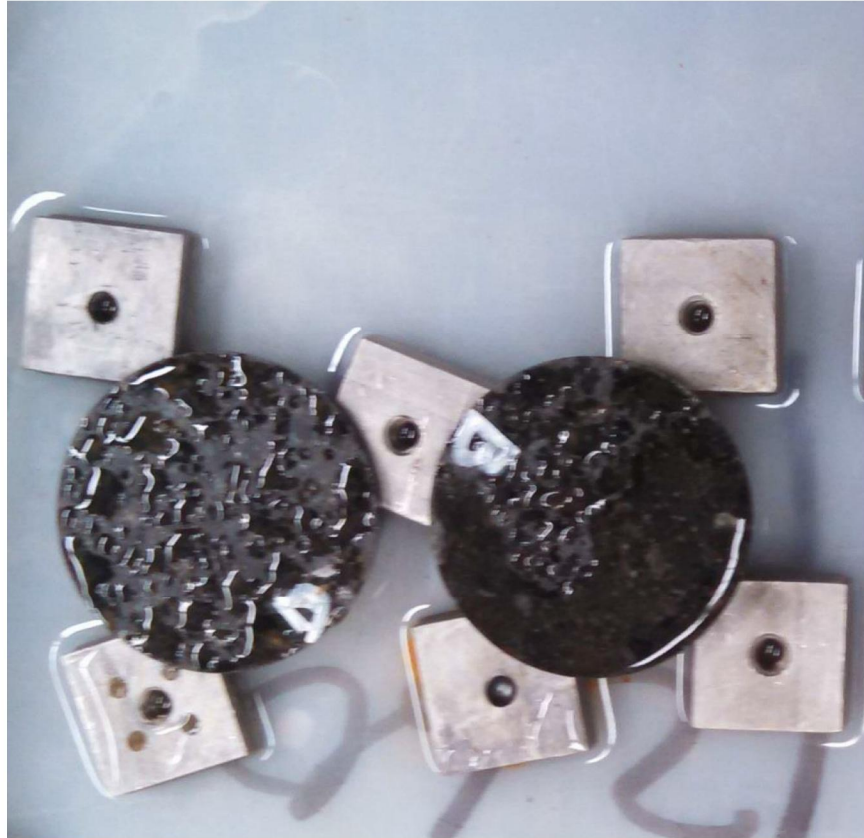
Figure 87 shows Claremont disks sides B and D placed on 1"x1"x1/4" stainless plate such that the disks were above the water line and subject to humidity only. The containers were placed in an oven held at 100 °F for 3 months. Figure 88 shows disk B/A after 3 months of storage over water held at 100 °F. It was noted that rust staining occurred on the plastic container where the stainless steel plate had been. The bottom side of the B face (side A) also showed rust where it had been placed on the stainless steel plate as shown on Figure 89. In all cases the stainless steel showed no signs of rust. The rust originates in the aggregate then becomes mobile and deposits elsewhere similar to what happens in the field on the paint markings and the HMA surface. A close up of the before and after soaked for 3 months is shown on Figure 90.

Figure 87 Claremont epoxy disks A/B and C/D stored over water
